2021 - Potable Water System Asset Management Plan Report

June 6, 2022

Township of Verona
Water Supply Treatment and Distribution Department
Essex County, New Jersey

Project No. 21004548A

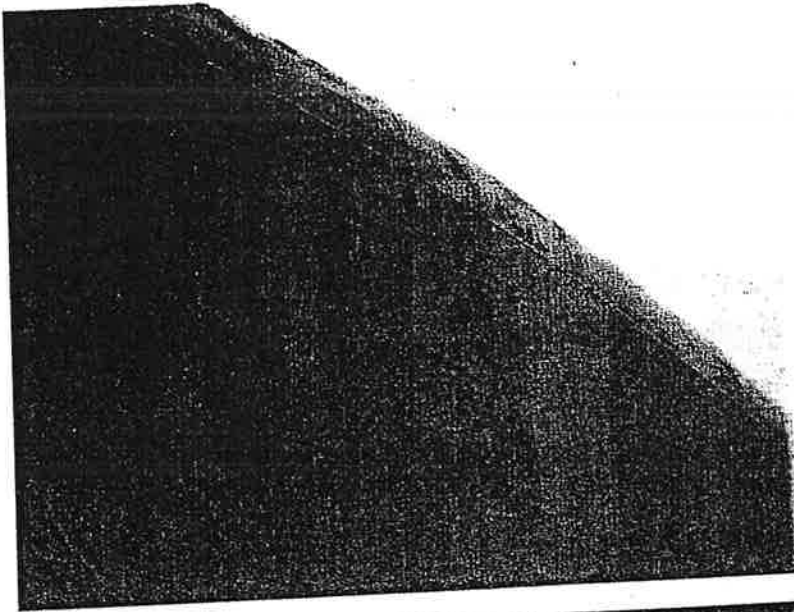
Photo #4

Notes
Pinhole corrosion on shell.

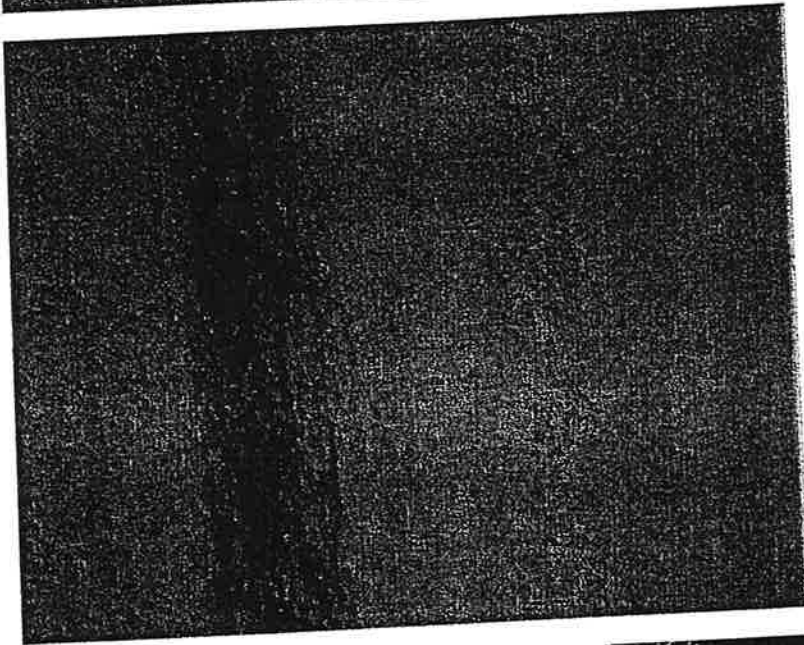
Photo #5

Notes
Pinhole corrosion on shell.

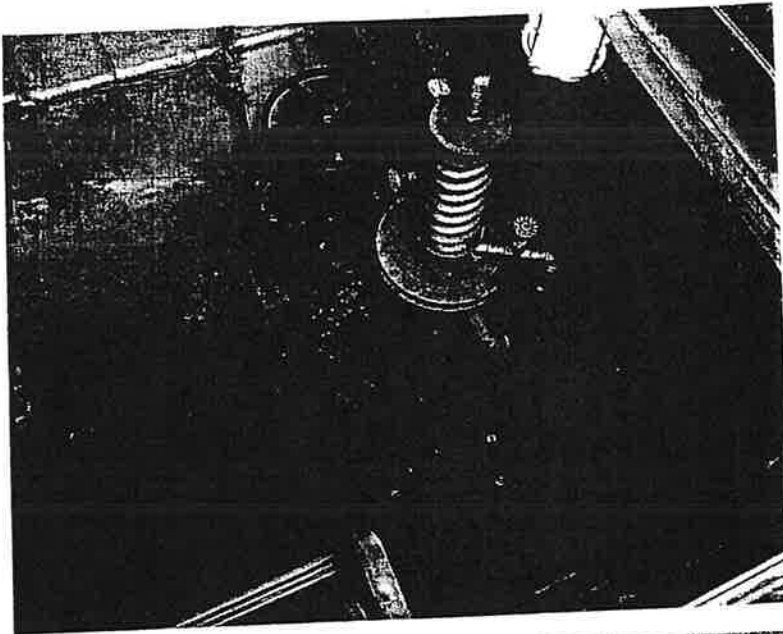
Photo #10

Corrosion on pipes.

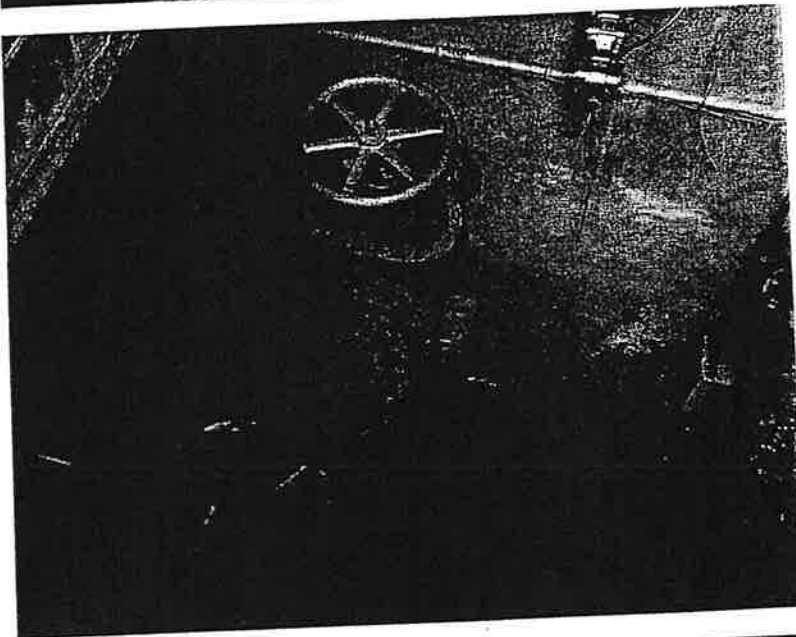
Photo #11

Corrosion on pipes.

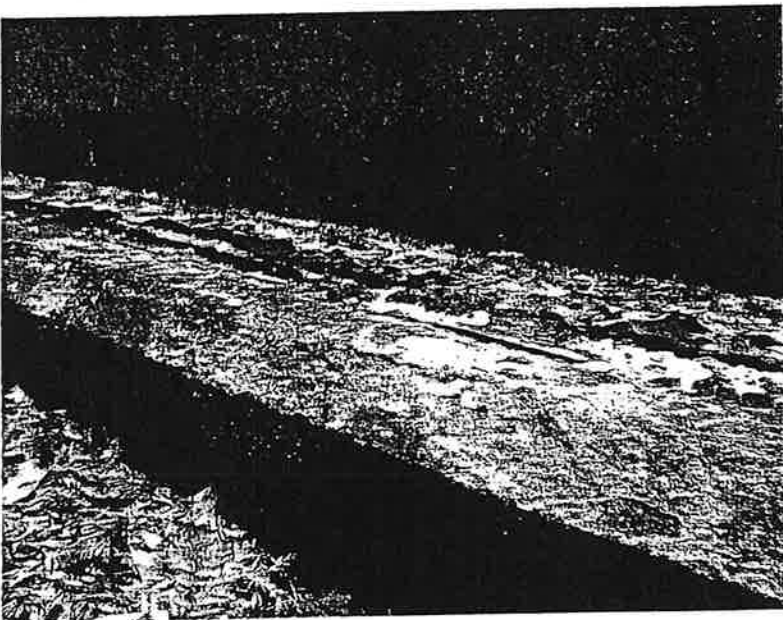
Photo #23

Corrosion on base plate, sealant breakdown, and foundation.

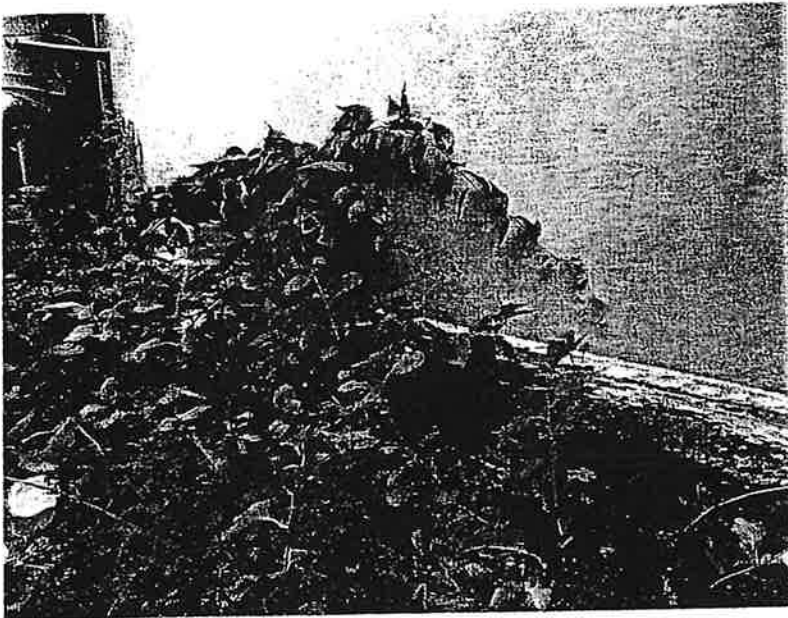
Photo #26

Overgrowth around tank foundation.

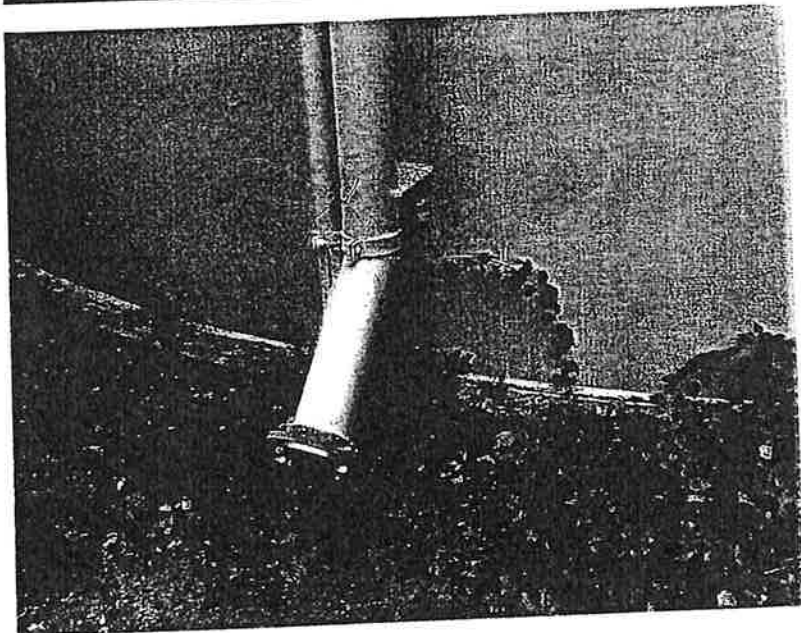
Photo #35

Corrosion on 18" x 24" shell manhole lip.

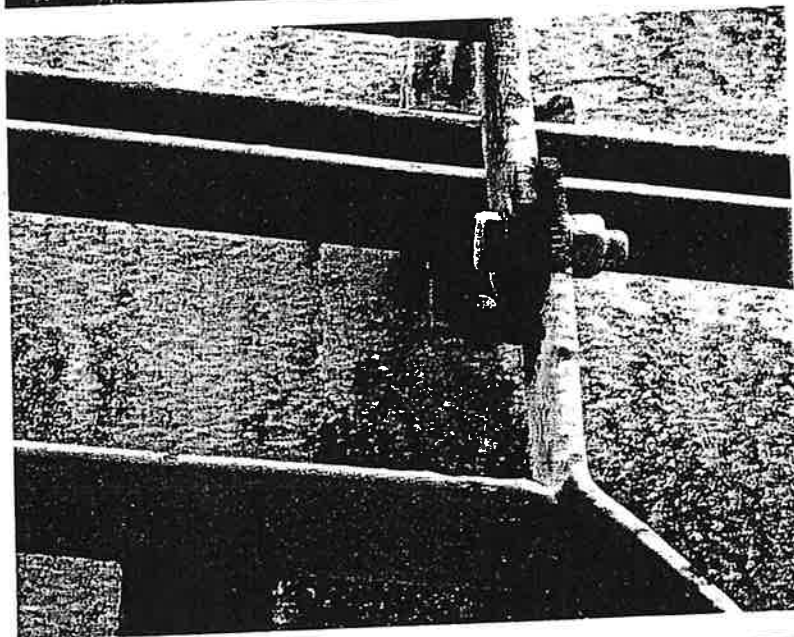
Photo #47

Corrosion on shell ladder gate hinge.

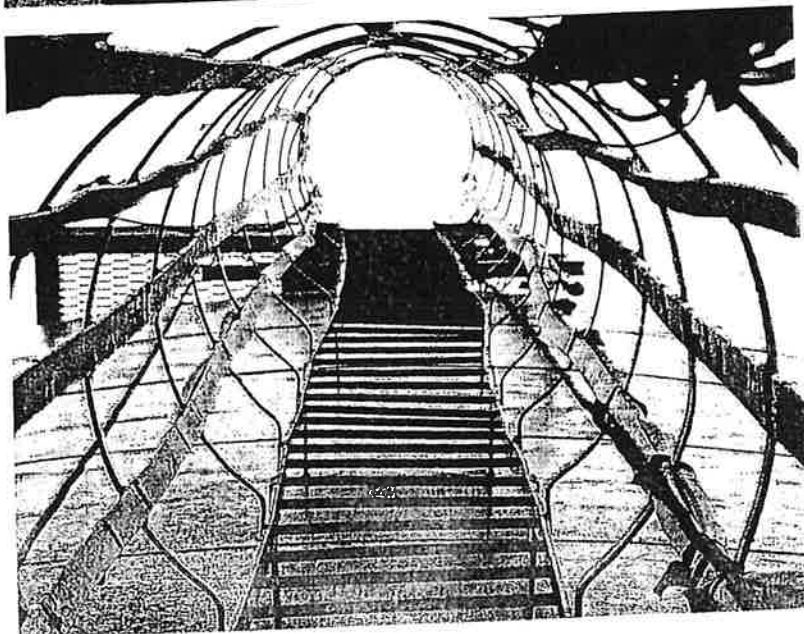
Photo #48

Corrosion on angled steel and shell.

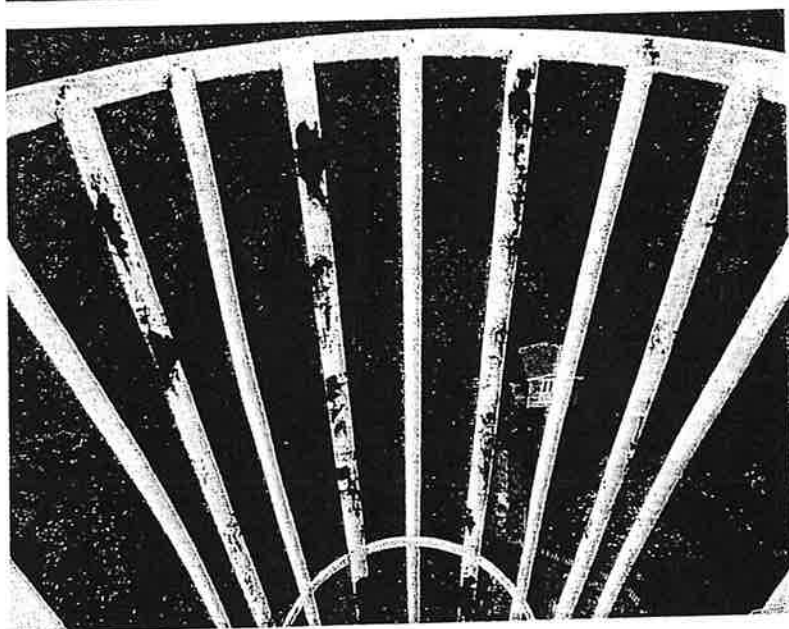
Photo #53

Corrosion on shell ladder cage.

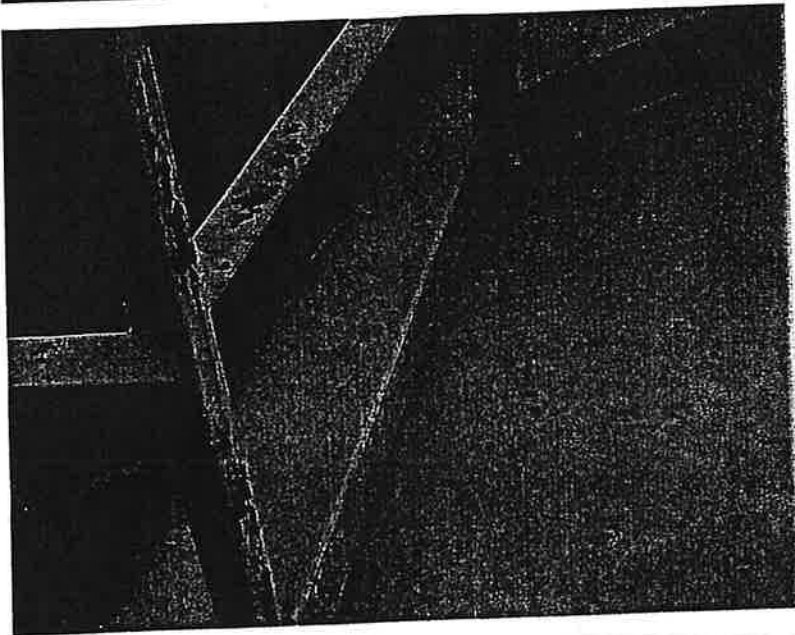
Photo # 56

Corrosion on roof handrails.

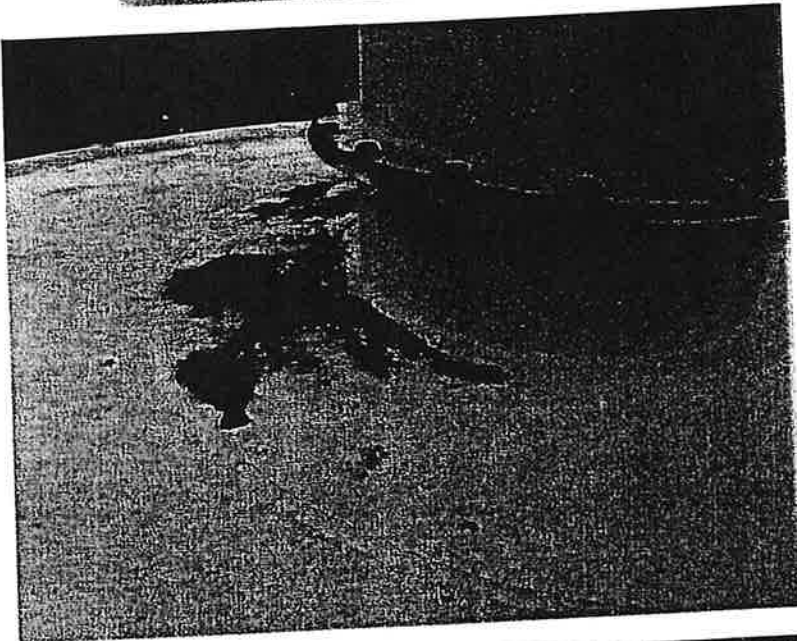
Photo #65

Corrosion at base of 18" dia. PV vent.

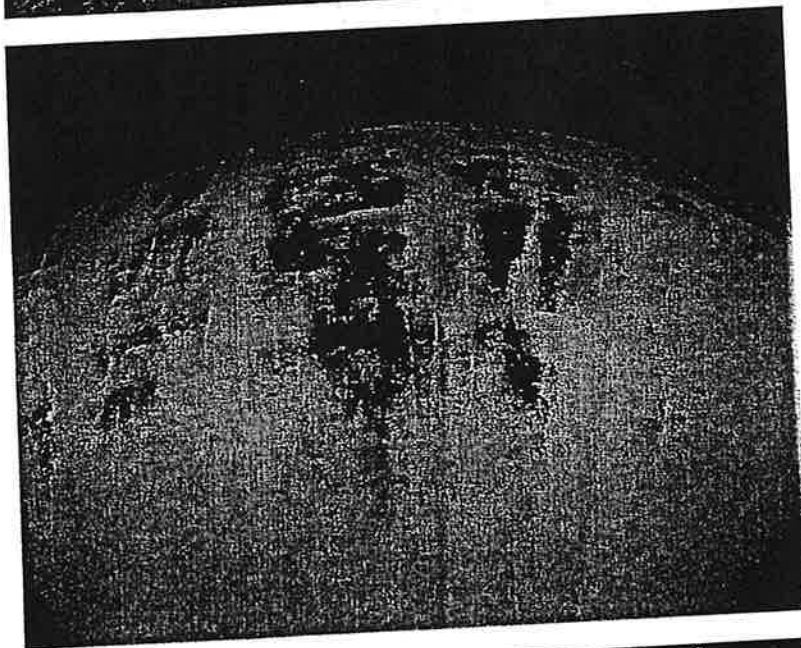
Photo #71

Corrosion on roof.

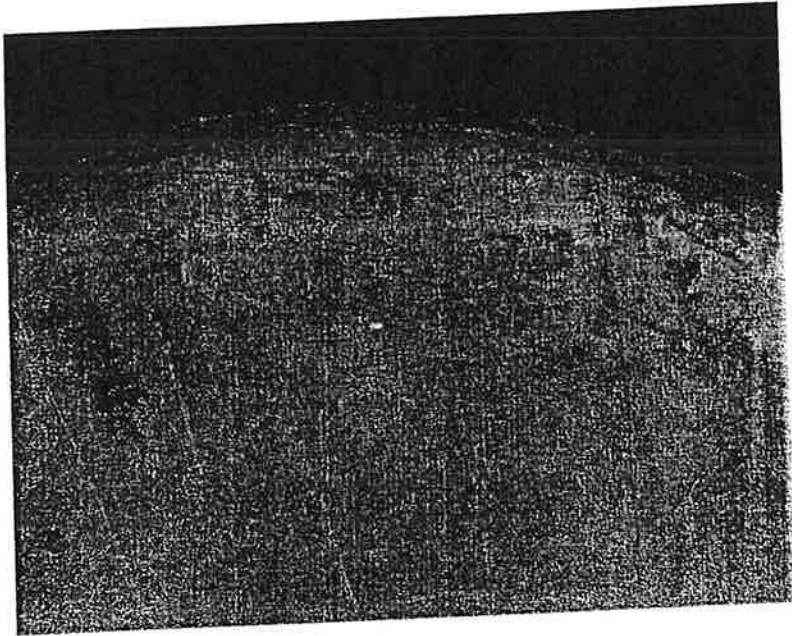
Photo #73

Notes
Corrosion on roof.

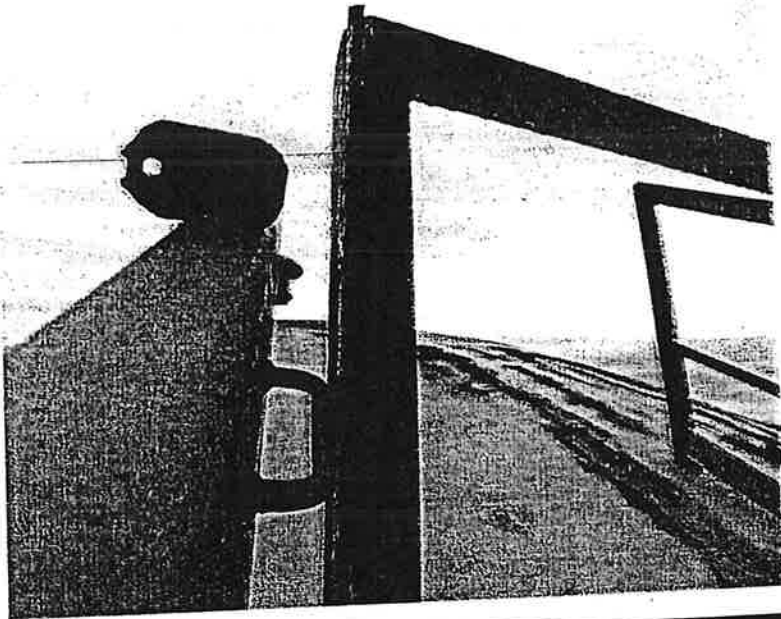
Photo # 76

24" x 24" roof manhole grab handle rests on roof handrail vertical post when opened.

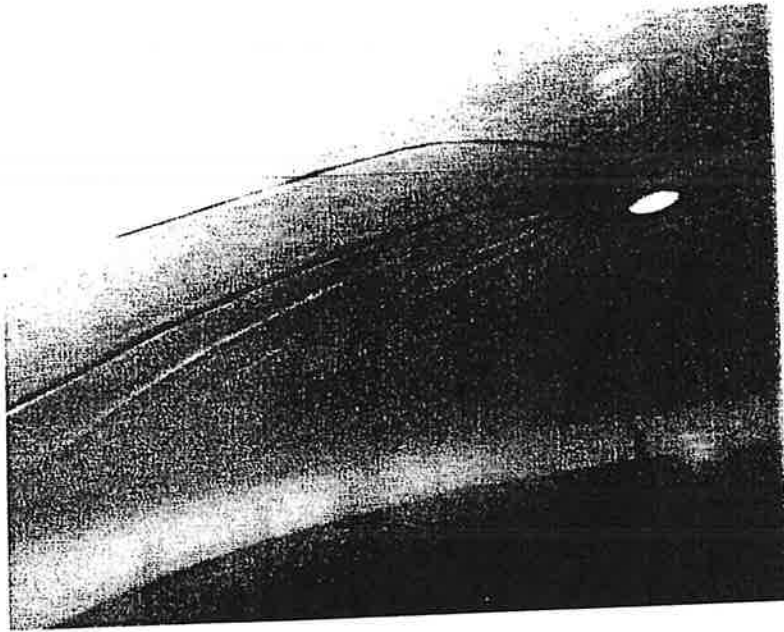
Photo #79

Coating on roof and rust staining in lap seams.
