## Wedgewood Gardens

### Preliminary Tree Preservation Report - Revised

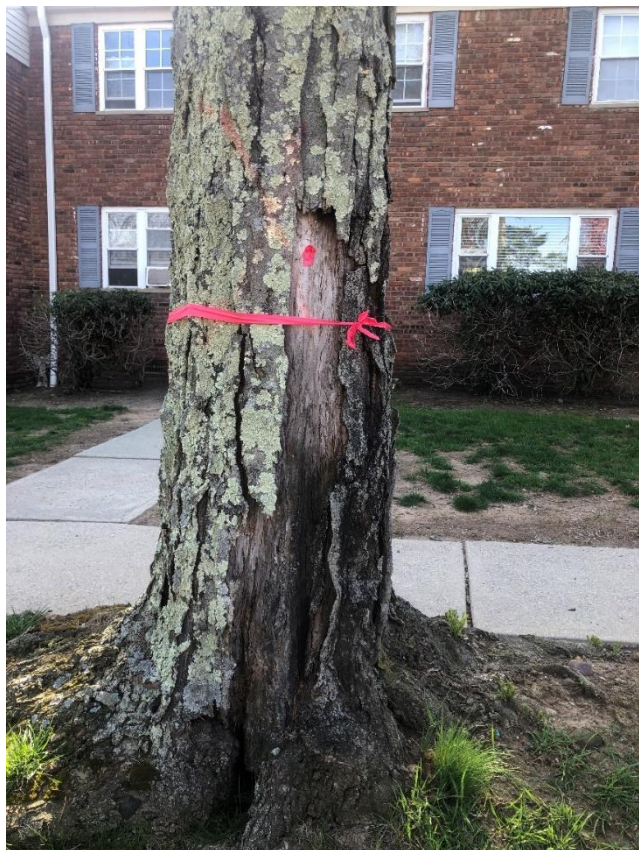
**Photo 1.** Common honeylocust #34 was in poor condition with decay in the stem and root flare.

All 17 of the trees were within 3 feet of the curbing and parking lot. 16 of the trees were in fair condition and had roots causing pavement and curbing damage. Common honeylocust (#34) was in poor condition and had decay in the stem and root flare. I do not expect these trees to survive the anticipated impacts.

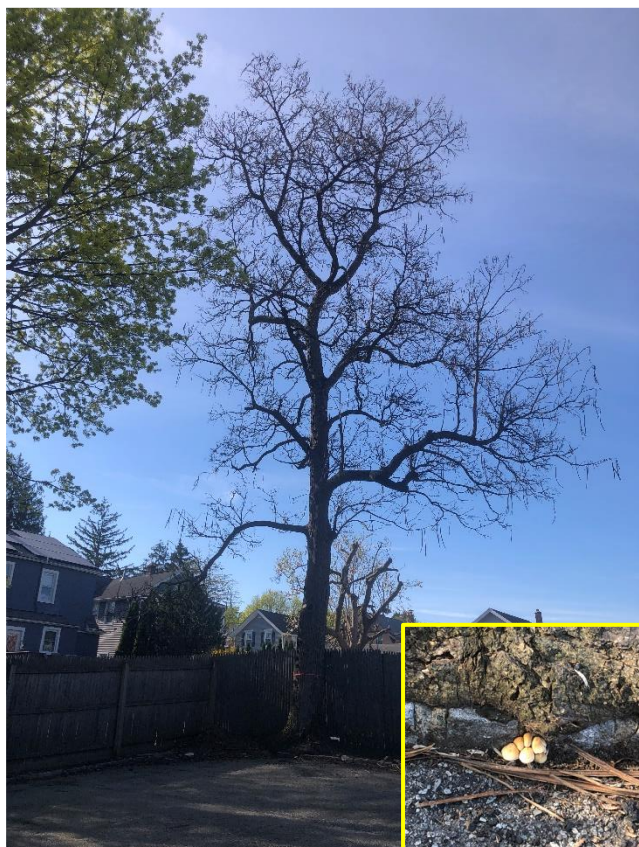
**Photo 2.** Northern catalpa #1 was in fair condition with curbing damage and unidentified fungi on a root flare (inset).
