PUBLIC SAFETY COMPLEX COUNCIL MEETING

PUBLIC SAFETY COMPLEX - CONCEPT

POLICE DEPARTMENT, FIRE DEPARTMENT - CO. #2, RESCUE SQUAD

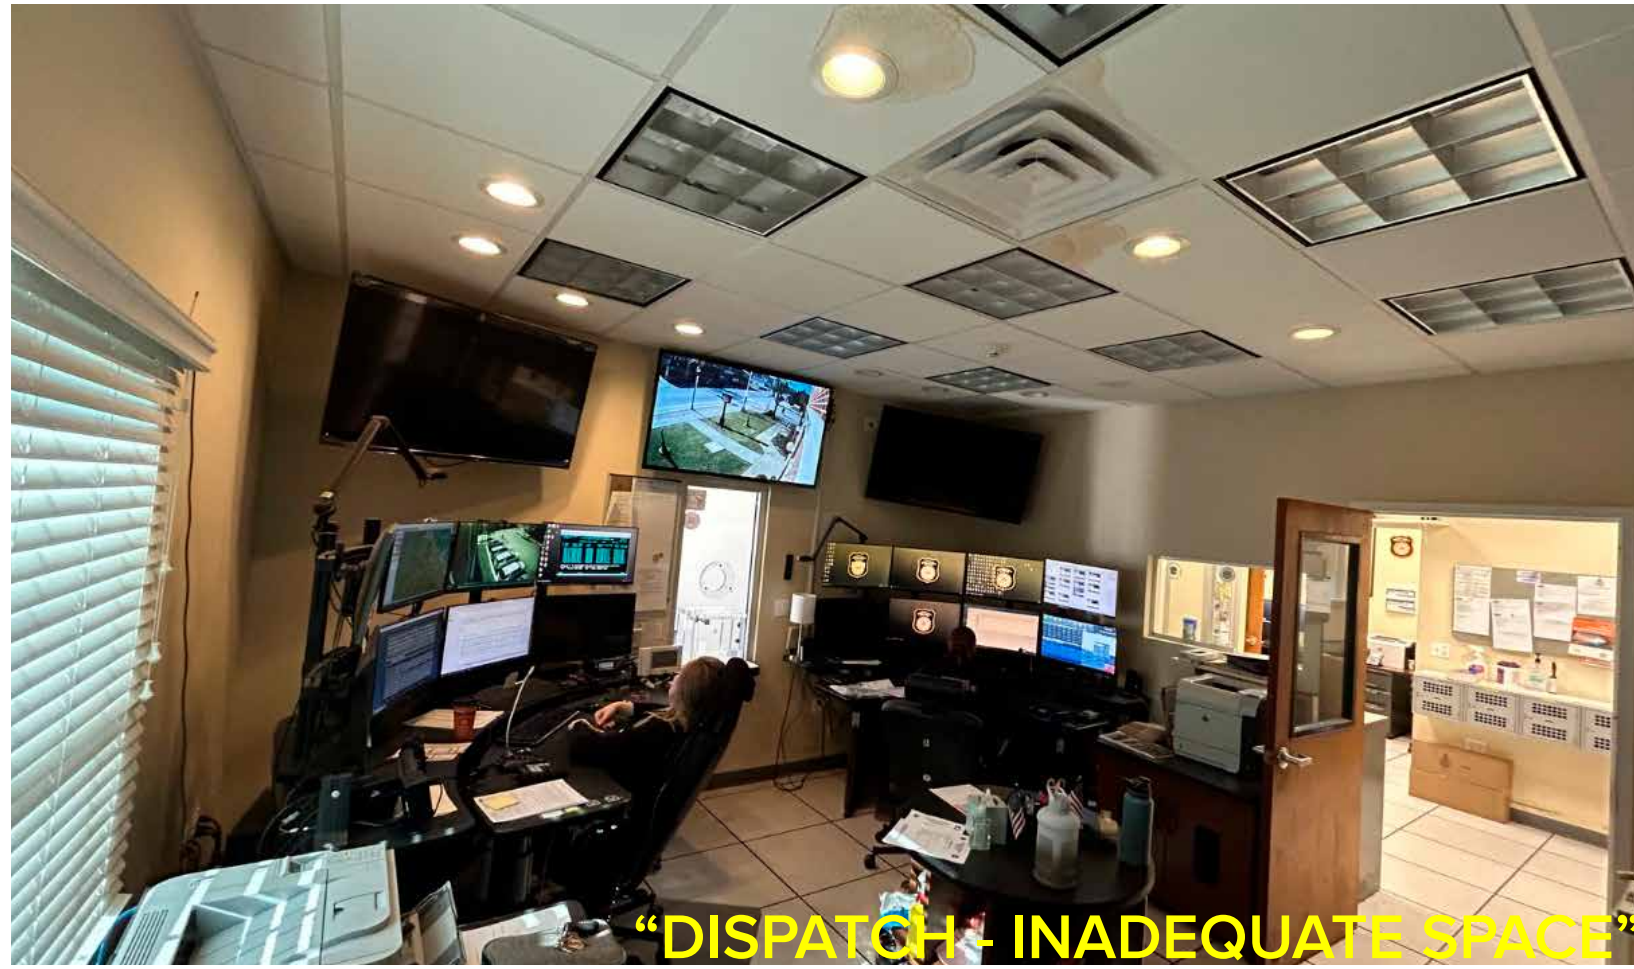
"DISPATCH - INADEQUATE SPACE"

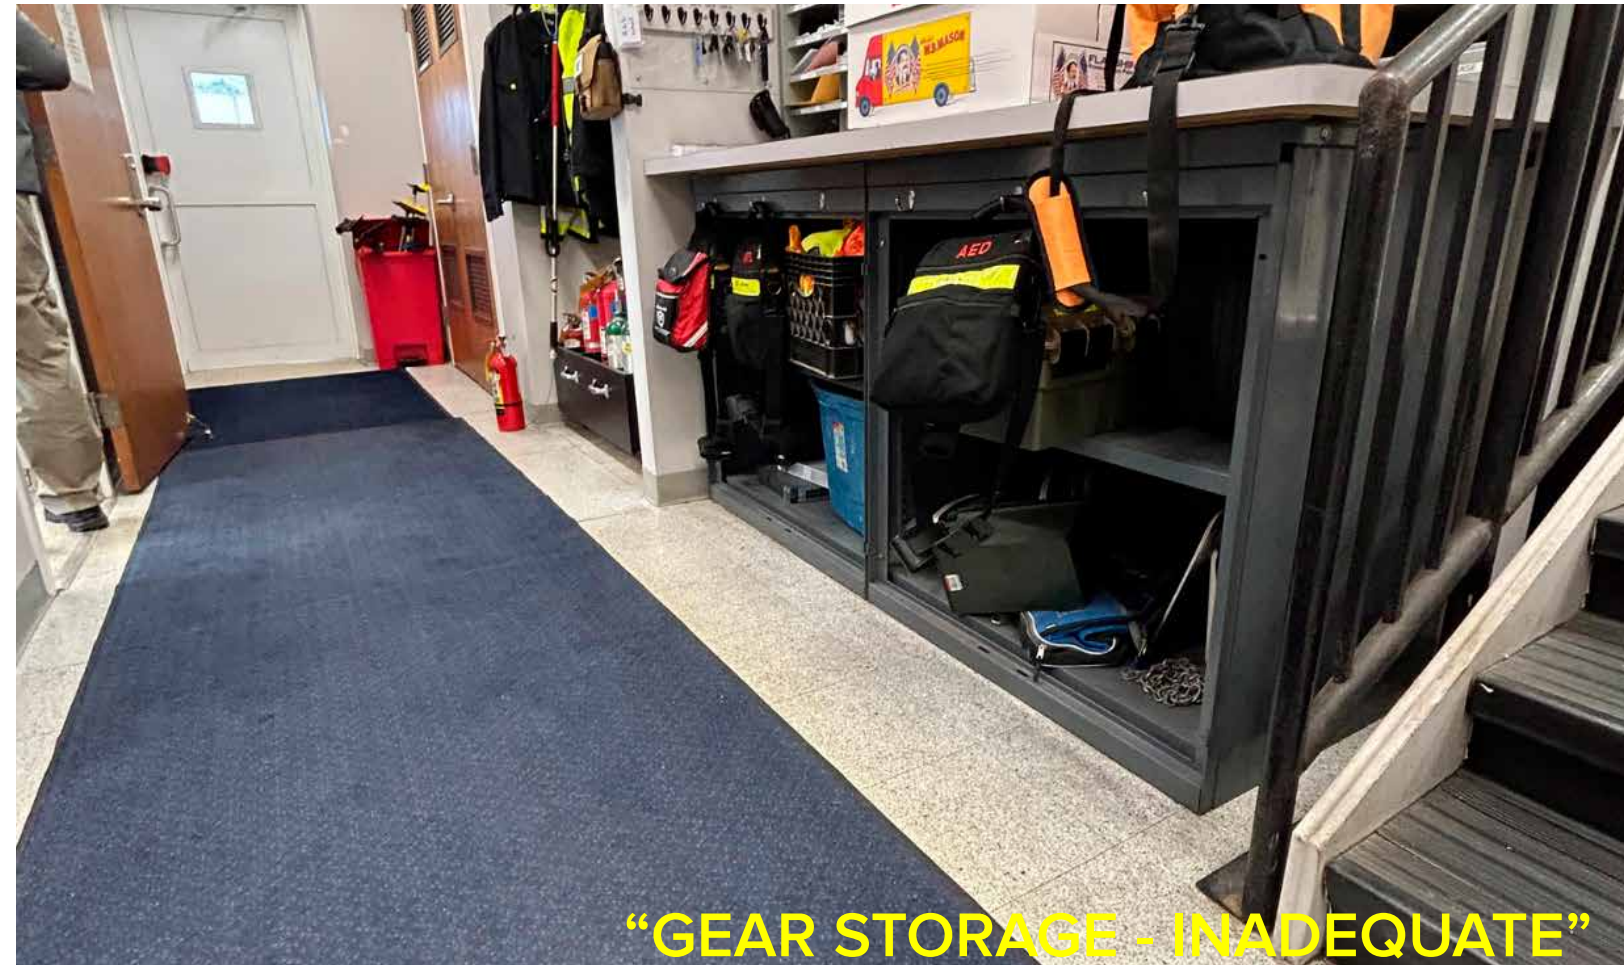
"GEAR STORAGE - INADEQUATE"

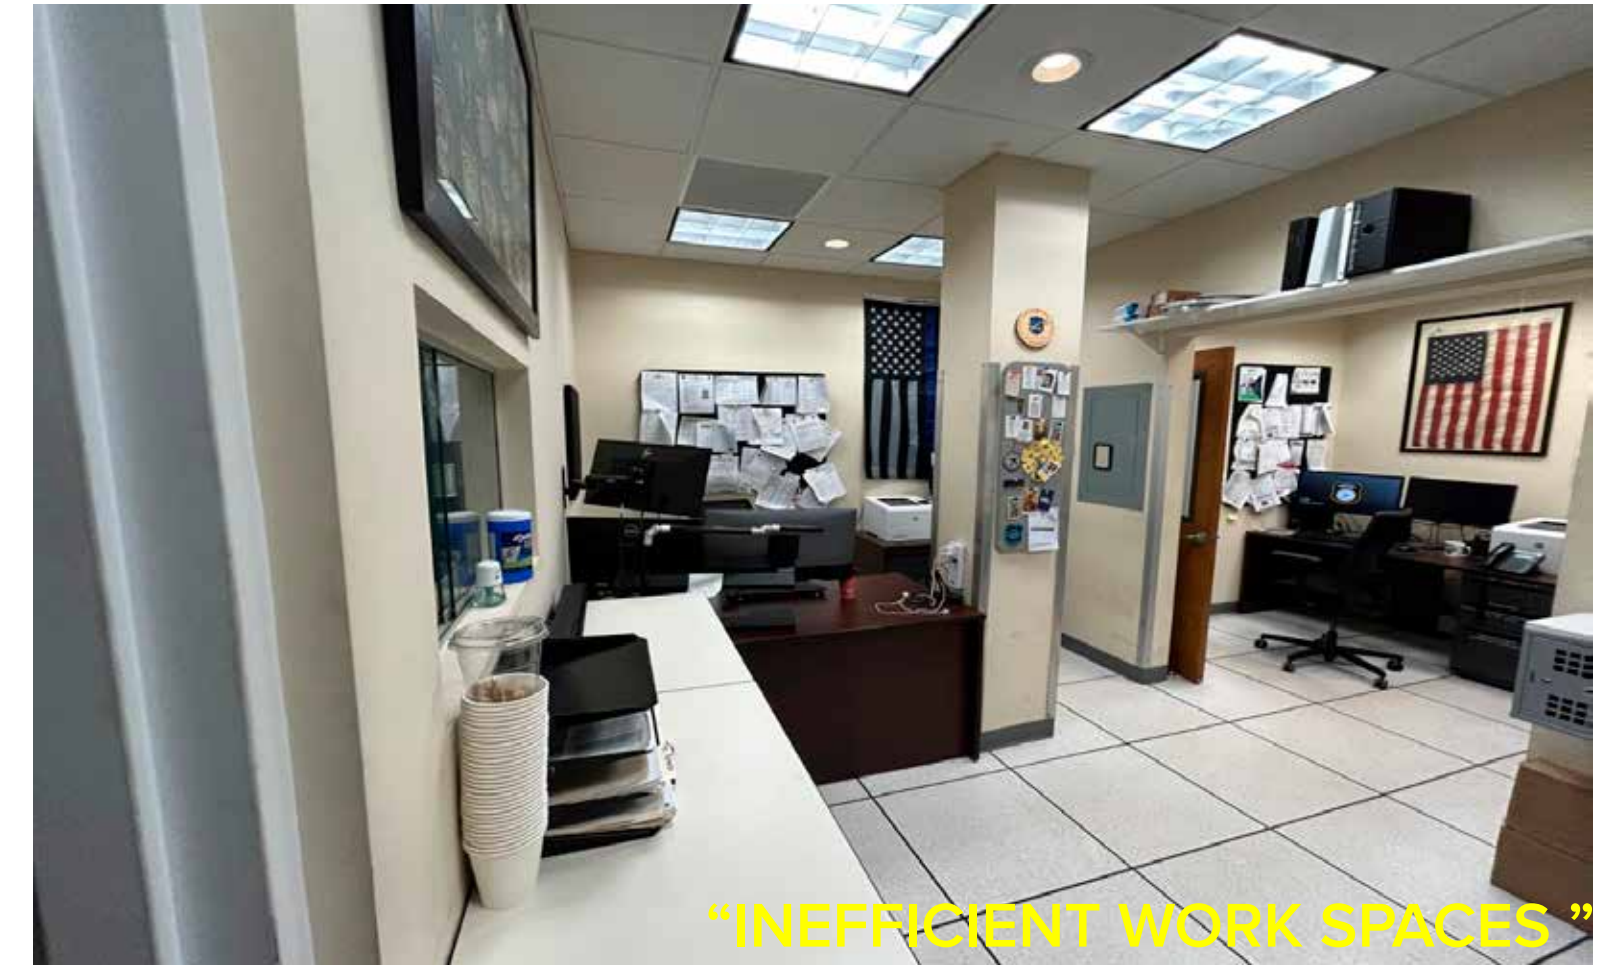
"INEFFICIENT WORK SPACES"

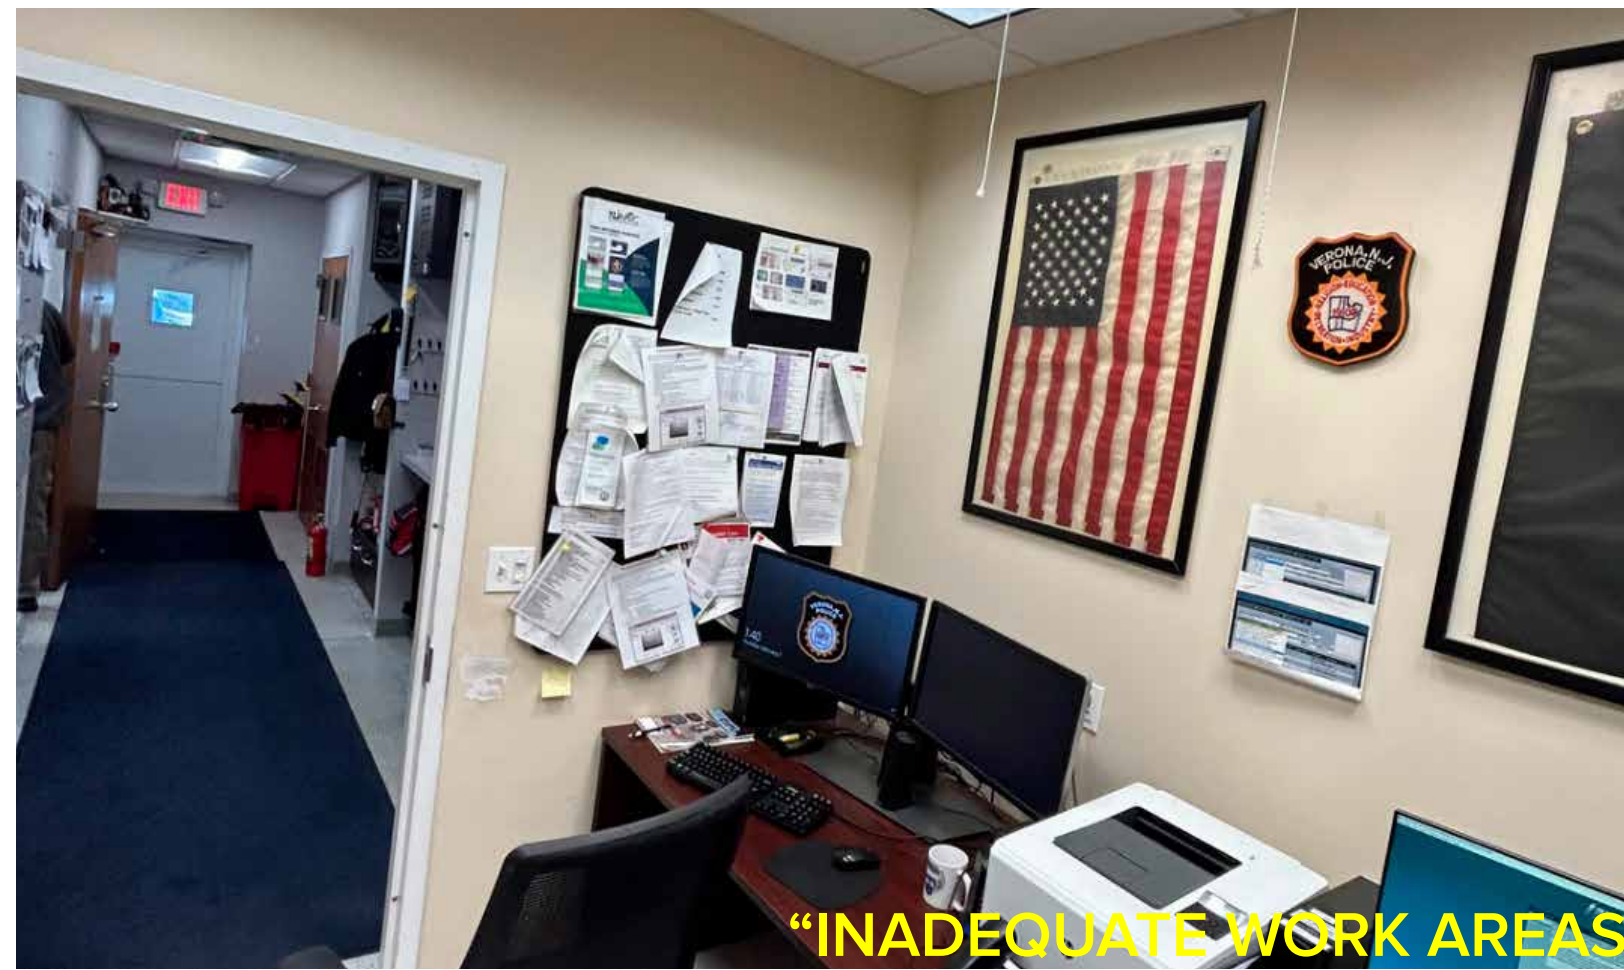
"INADEQUATE WORK AREAS"

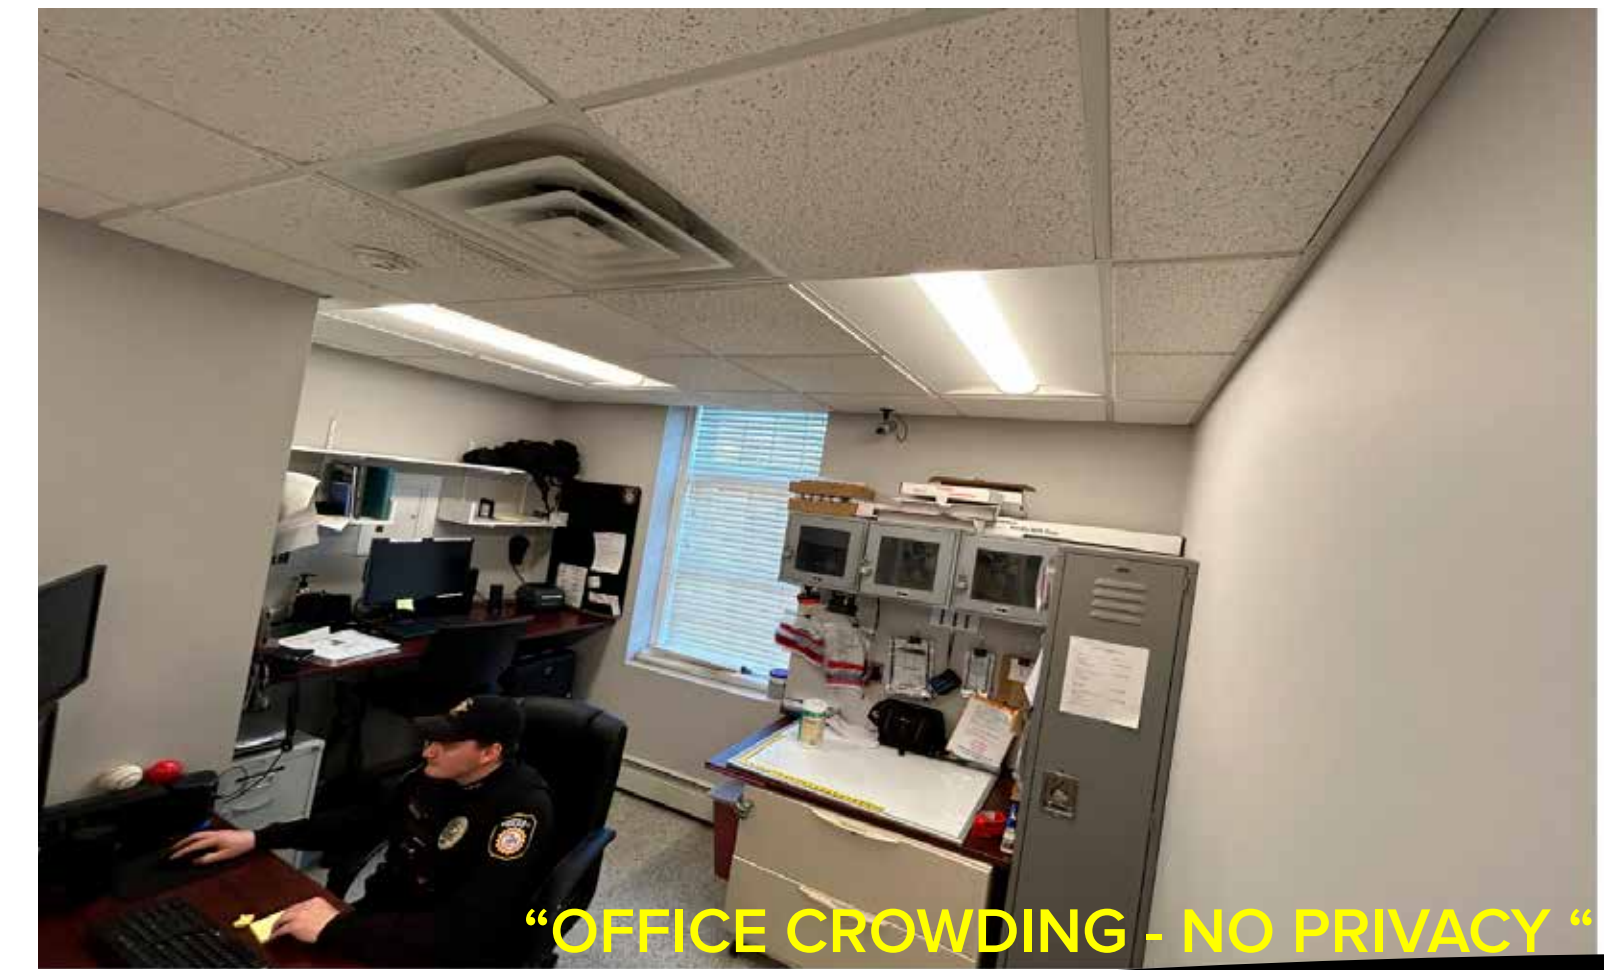
"OFFICE CROWDING - NO PRIVACY"

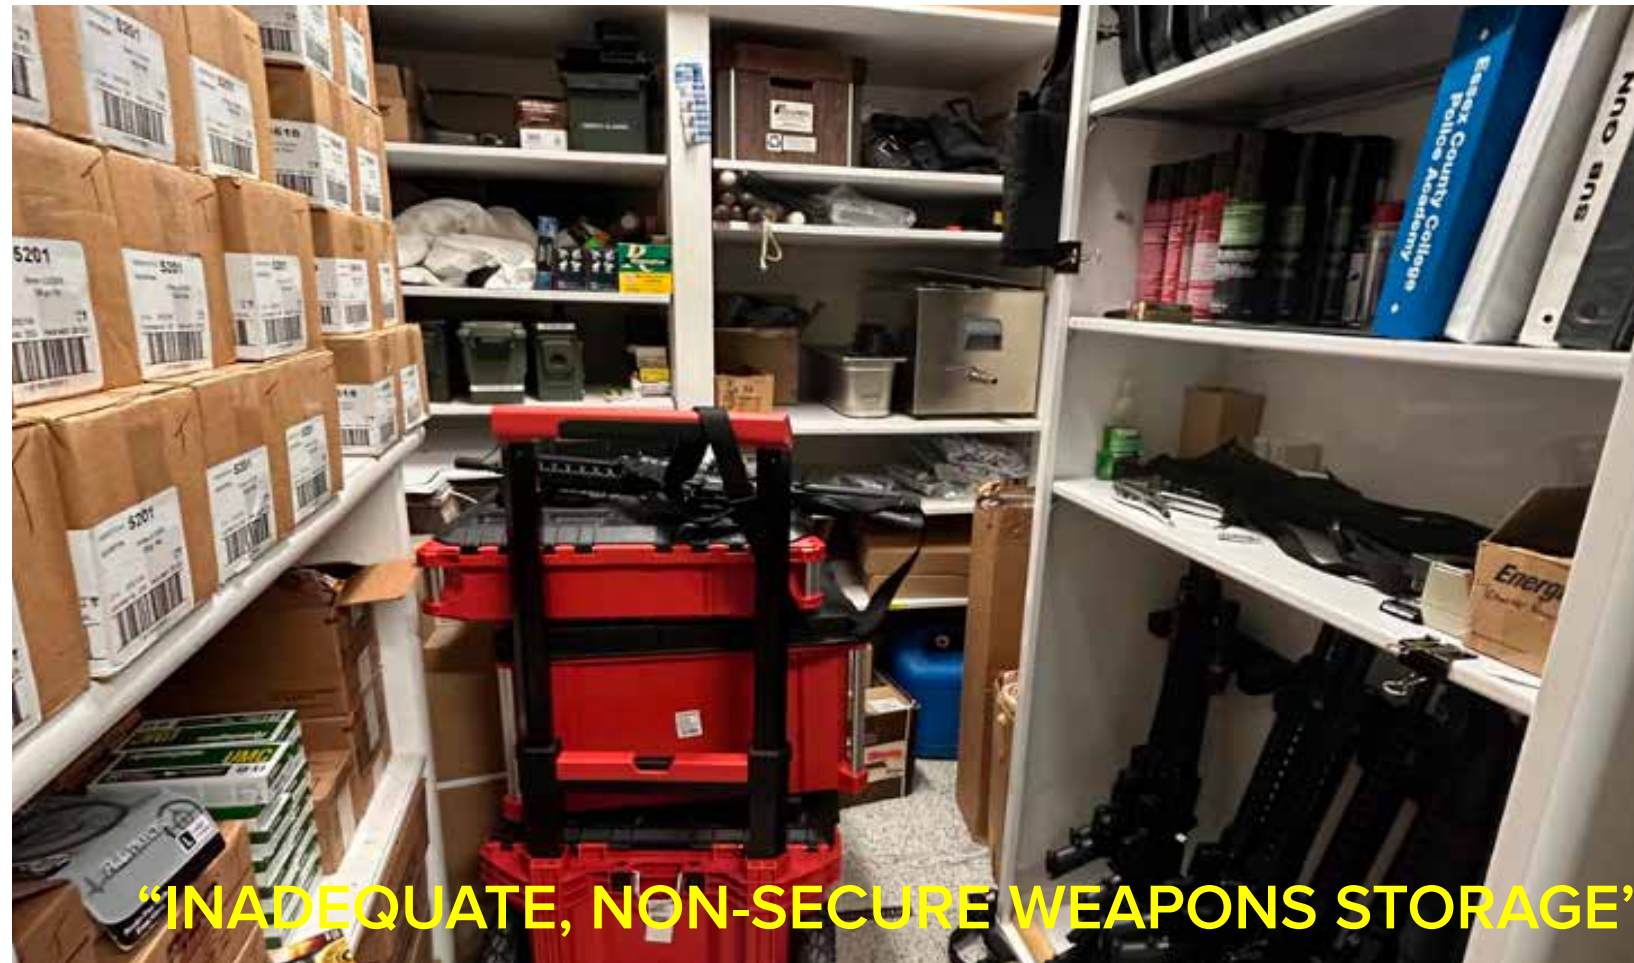
"INADEQUATE, NON-SECURE WEAPONS STORAGE"

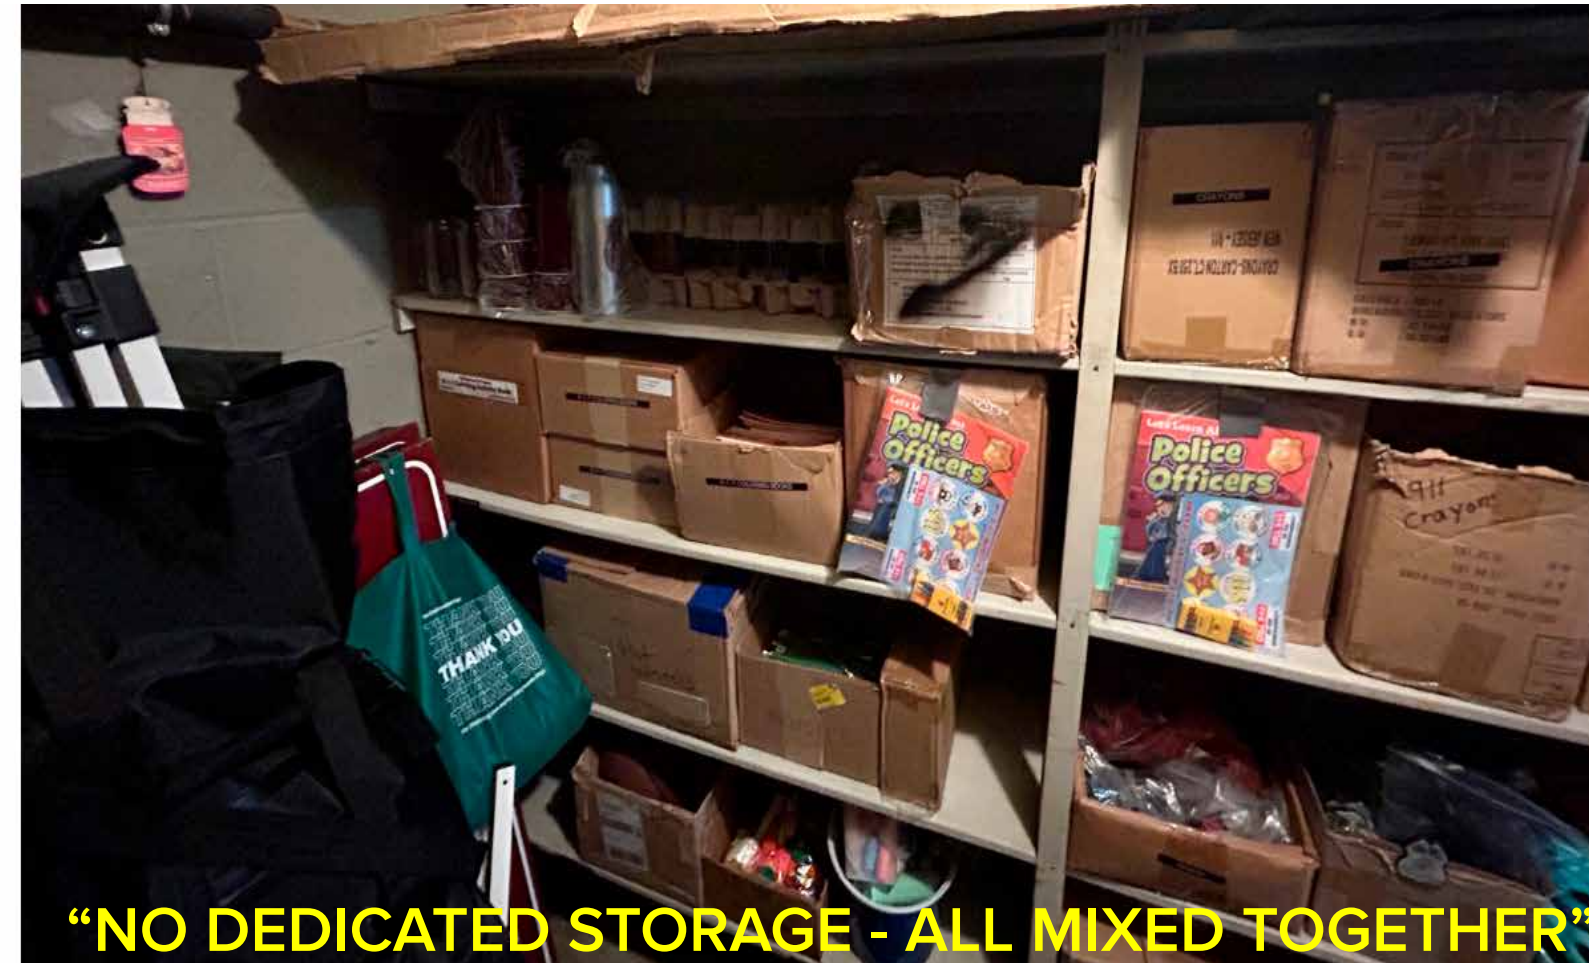
"NO DEDICATED STORAGE - ALL MIXED TOGETHER"

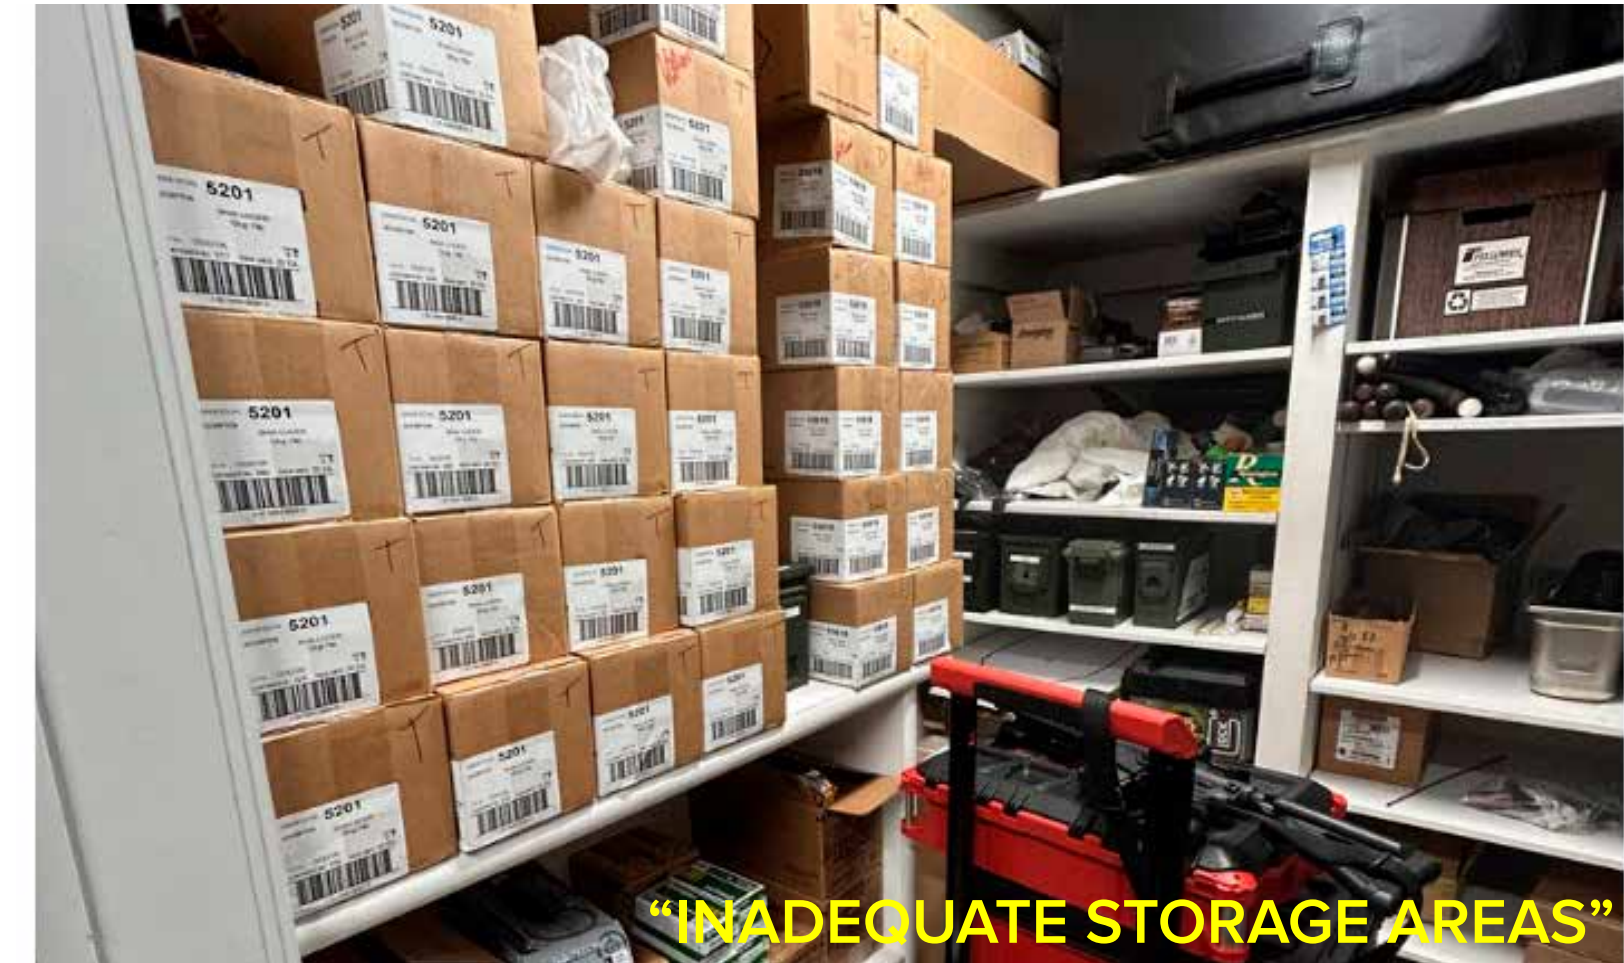
"INADEQUATE STORAGE AREAS"

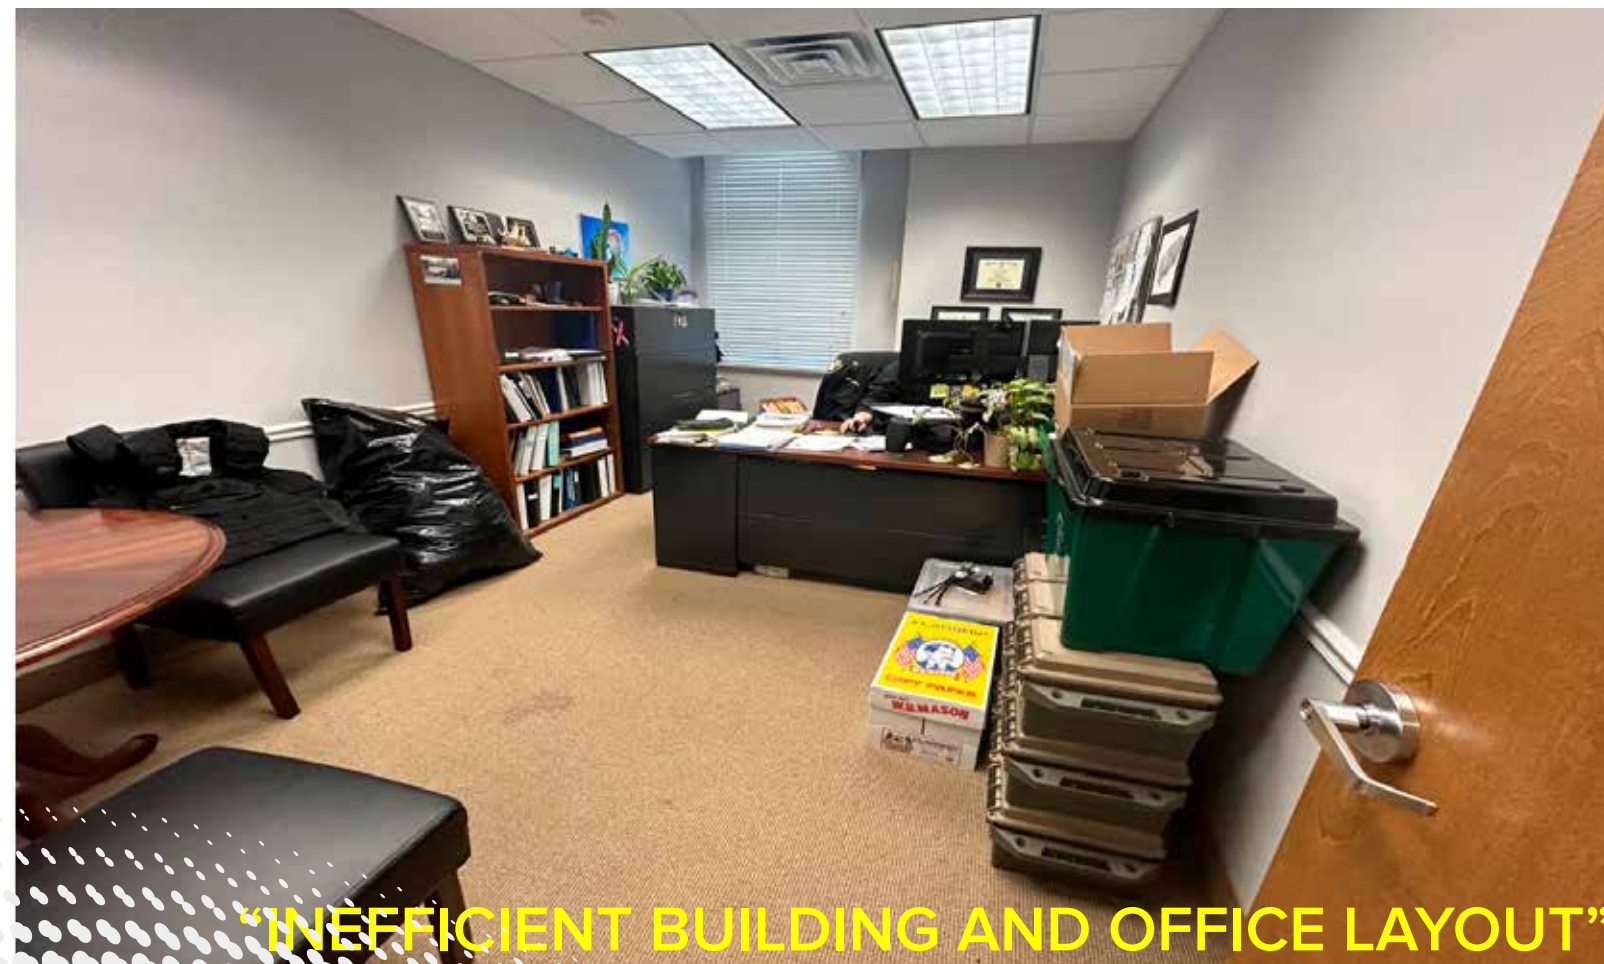
"INEFFICIENT BUILDING AND OFFICE LAYOUT"

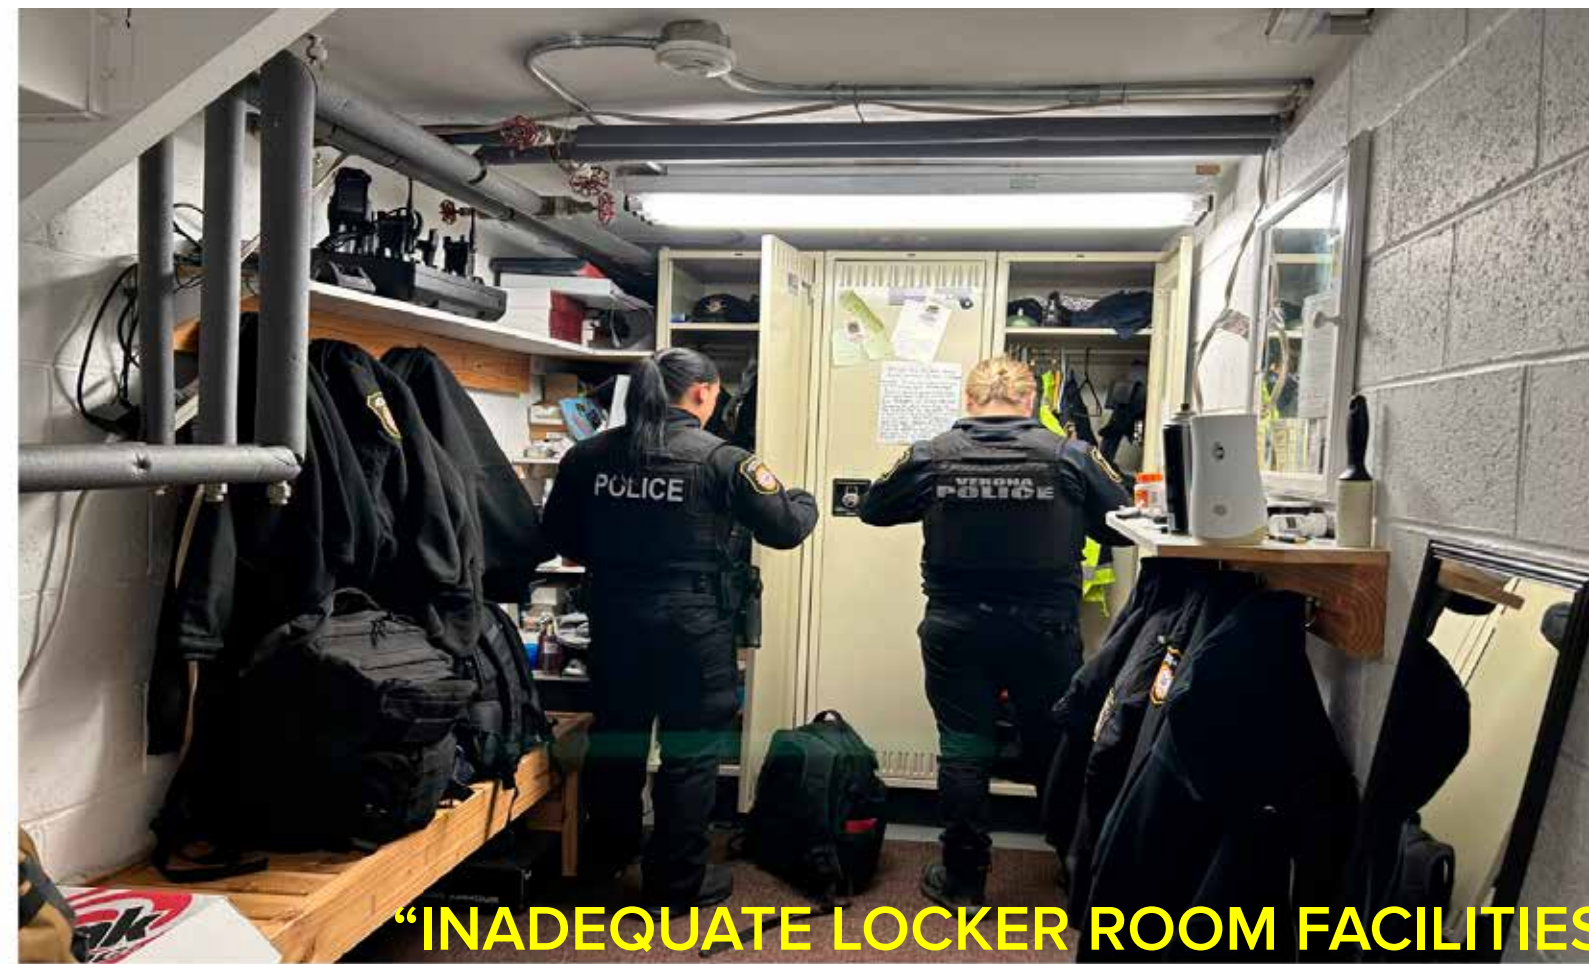
"INADEQUATE LOCKER ROOM FACILITIES"

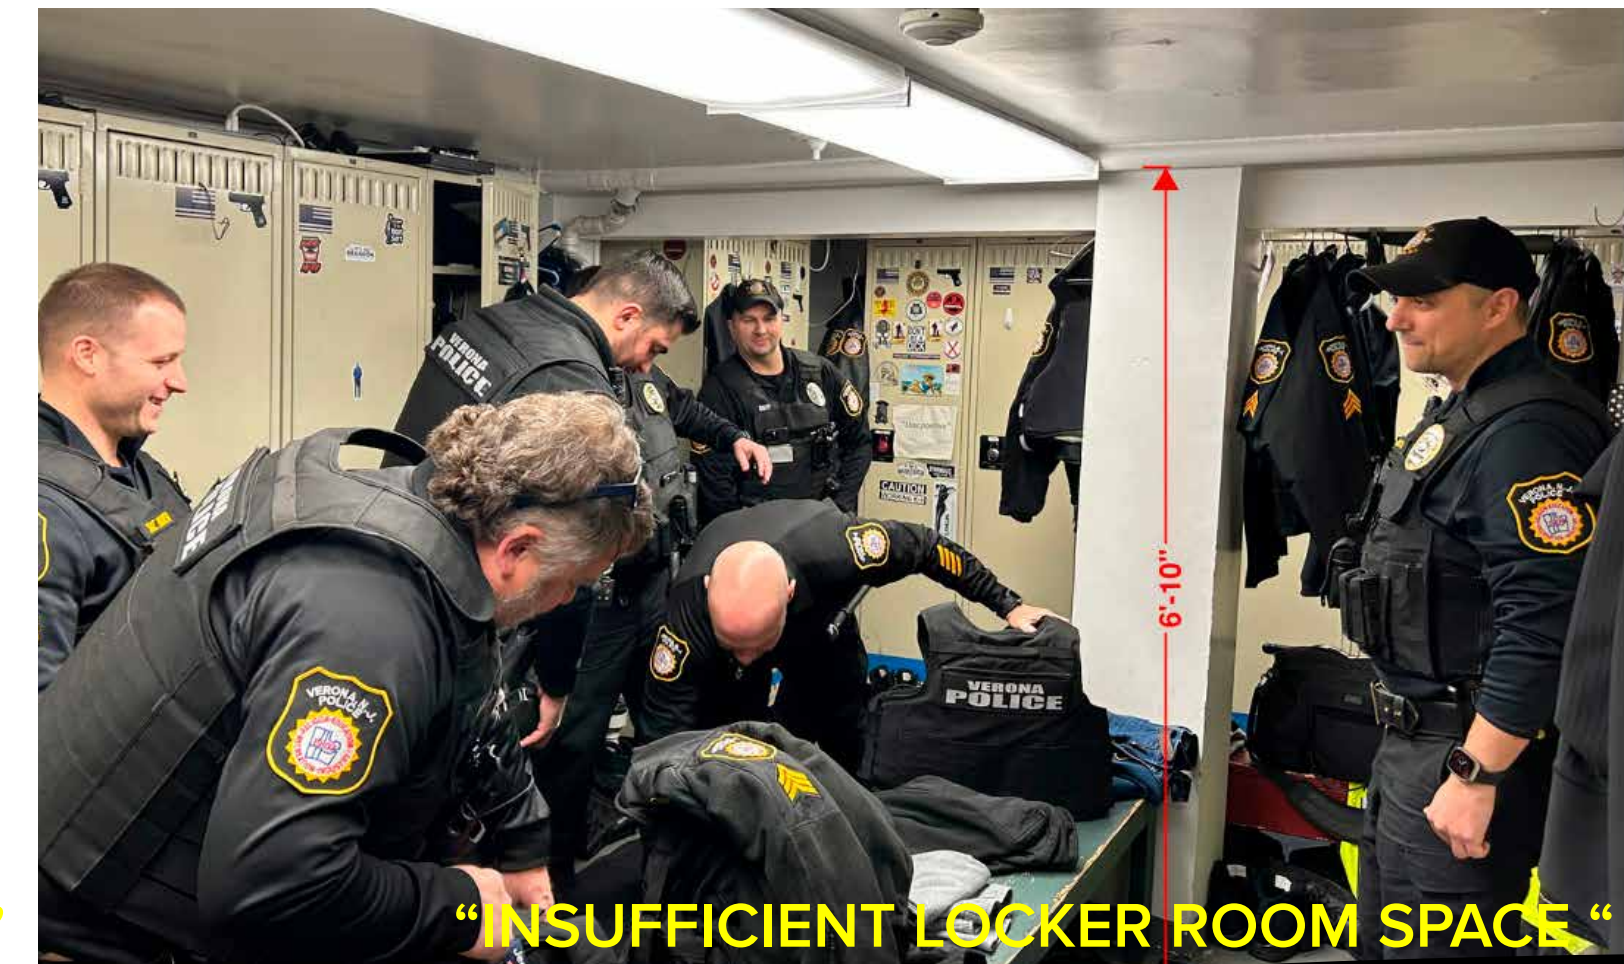
"INSUFFICIENT LOCKER ROOM SPACE"

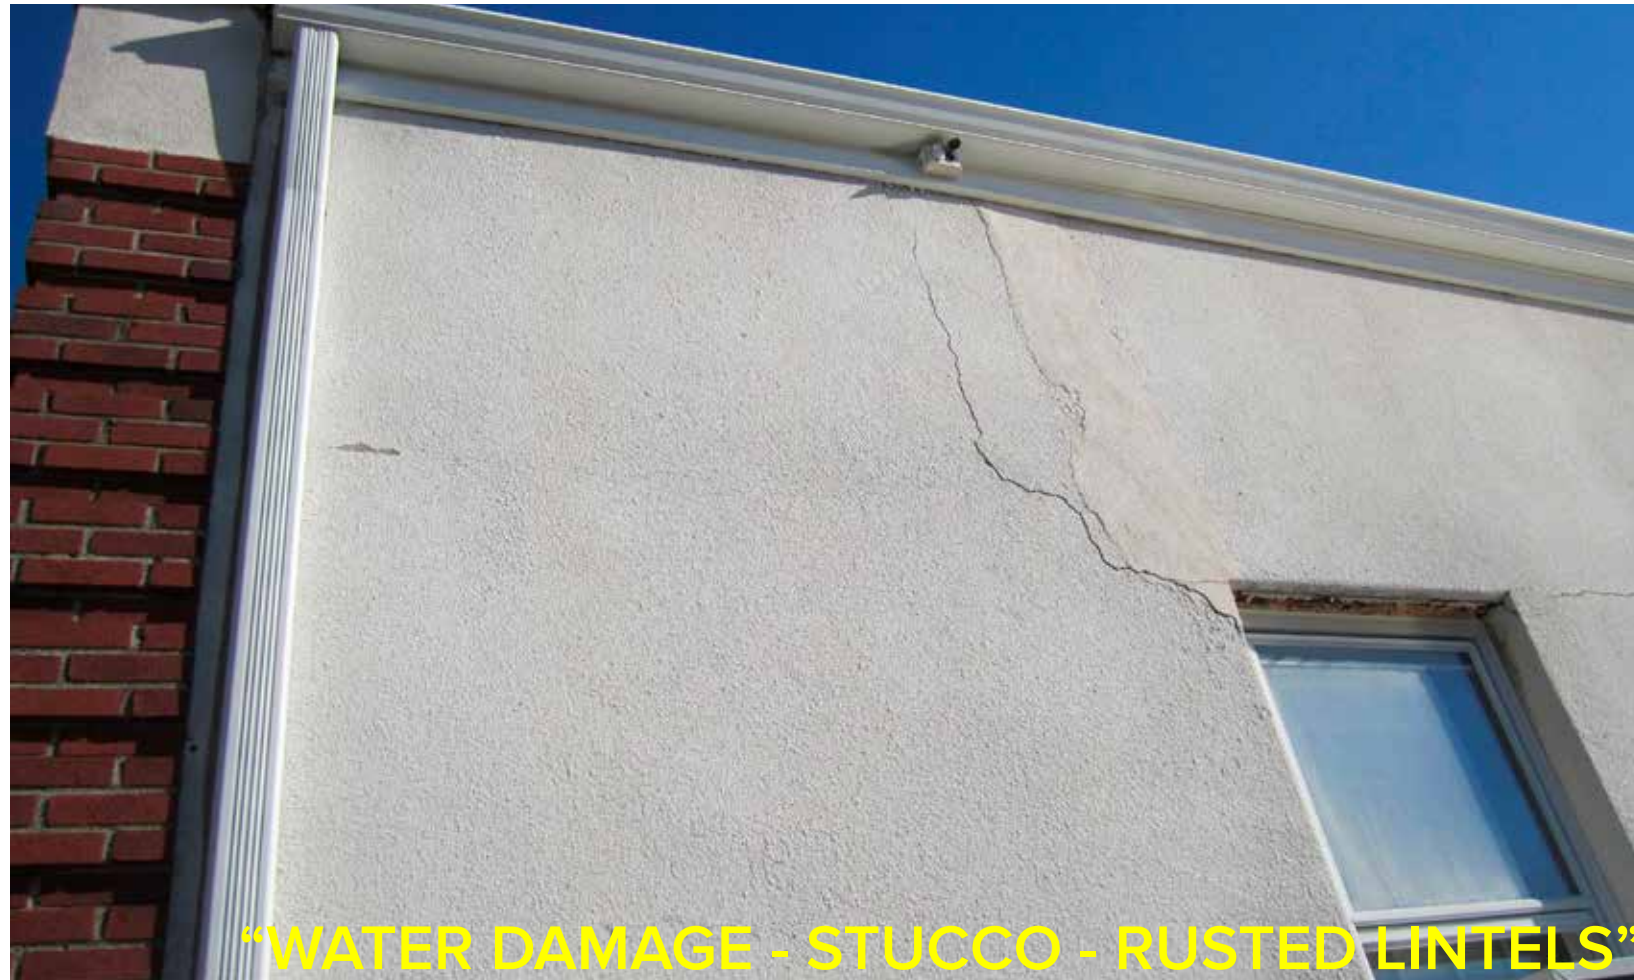
- » Major roofing/flashing issues allowing water infiltration causing facade separation, exterior wall, window and door issues/cracking + stucco/plaster damage.
- » Major structural issues due to building settling likely from the building being constructed over organic materials leftover from fire demolition in 1949.
- » Floor tiles popping, wood floors warping, window frames at meeting room / basement are rotted/leaking. Steel lintels are rusted and bowing.
- » August 2017 - Break in main sewer line, flooded the basement. Two sump pumps in basement are inadequate to keep up during heavy rain storms resulting in more water infiltration.

"WATER DAMAGE - STUCCO - RUSTED LINTELS"

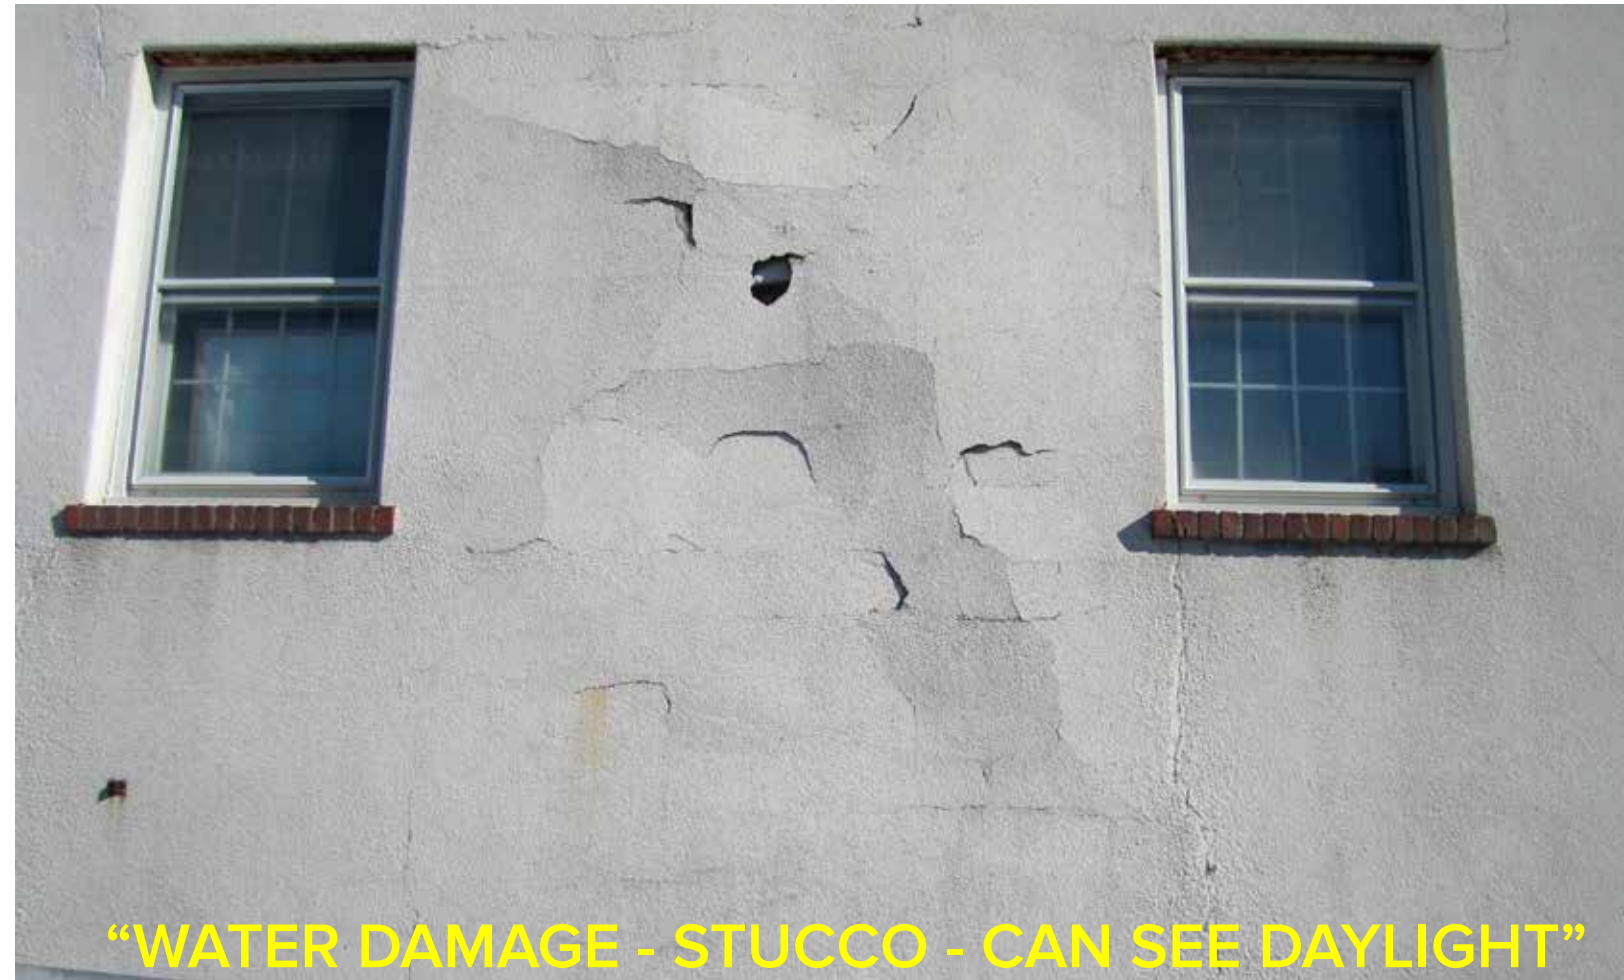
"WATER DAMAGE - STUCCO - CAN SEE DAYLIGHT"

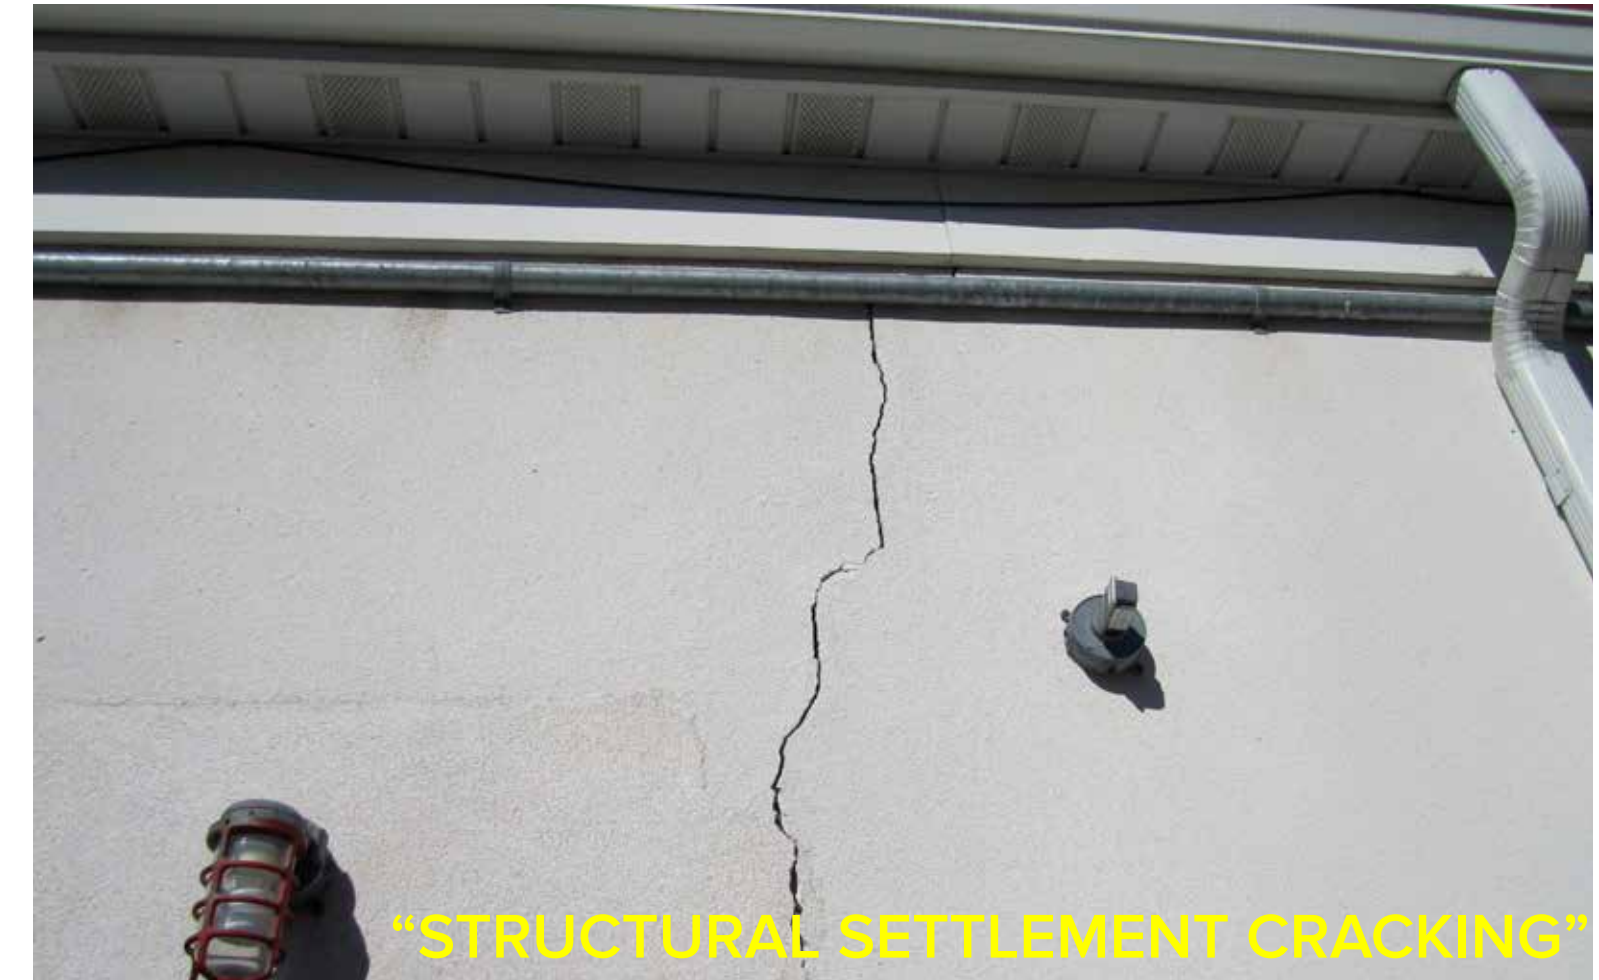
"STRUCTURAL SETTLEMENT CRACKING"
