PUBLIC SAFETY COMPLEX COUNCIL MEETING

PUBLIC SAFETY COMPLEX - CONCEPT

POLICE DEPARTMENT, FIRE DEPARTMENT - CO. #2, RESCUE SQUAD

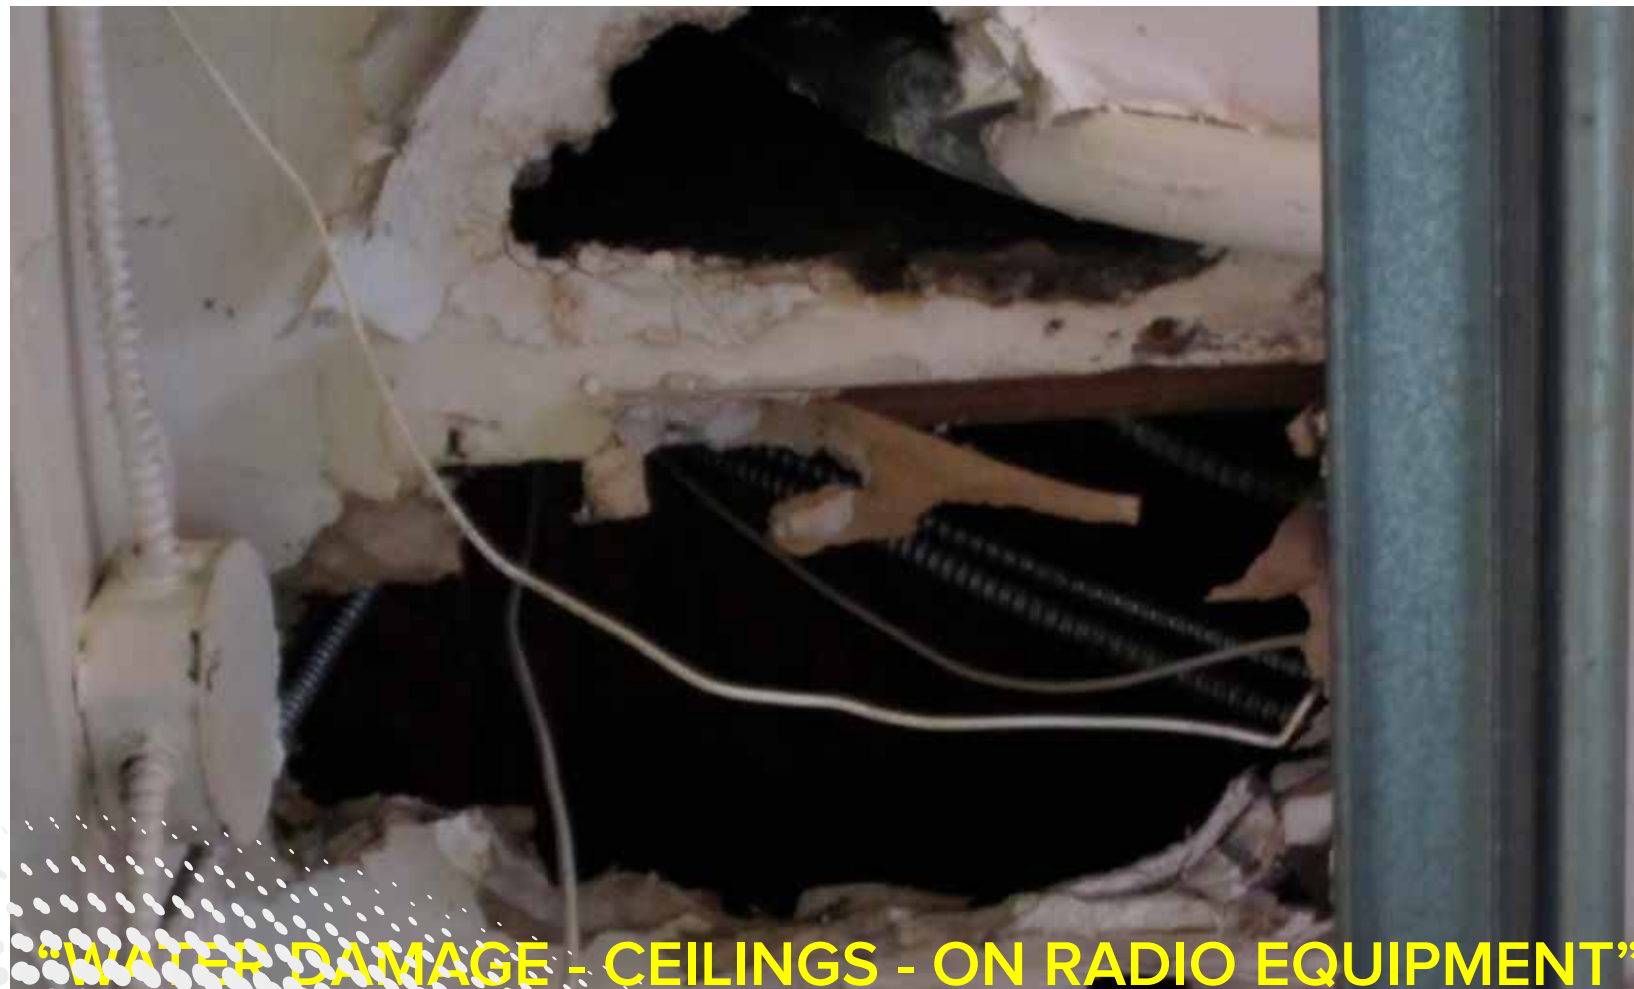
"WATER DAMAGE - CEILINGS - ON RADIO EQUIPMENT"

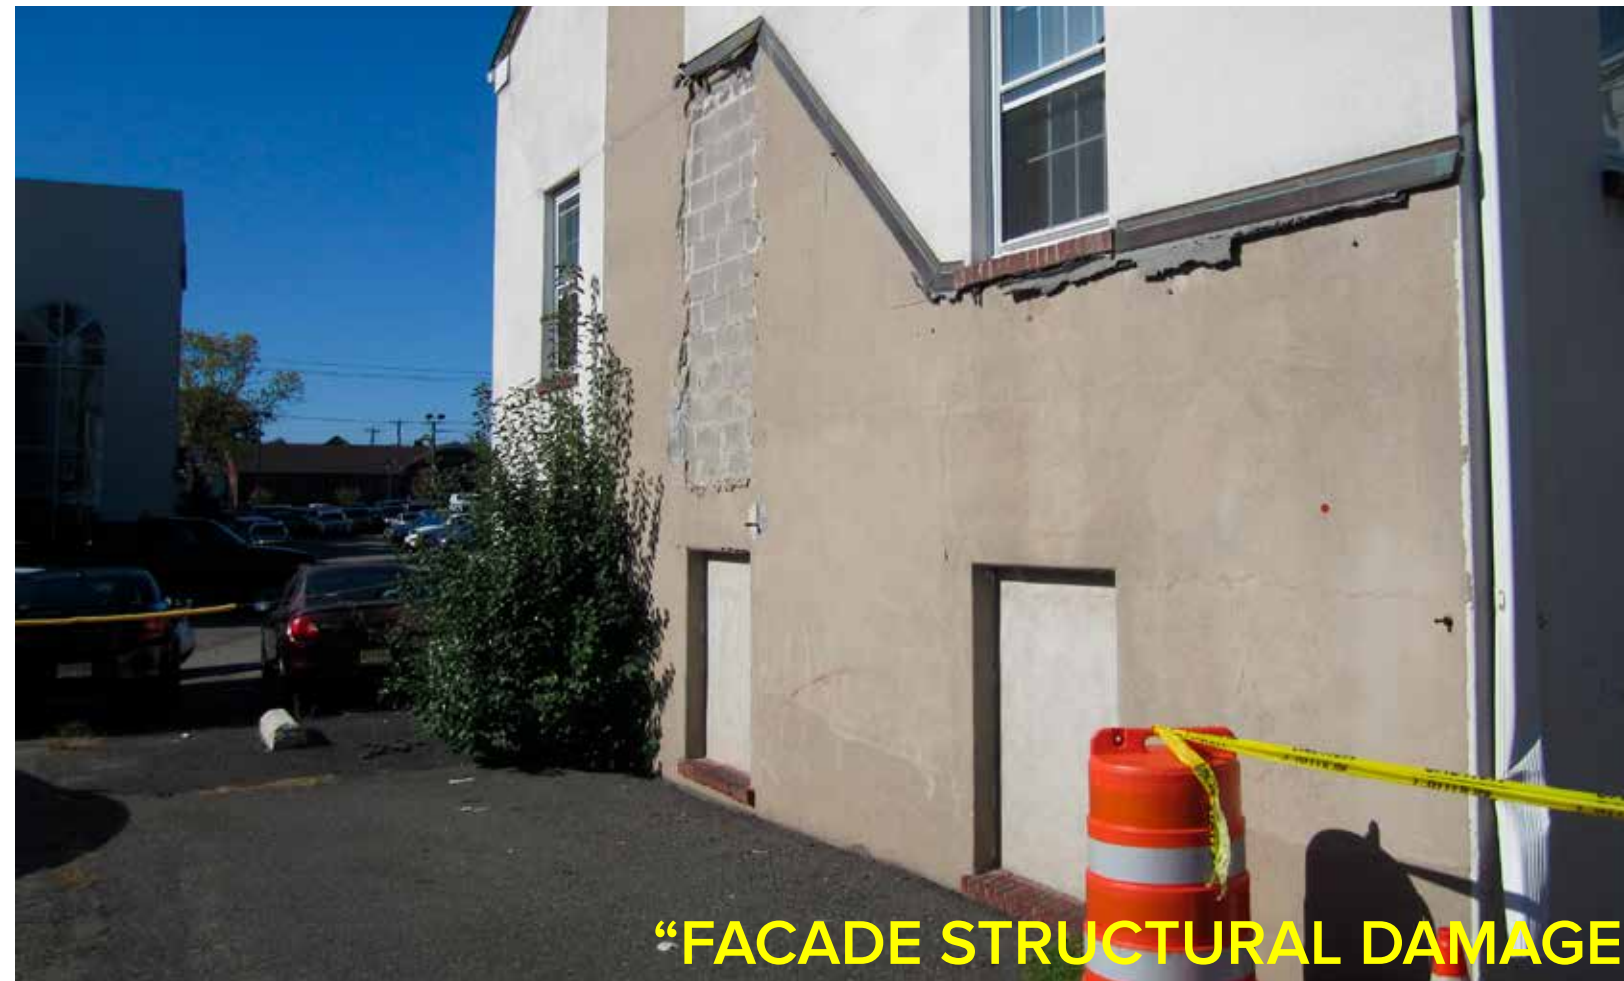
"FACADE STRUCTURAL DAMAGE"

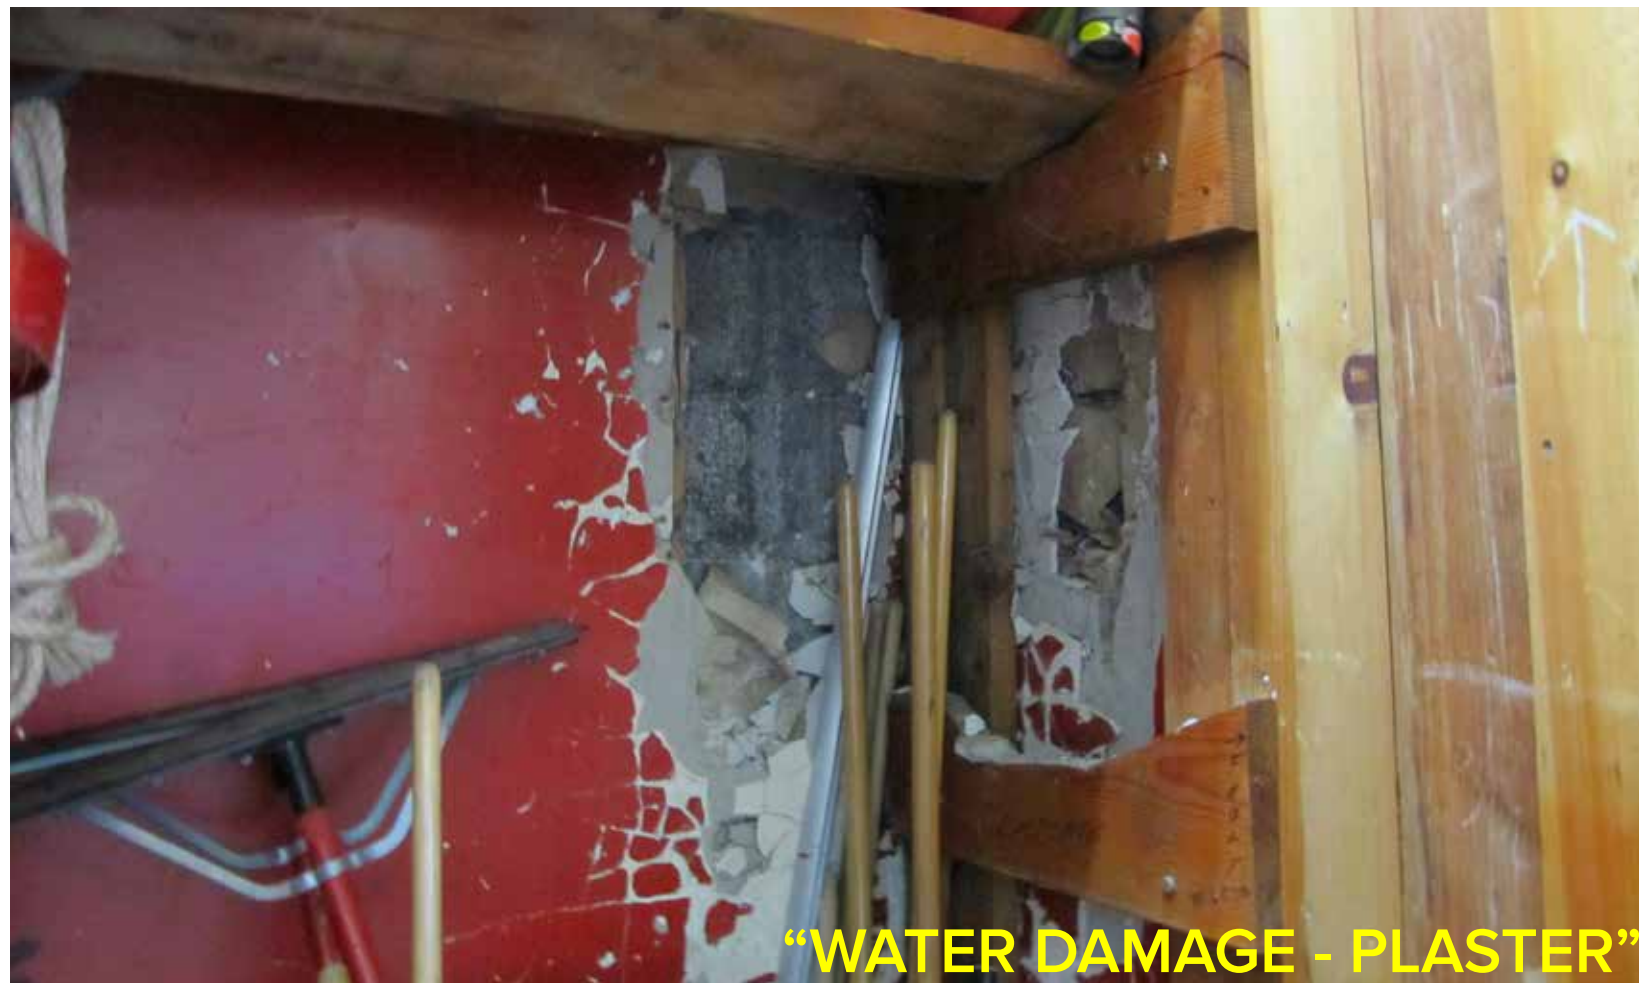
“WATER DAMAGE - PLASTER”

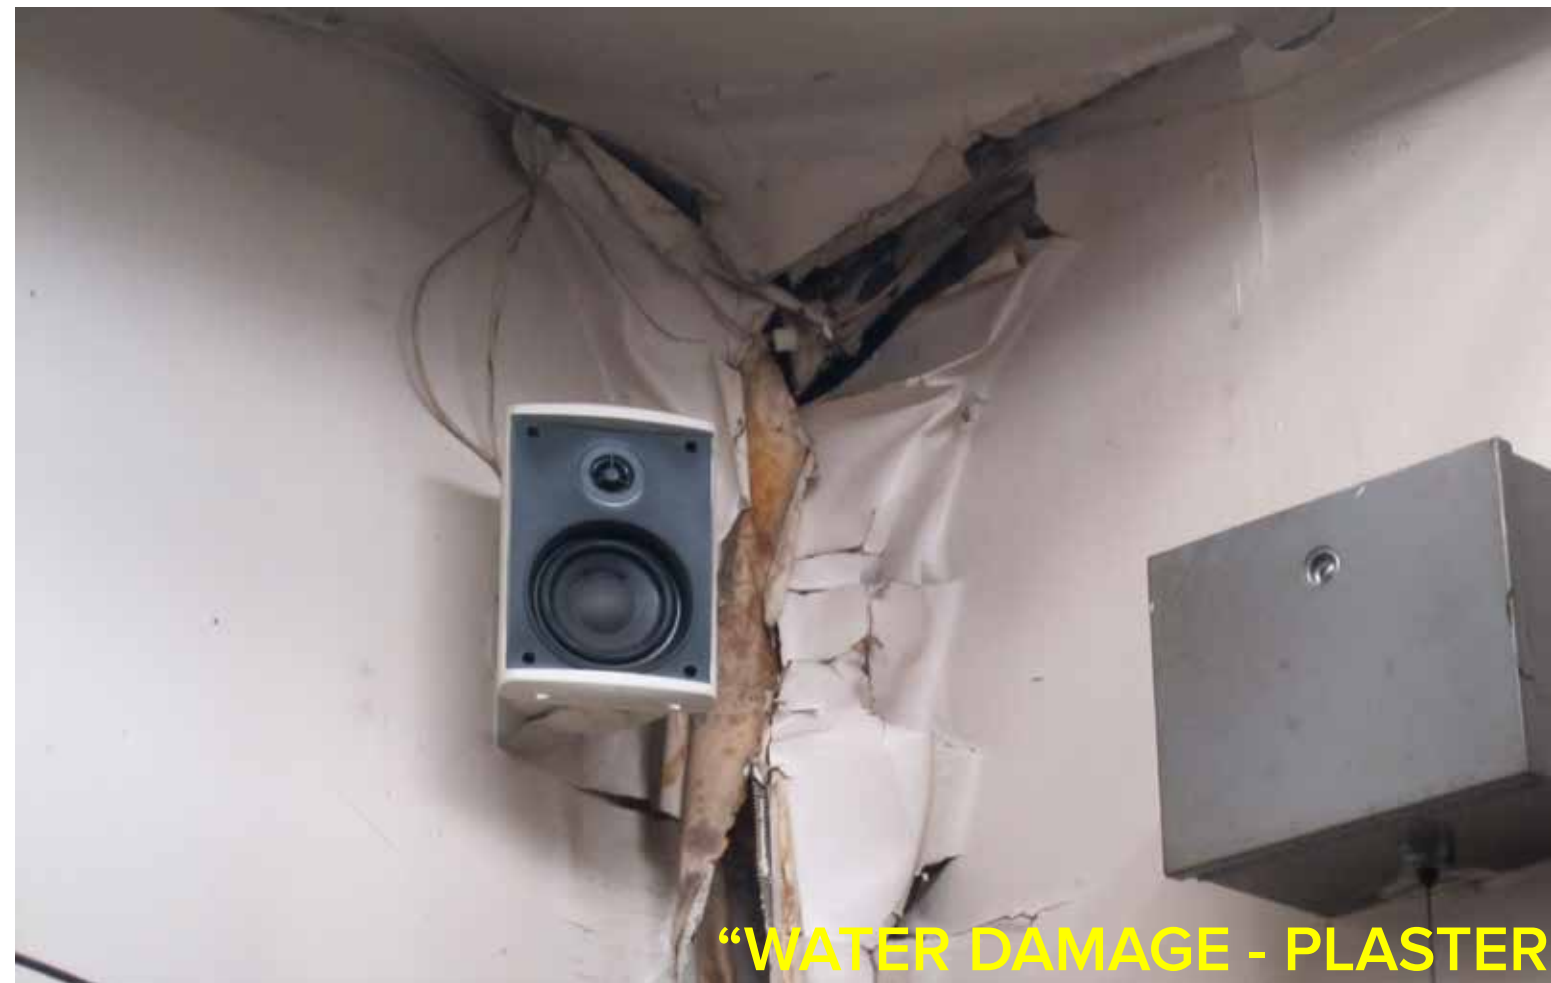
“WATER DAMAGE - PLASTER”

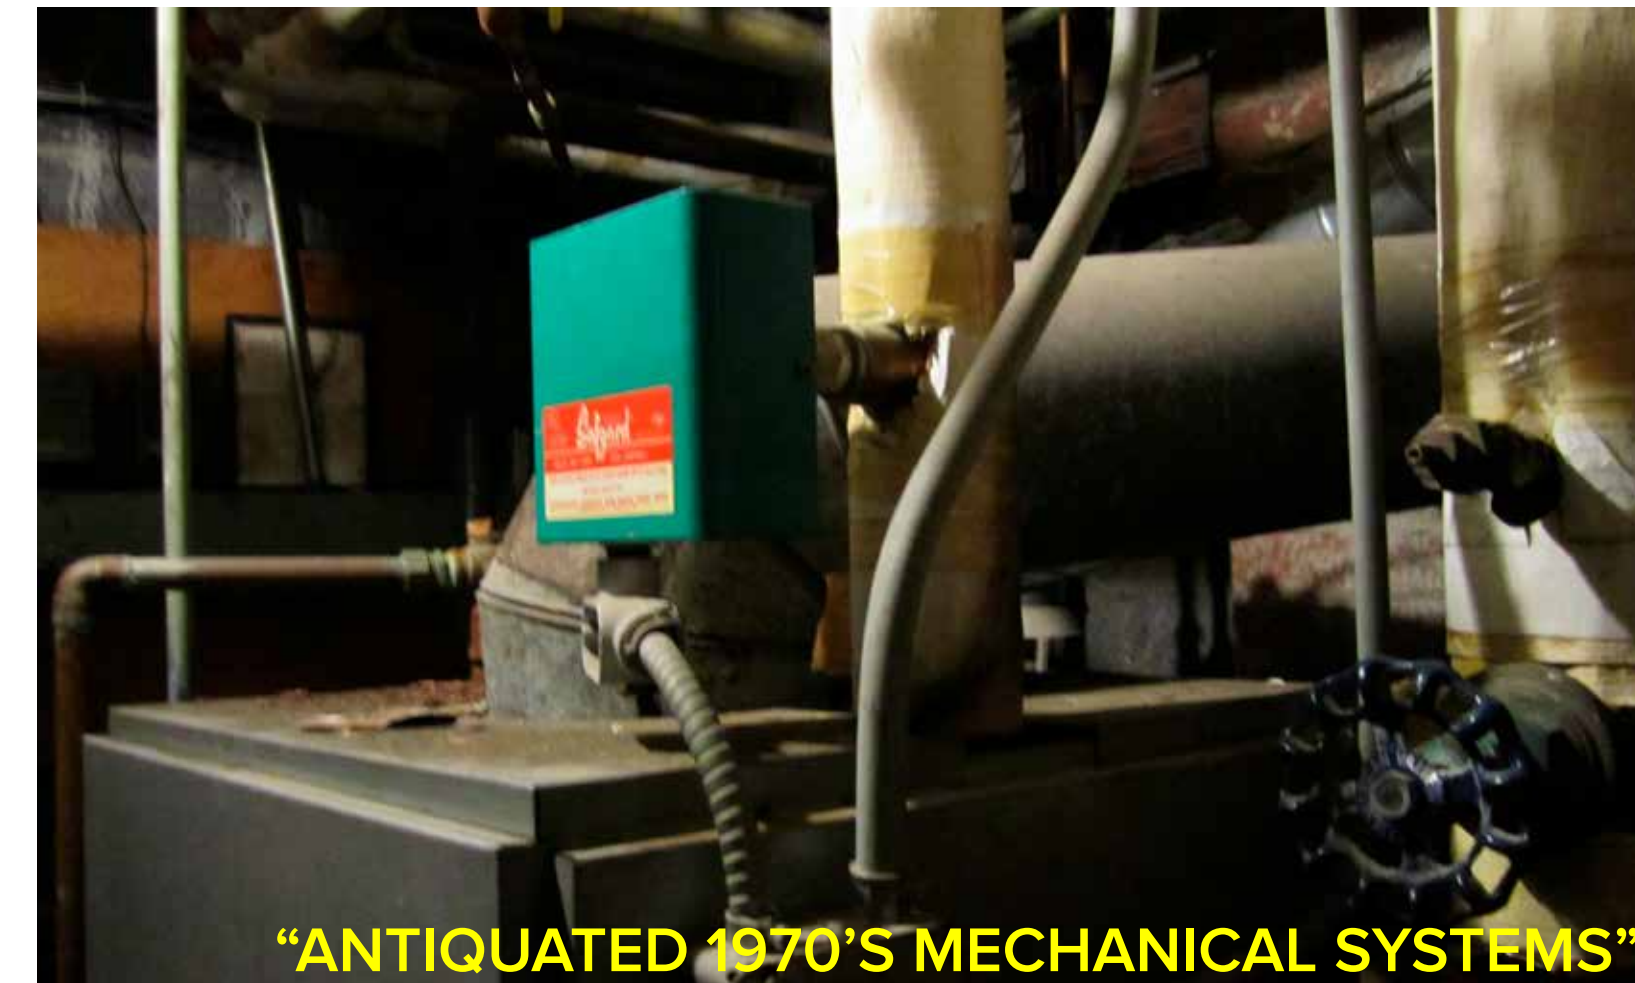
- » The air conditioning unit on the roof is irreparable. Building and Grounds had a company come in to assess the unit, and they estimated that it would be \$15,000 to replace it.
- » Heating system was overhauled in 2020, but the boiler that was installed 70's was never replaced in spite of extensive repairs, it is in need of replacement.
- » Major plumbing leaks throughout the facility, sediment found in the system. Apparatus bay floor drains do not appear to have an oil separator.
- » The basement entry stairwell floods during heavy rain. Basement door-deteriorated and does not open, posing a safety problem. Basement cannot be used.

“ANTIQUATED 1970'S MECHANICAL SYSTEMS”

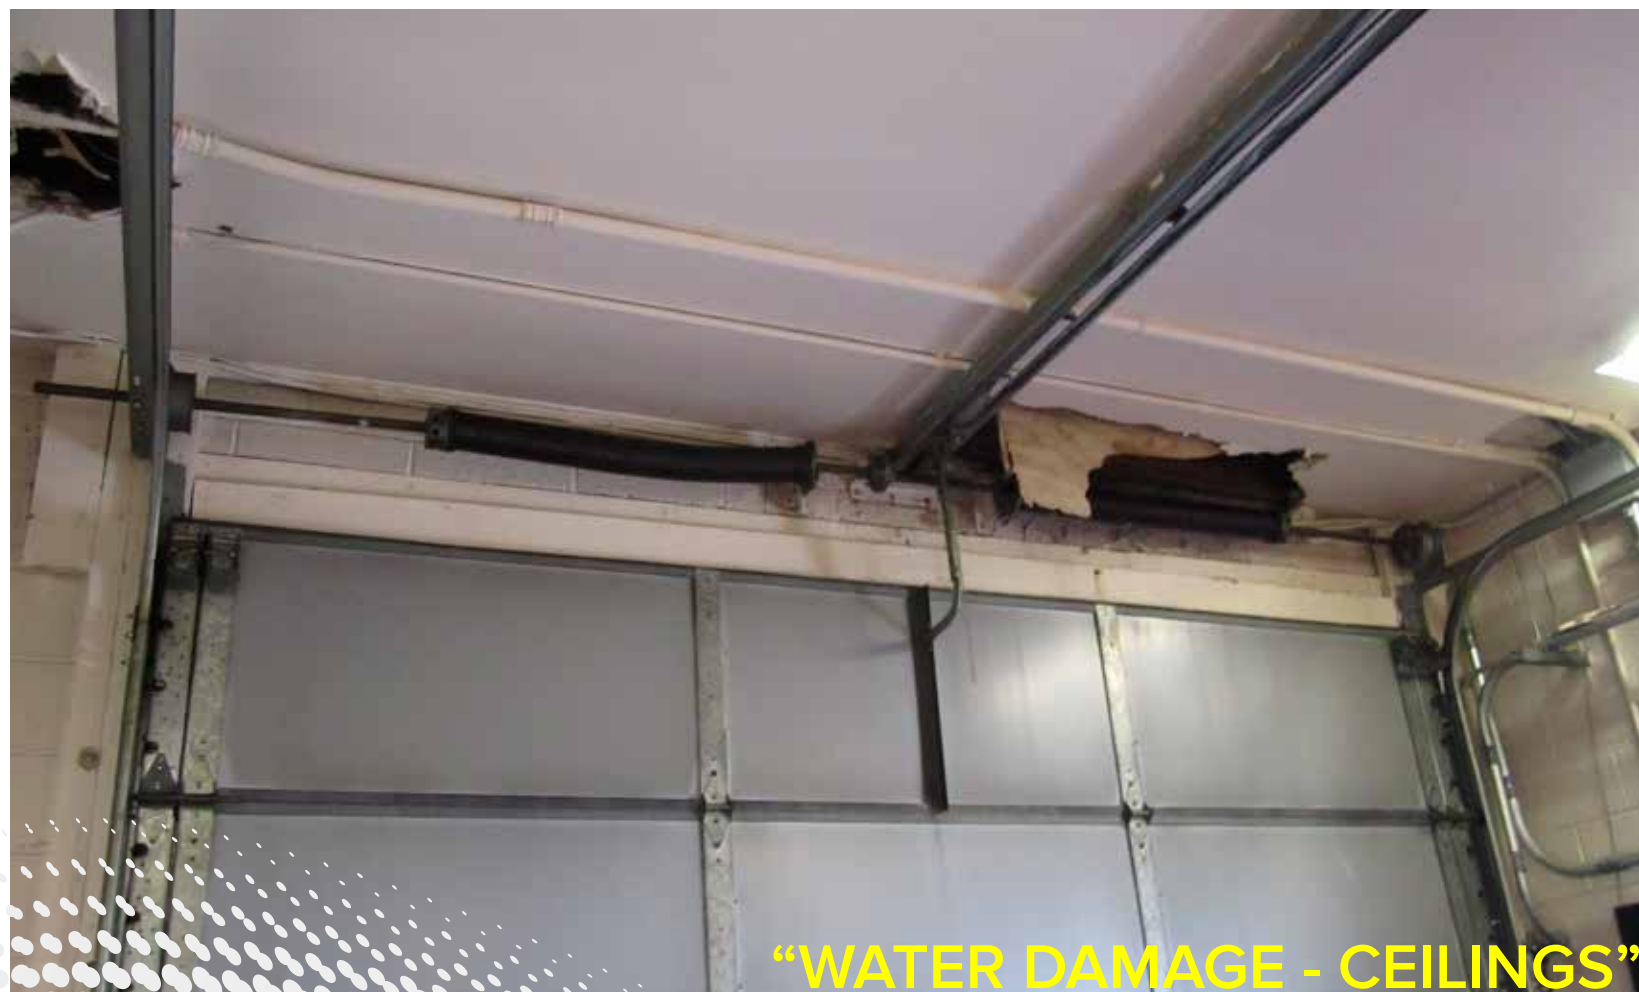
“WATER DAMAGE - CEILINGS”

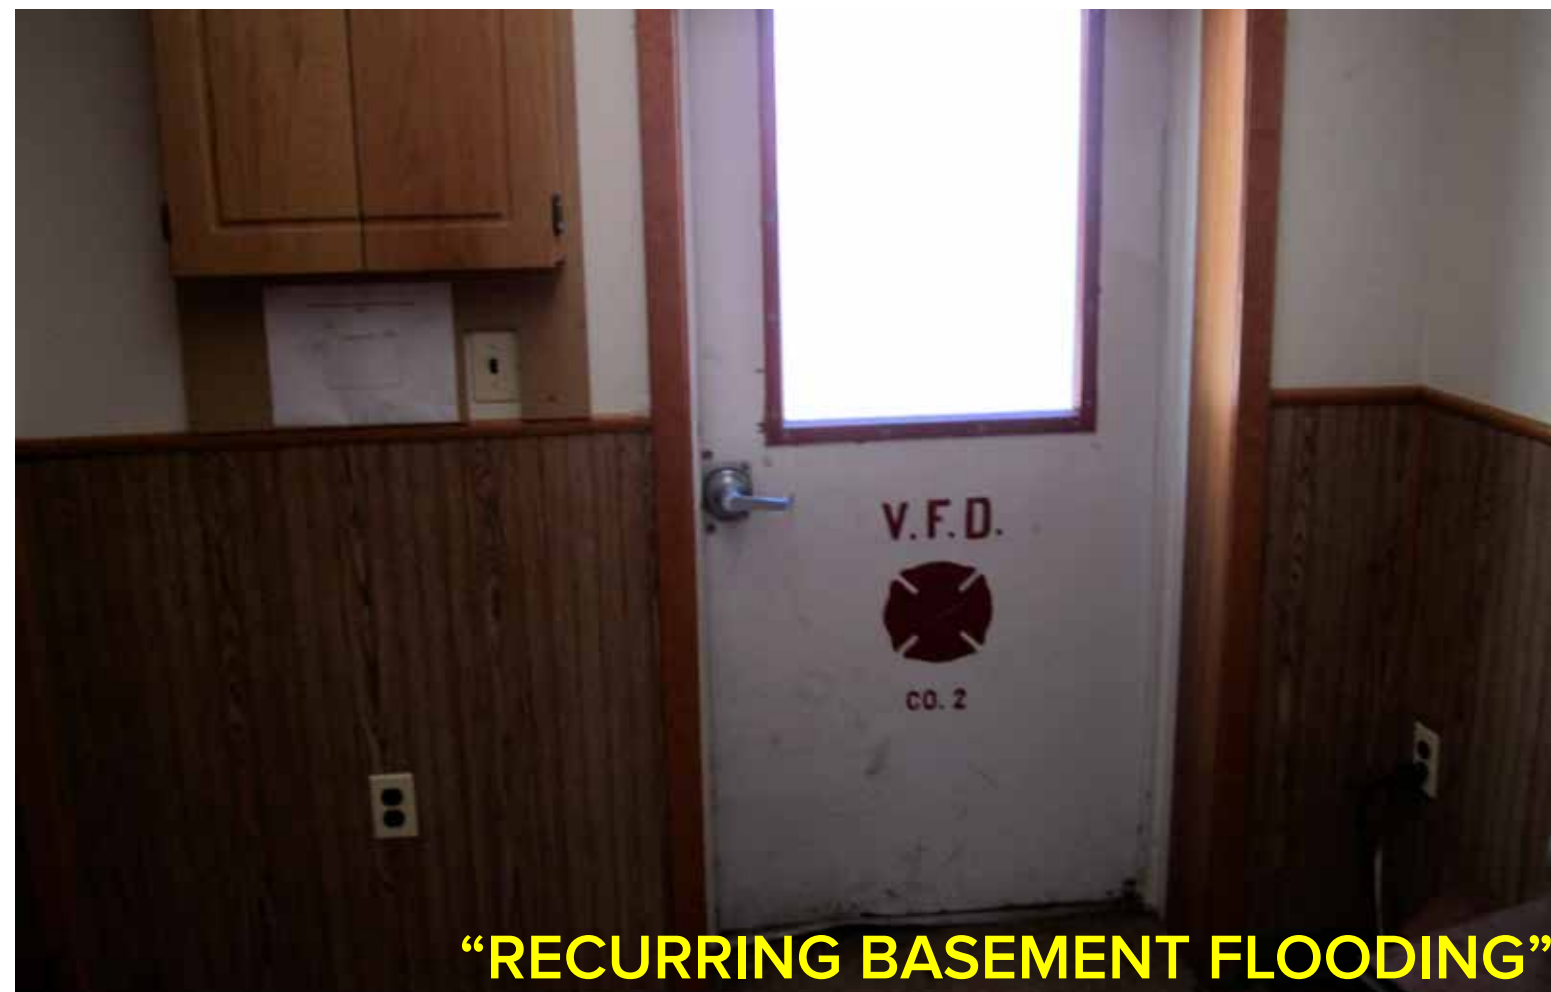
“RECURRING BASEMENT FLOODING”

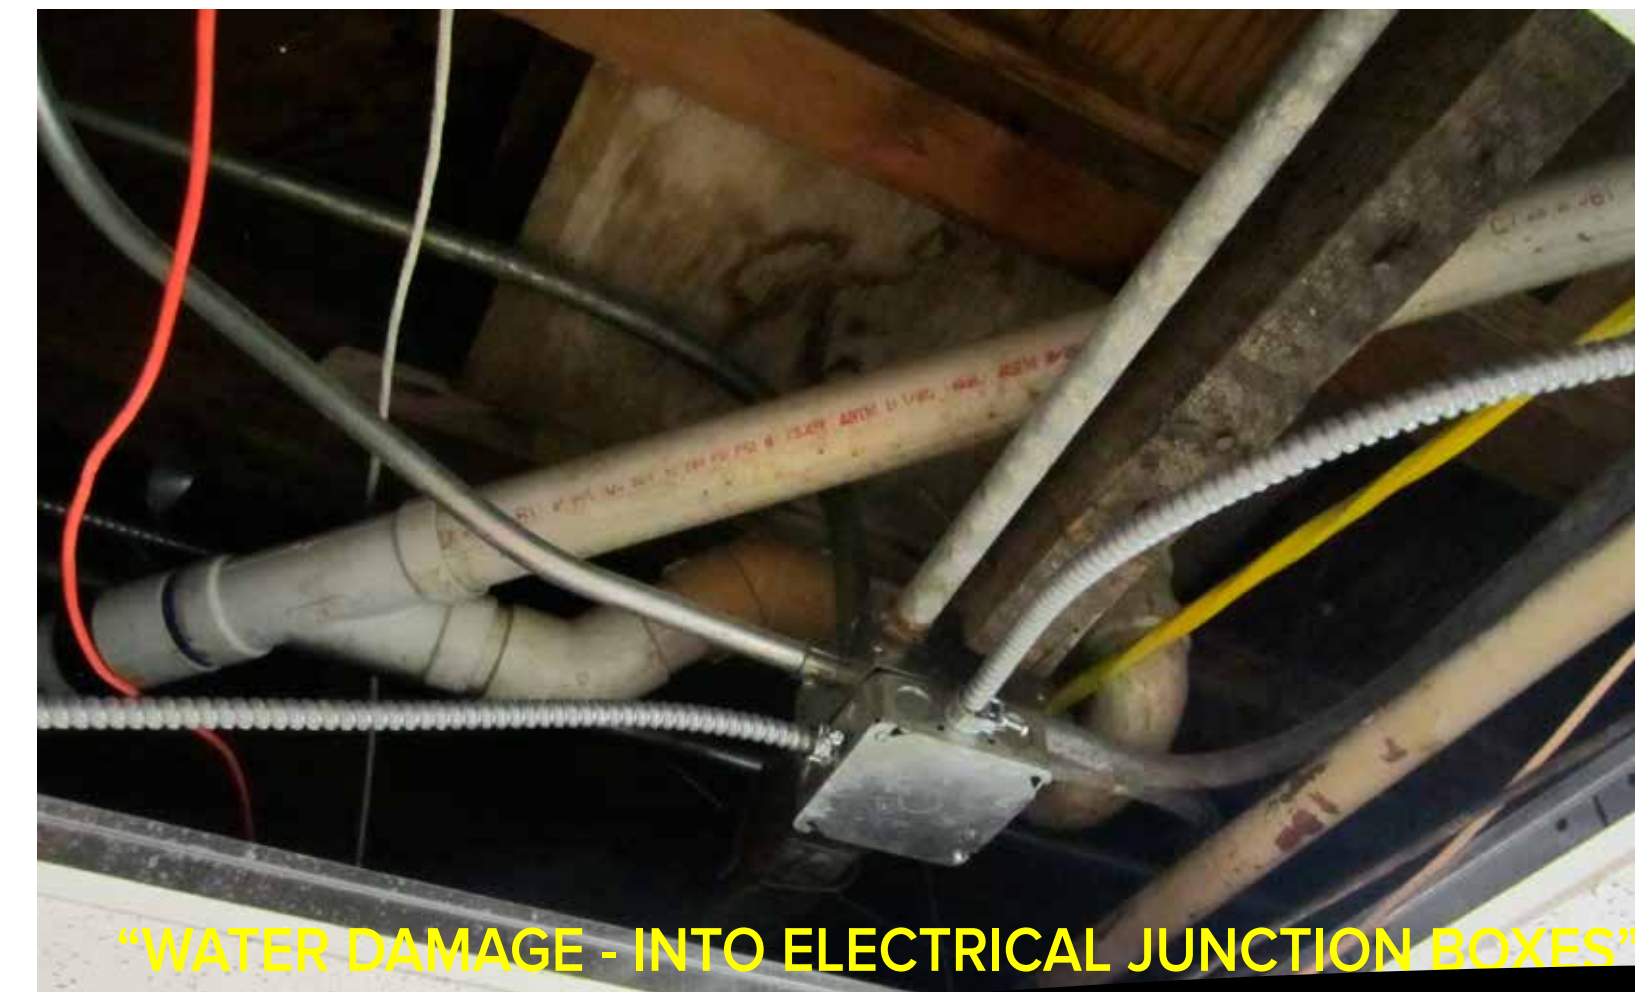
“WATER DAMAGE - INTO ELECTRICAL JUNCTION BOXES”
