PUBLIC PRESENTATION

VERONA EMERGENCY SERVICES COMPLEX

POLICE DEPARTMENT, FIRE DEPARTMENT - CO. #2, RESCUE SQUAD

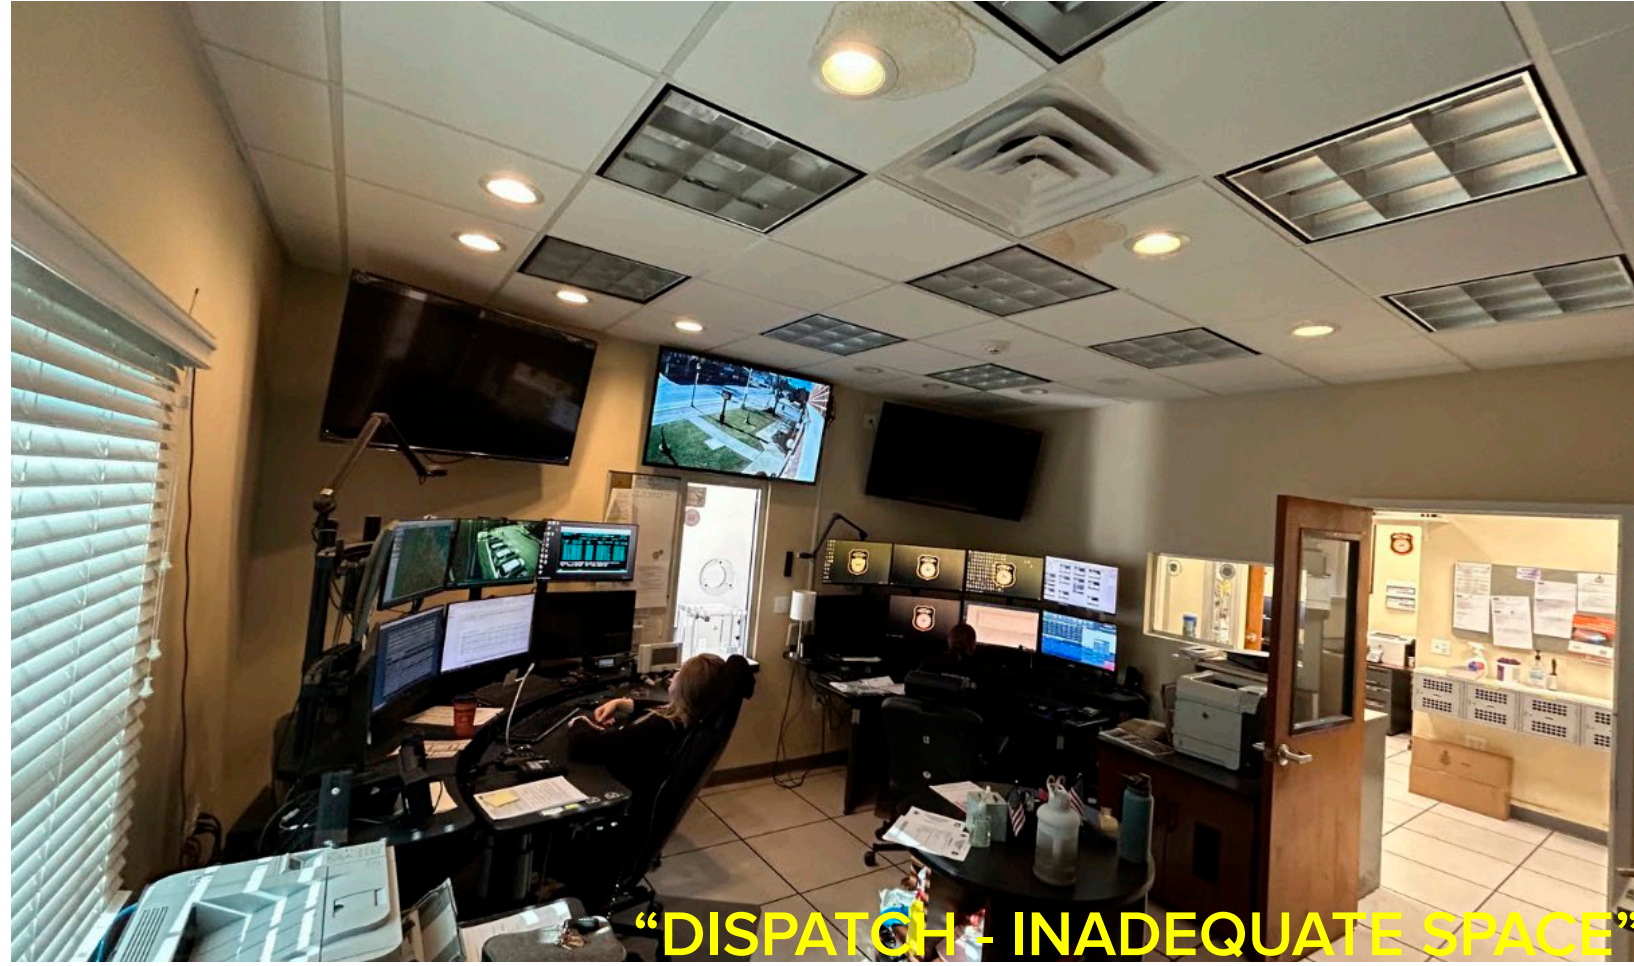
"DISPATCH - INADEQUATE SPACE"

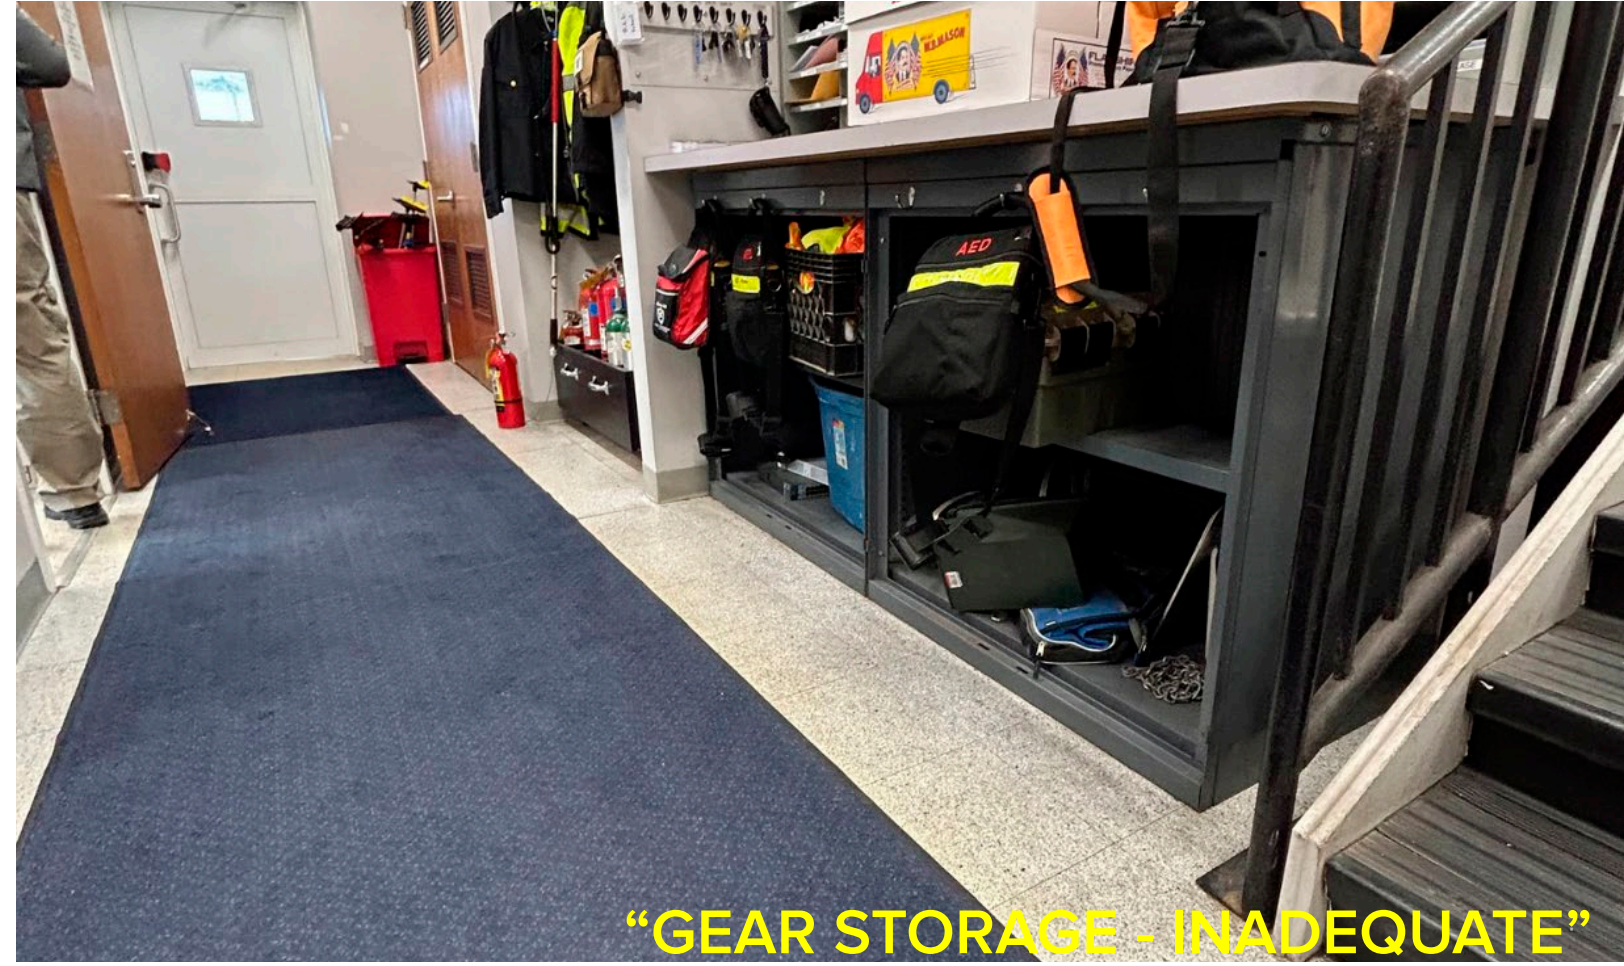
"GEAR STORAGE - INADEQUATE"

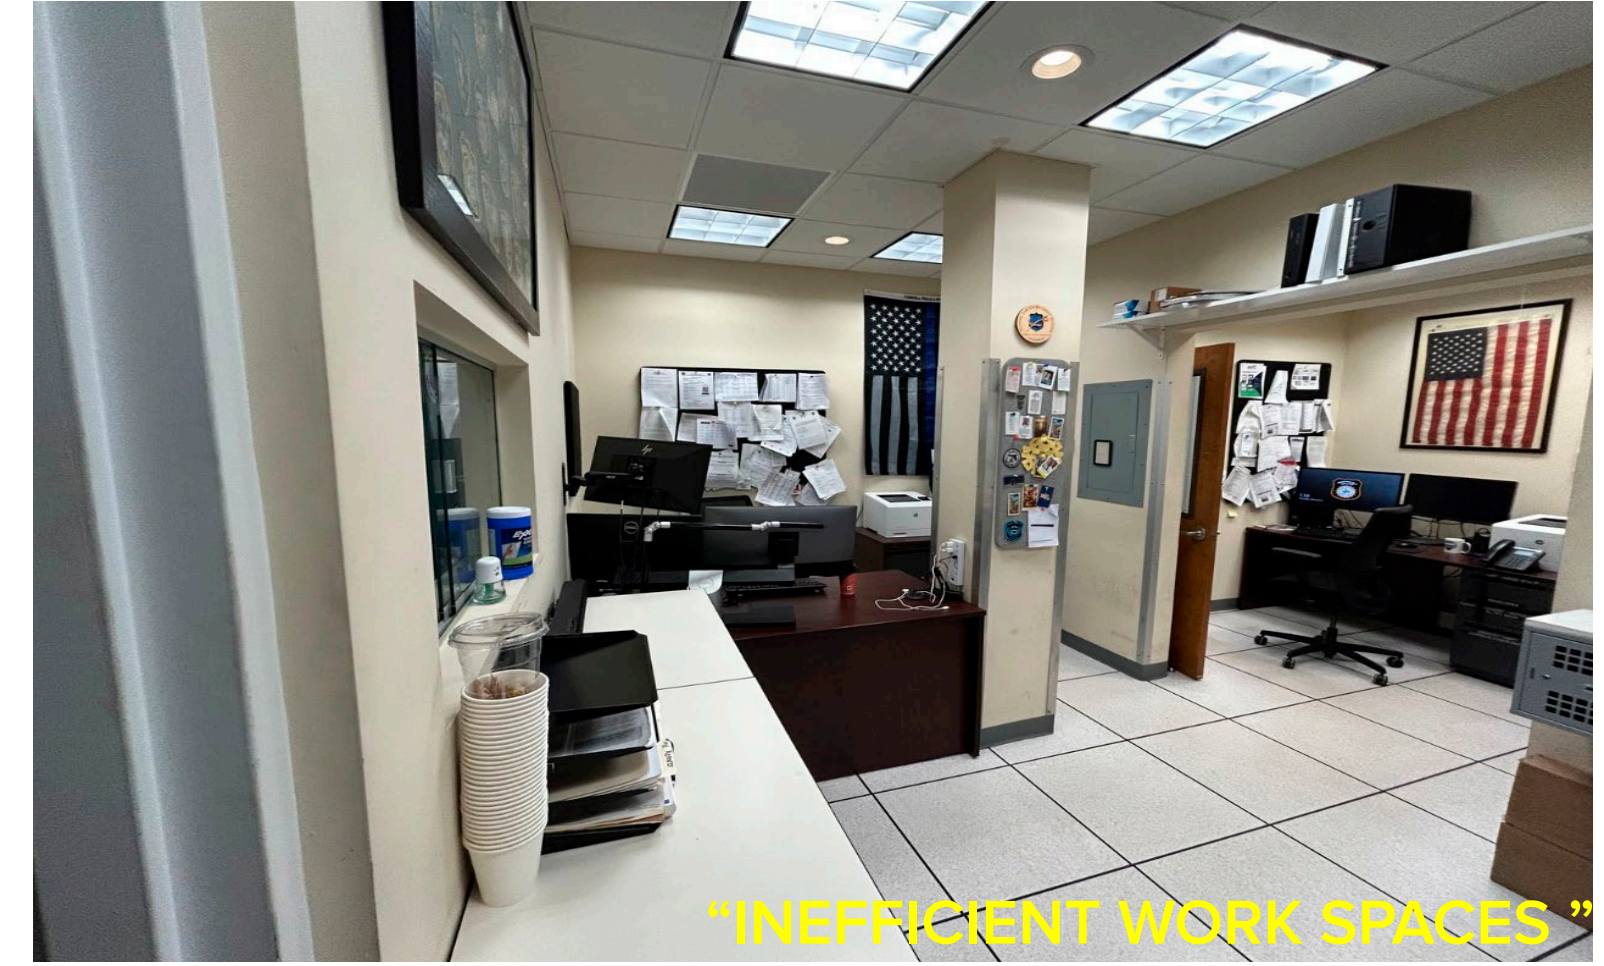
"INEFFICIENT WORK SPACES"

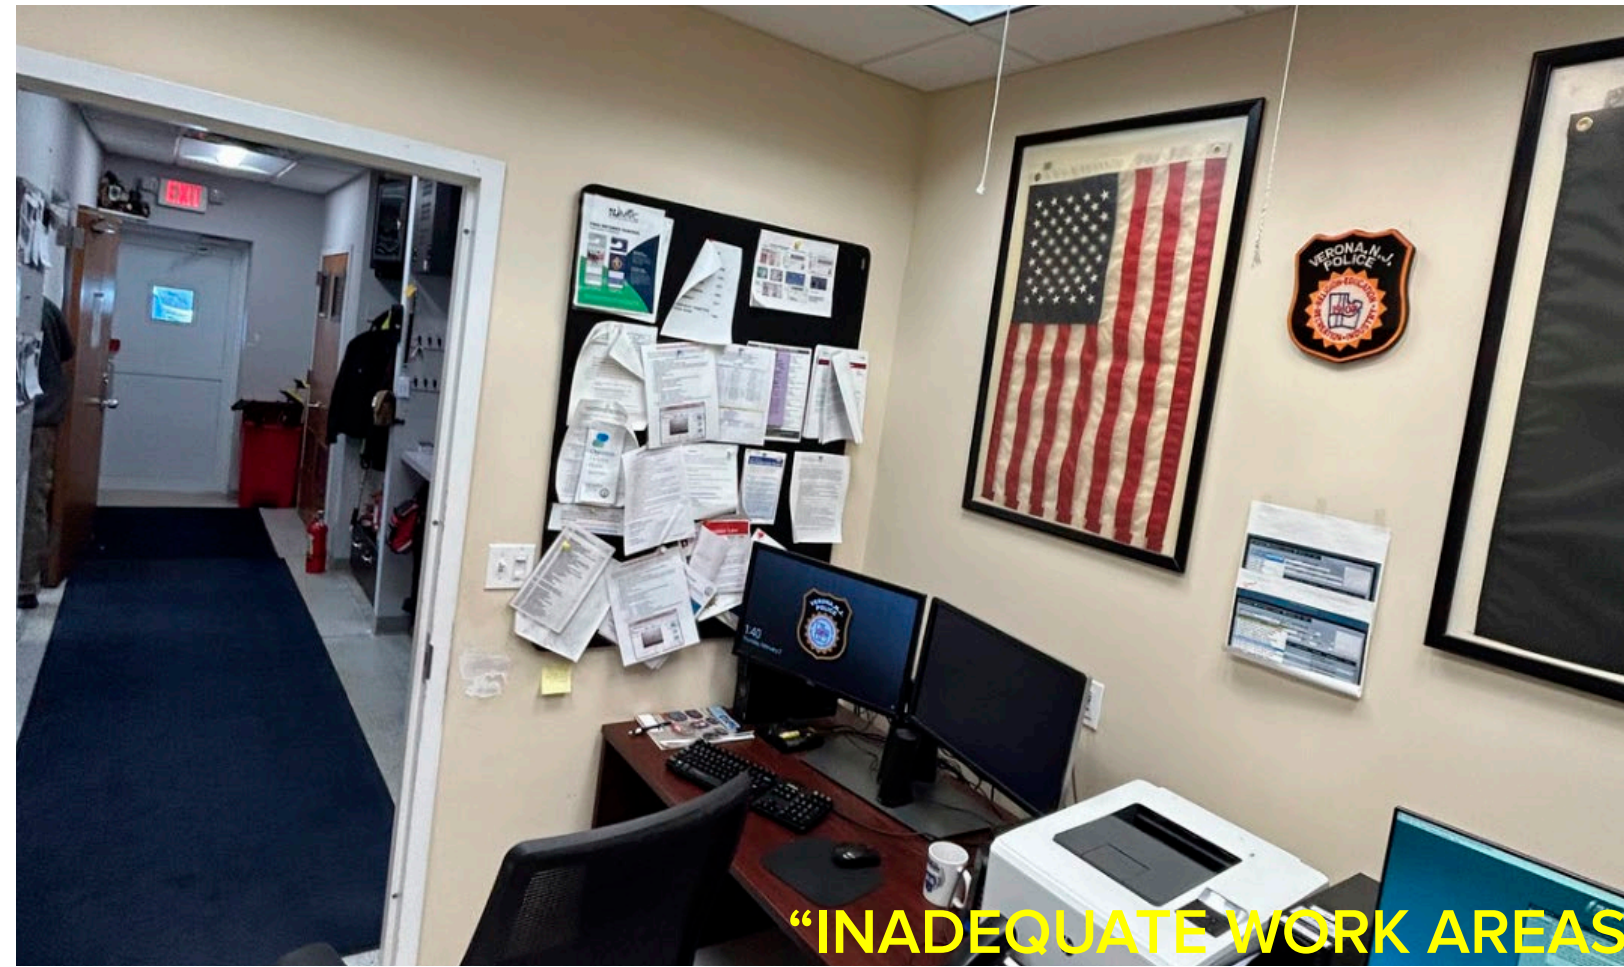
"INADEQUATE WORK AREAS"

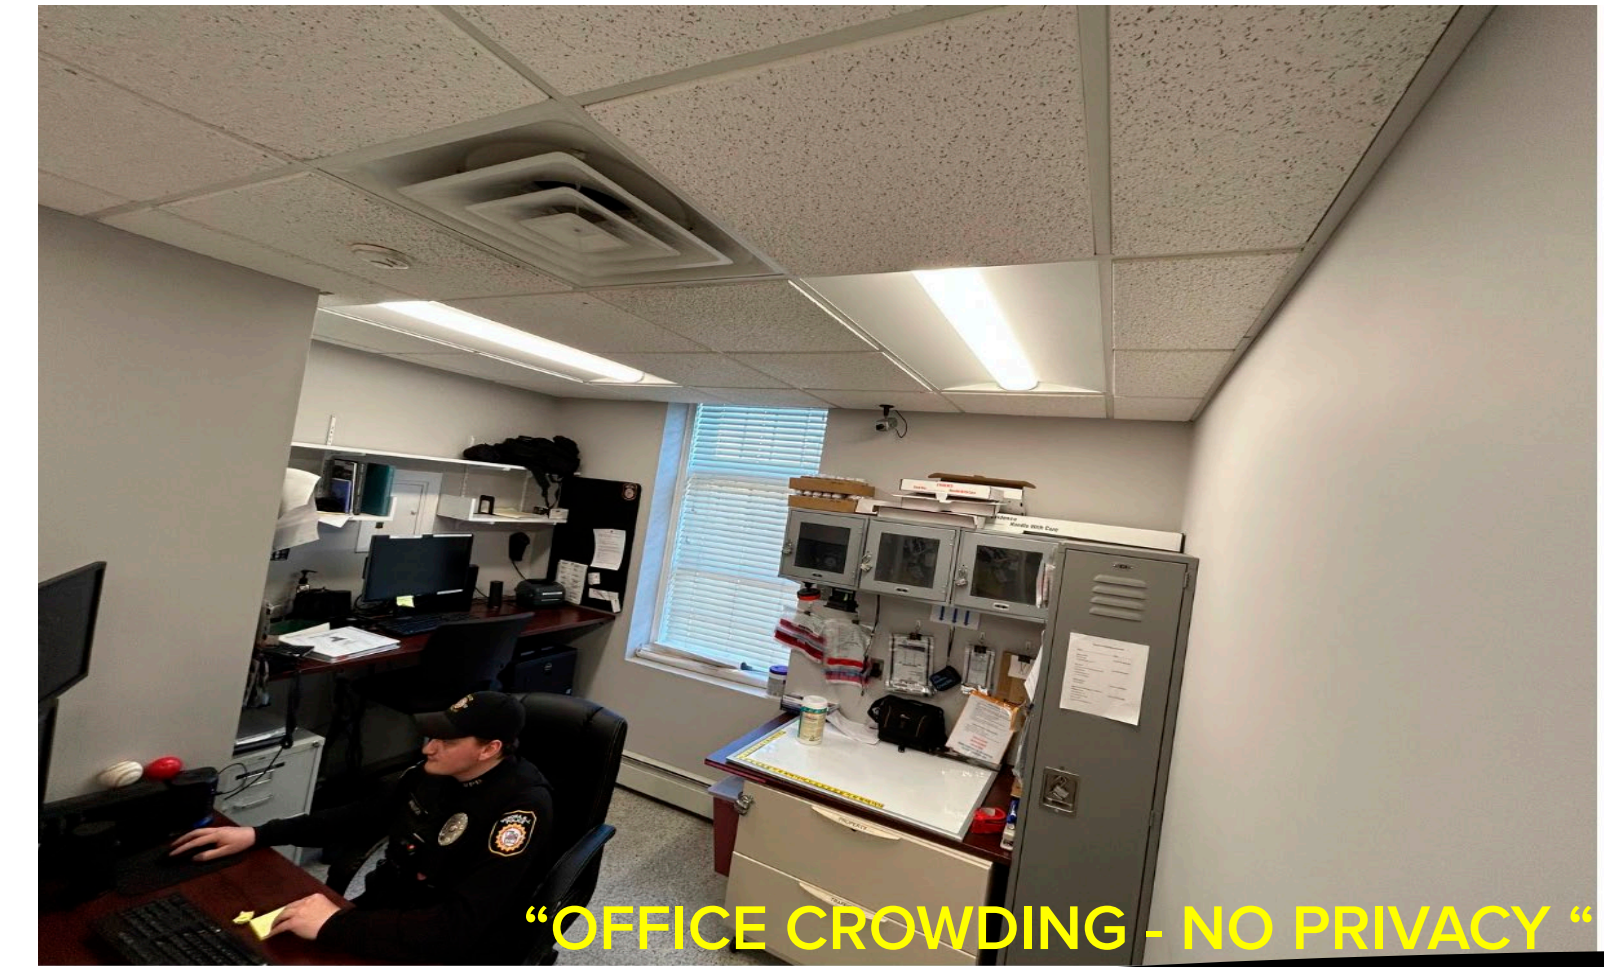
"OFFICE CROWDING - NO PRIVACY"

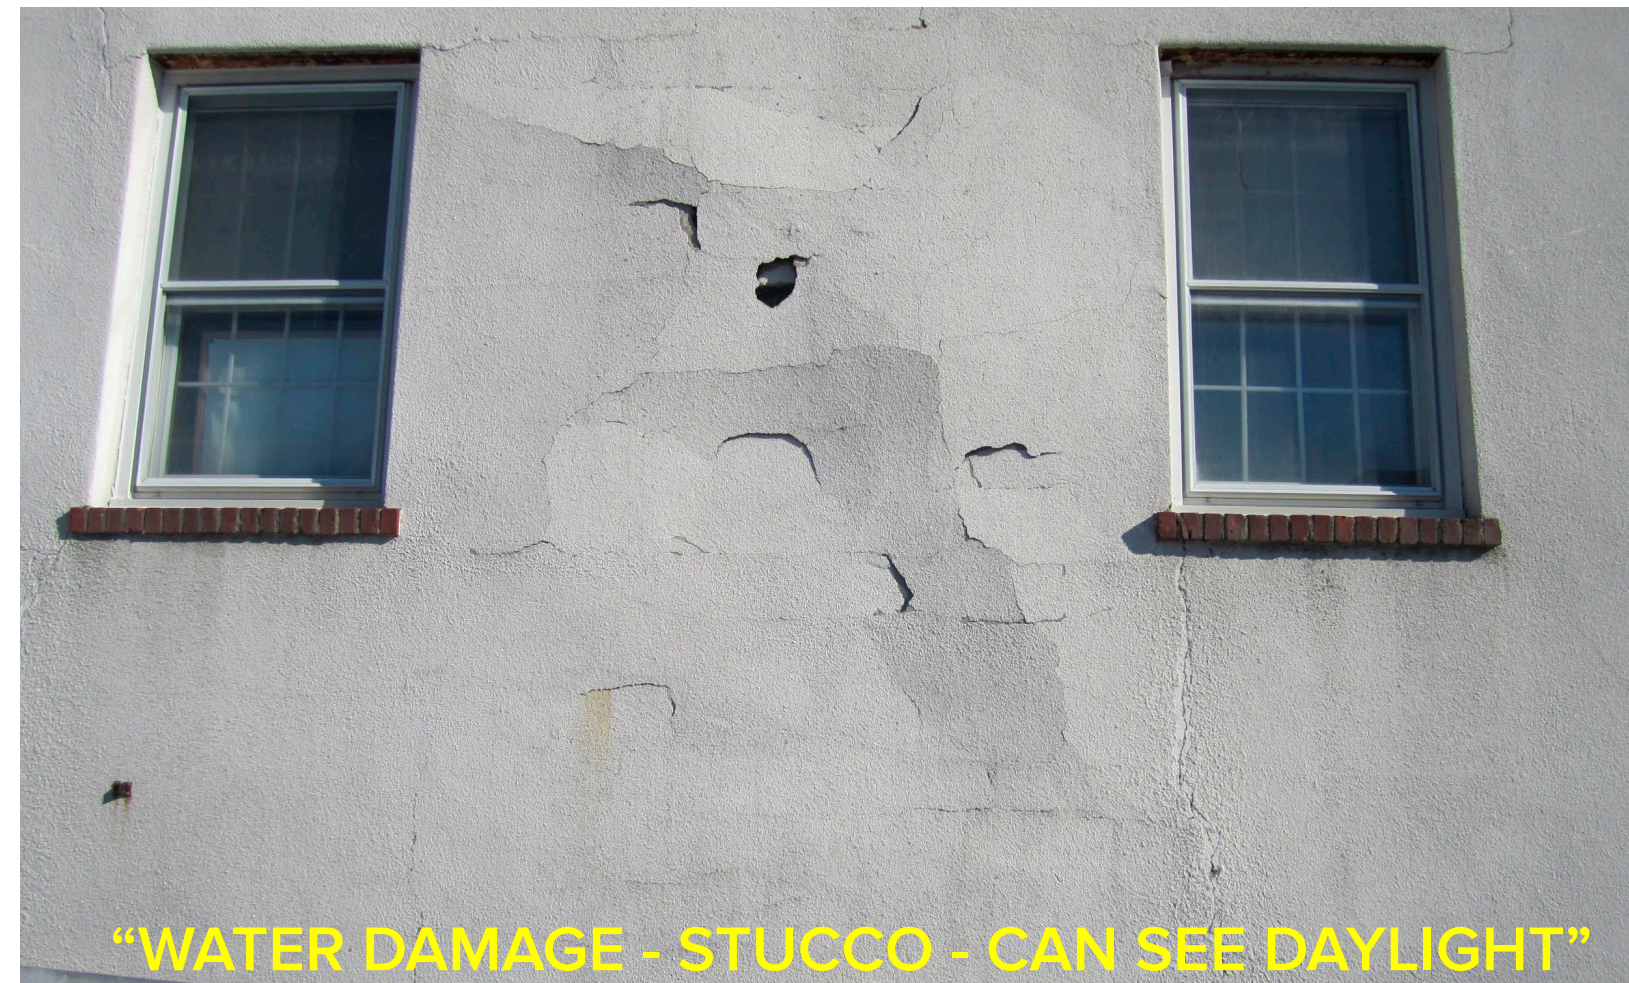
"WATER DAMAGE - STUCCO - CAN SEE DAYLIGHT"

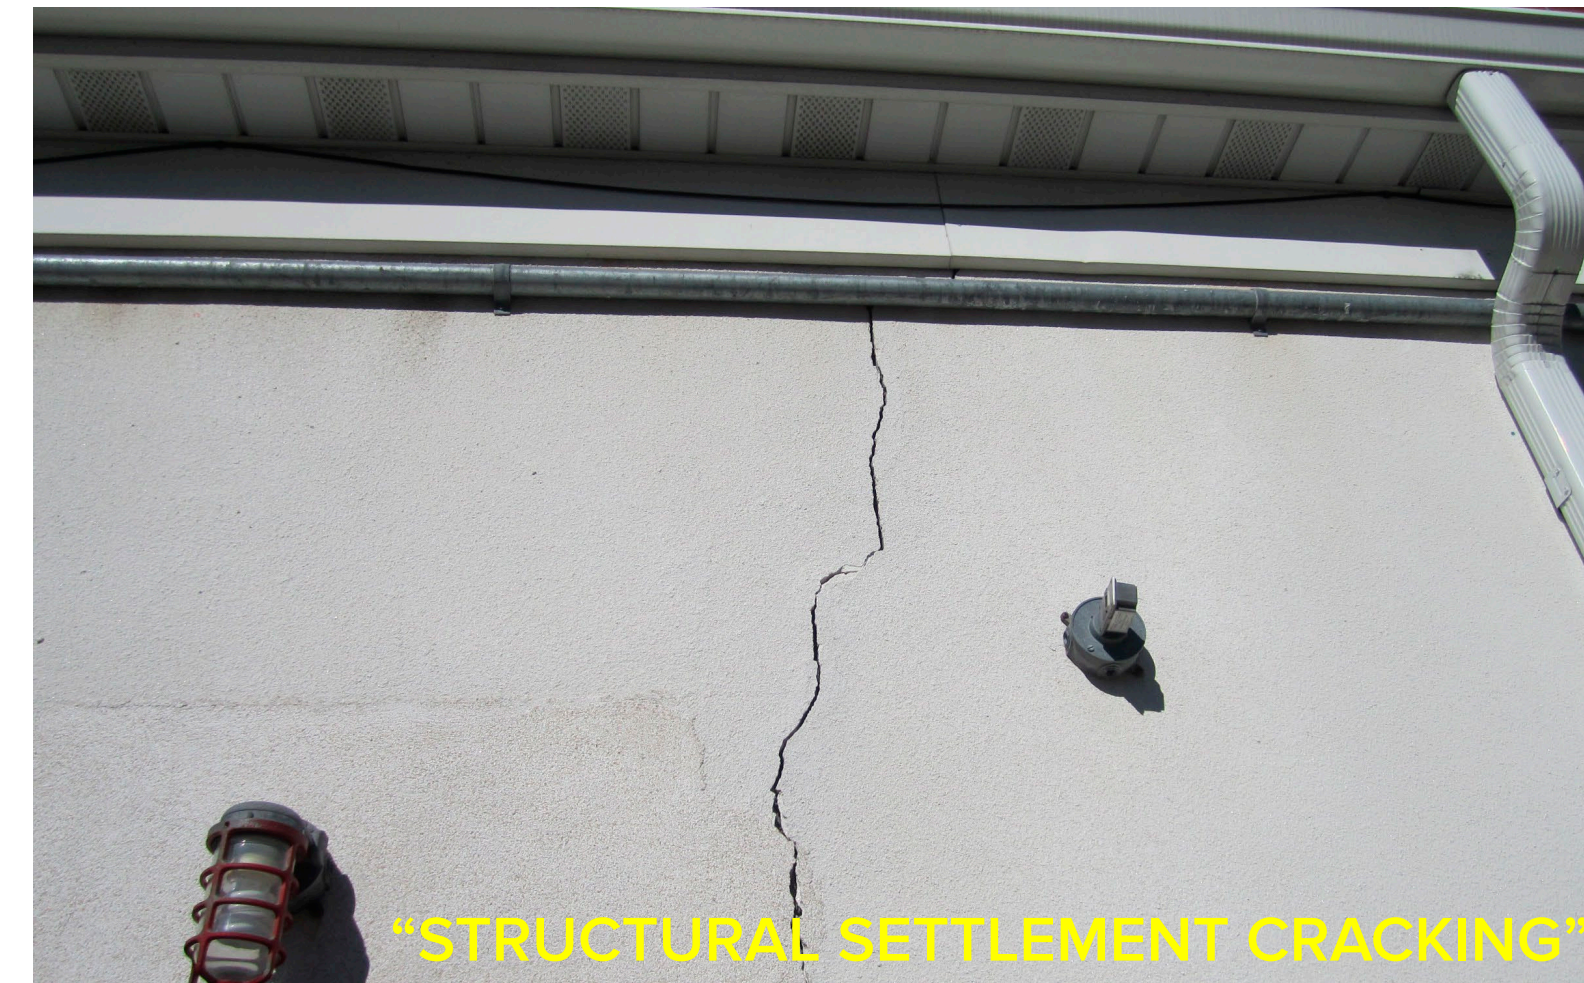
"STRUCTURAL SETTLEMENT CRACKING"

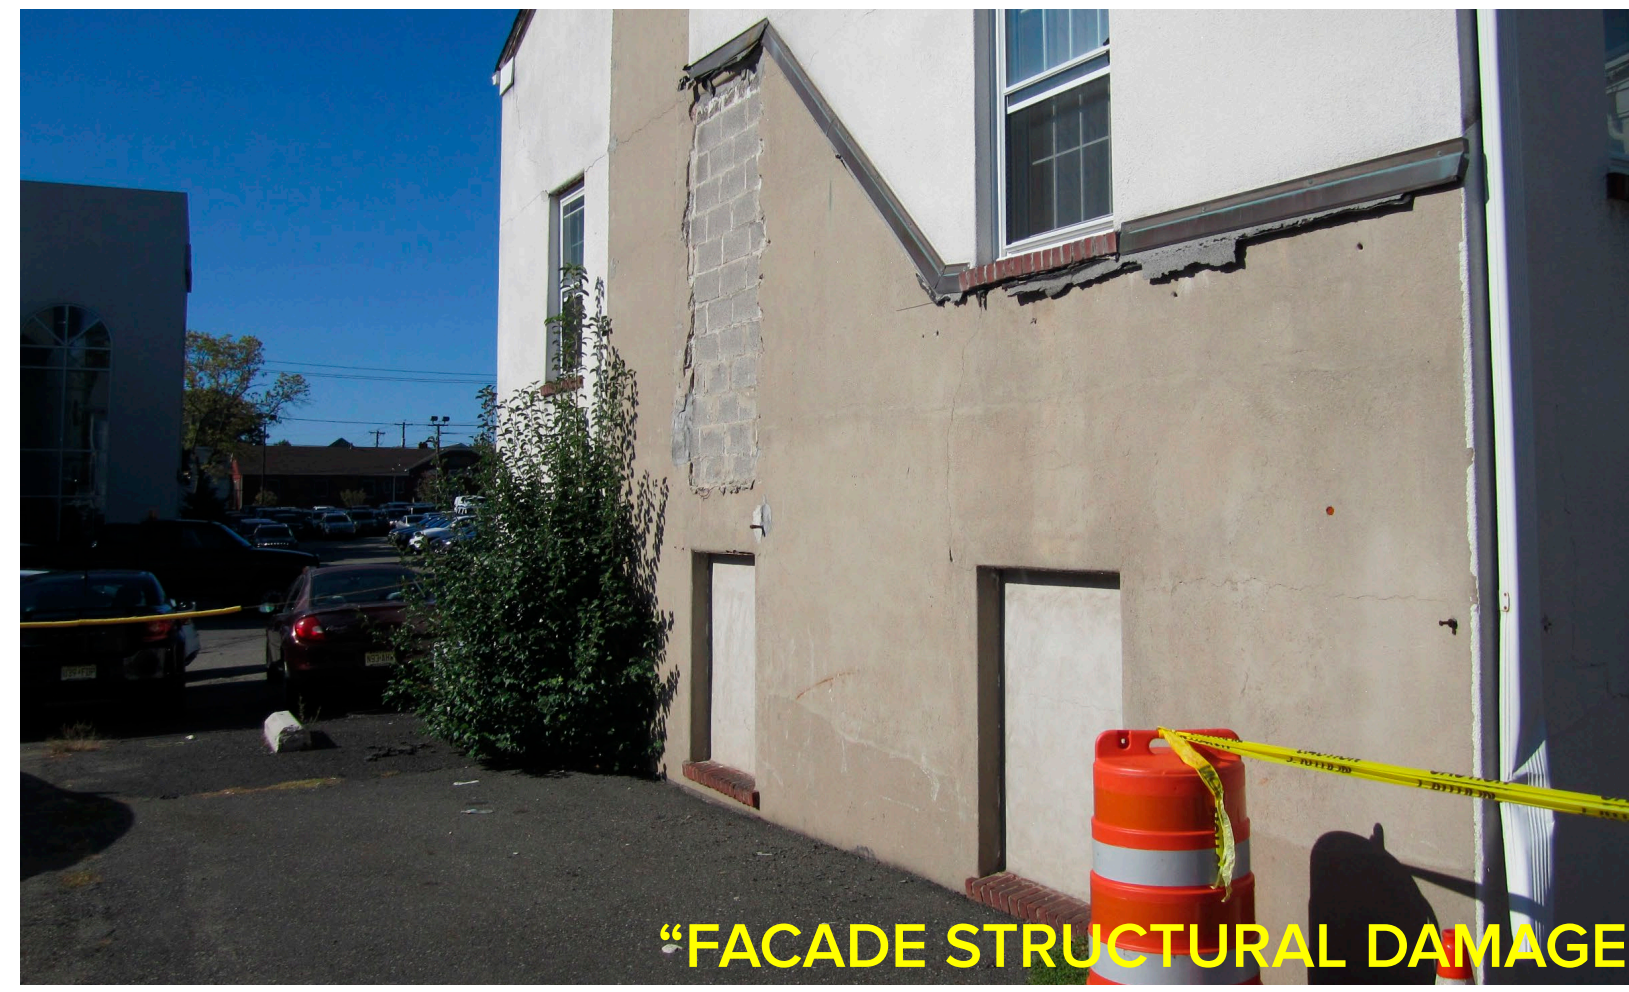
"FACADE STRUCTURAL DAMAGE"

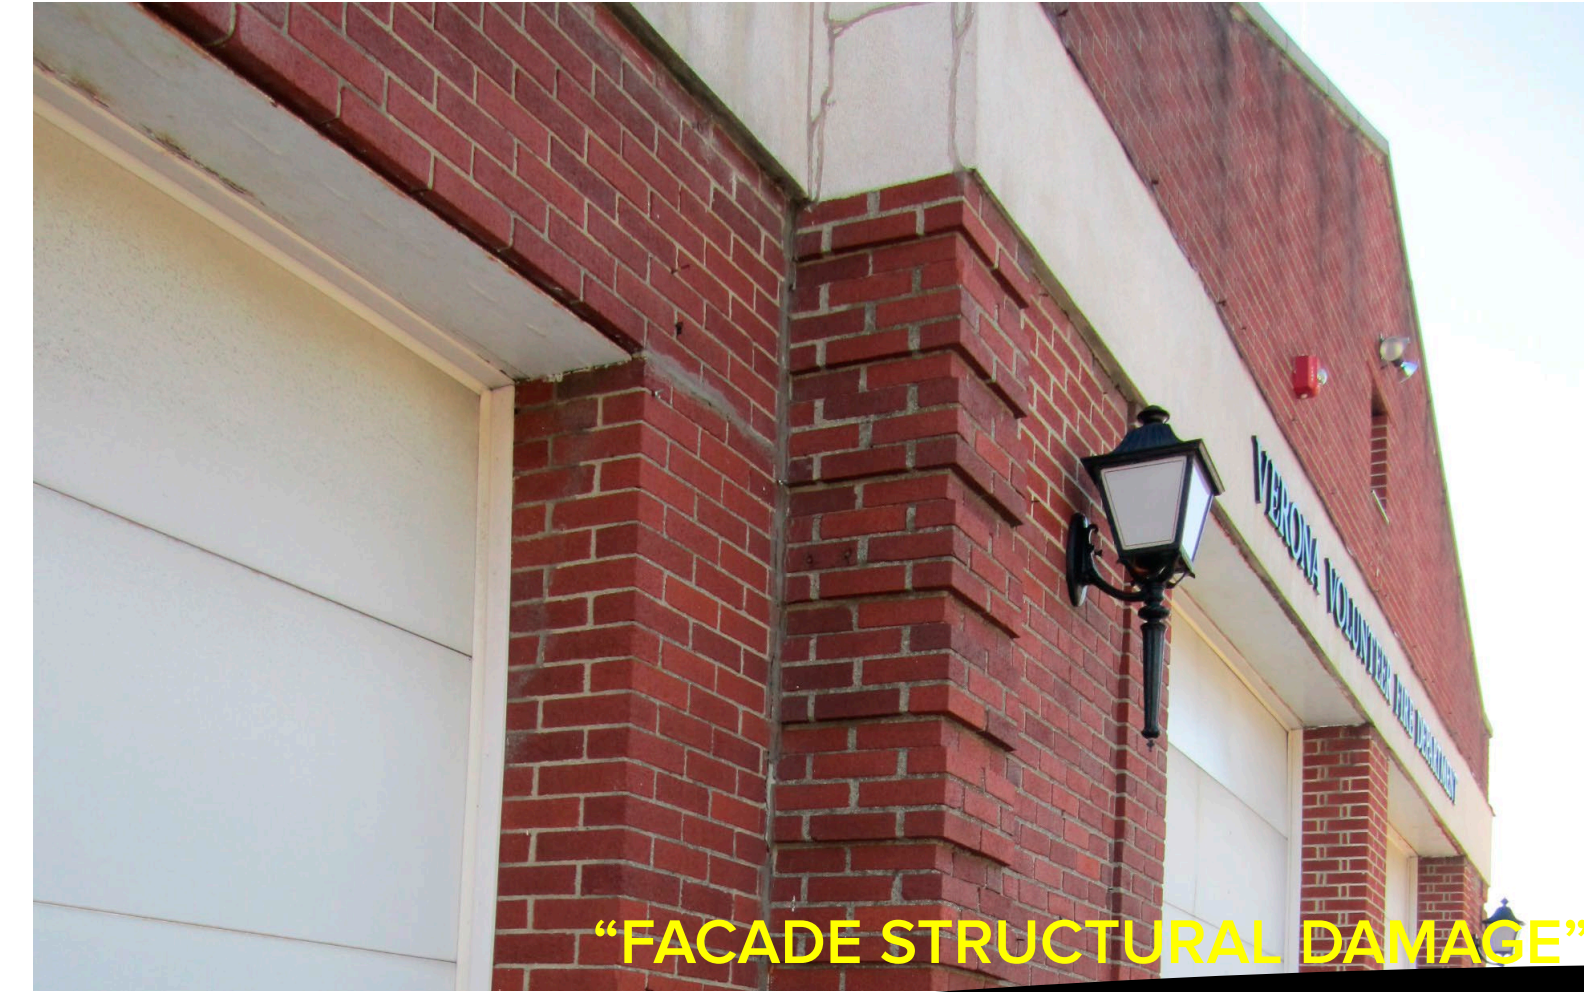
"FACADE STRUCTURAL DAMAGE"

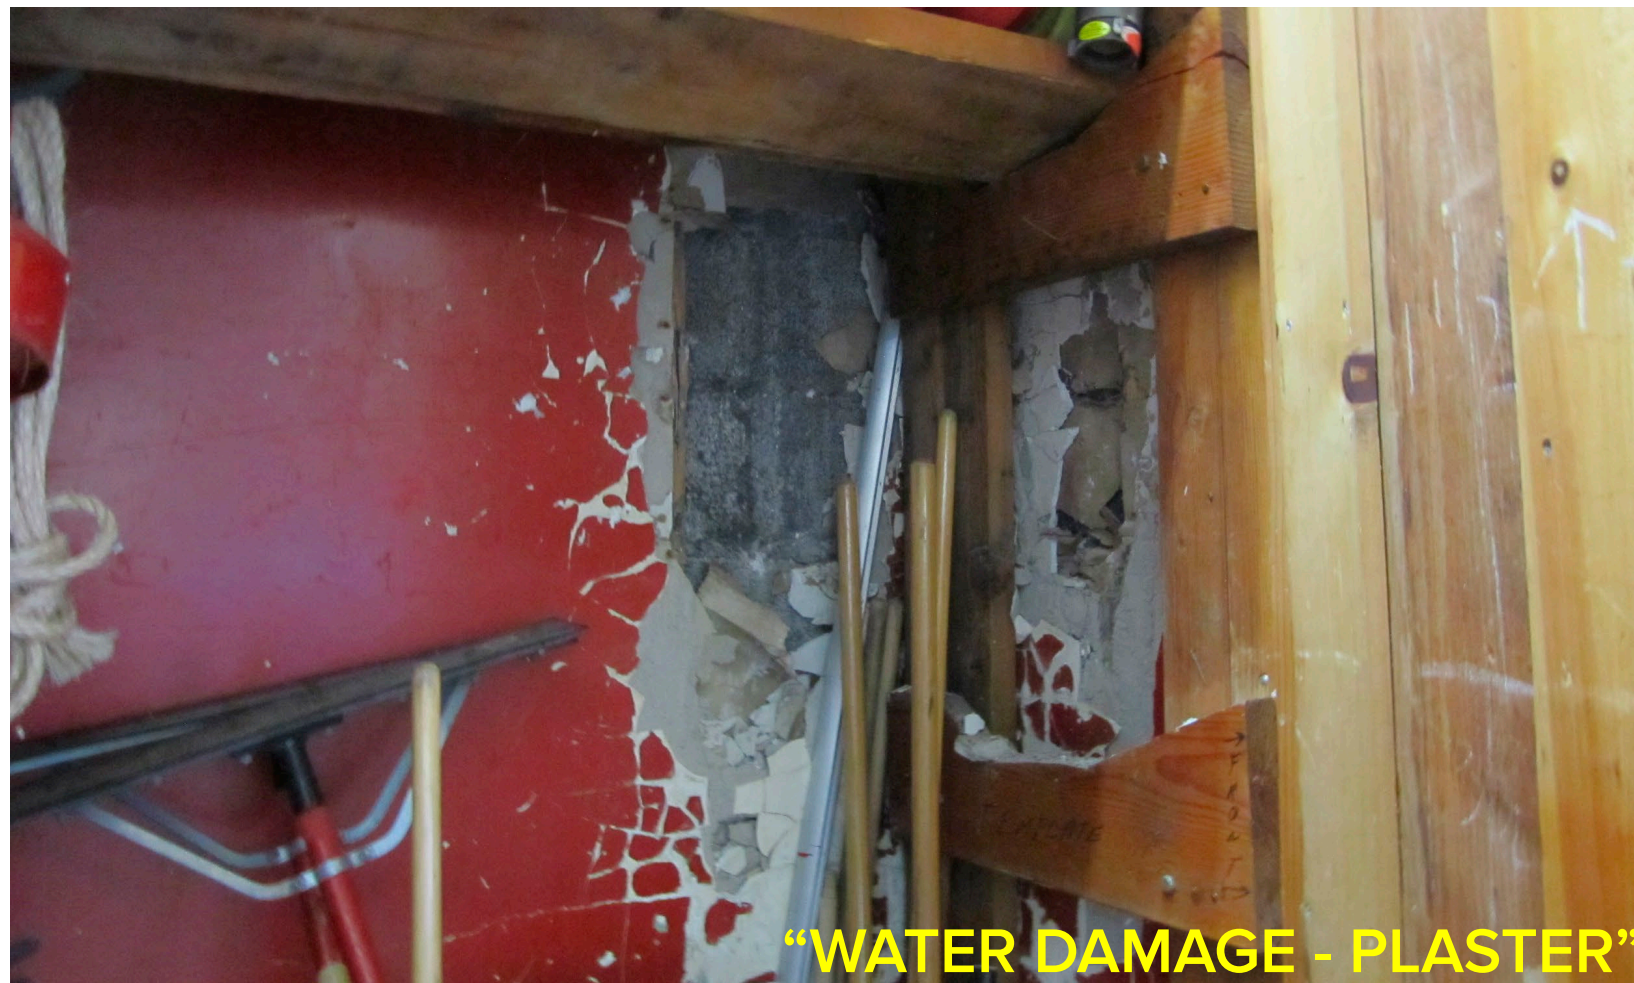
“WATER DAMAGE - PLASTER”

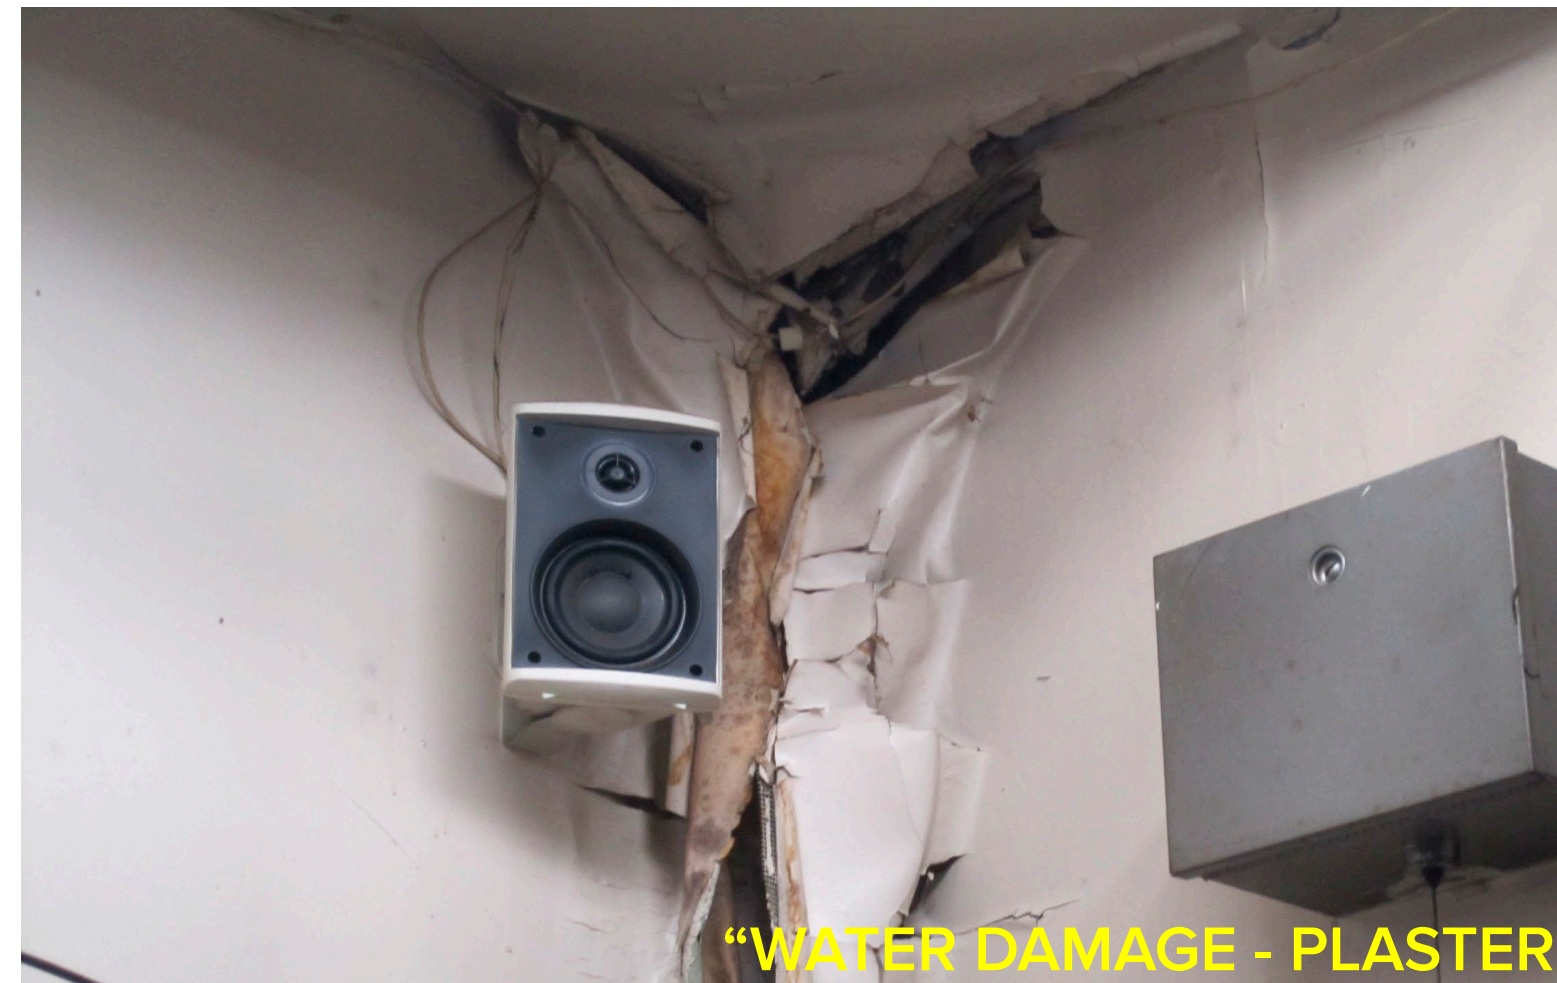
“WATER DAMAGE - PLASTER”

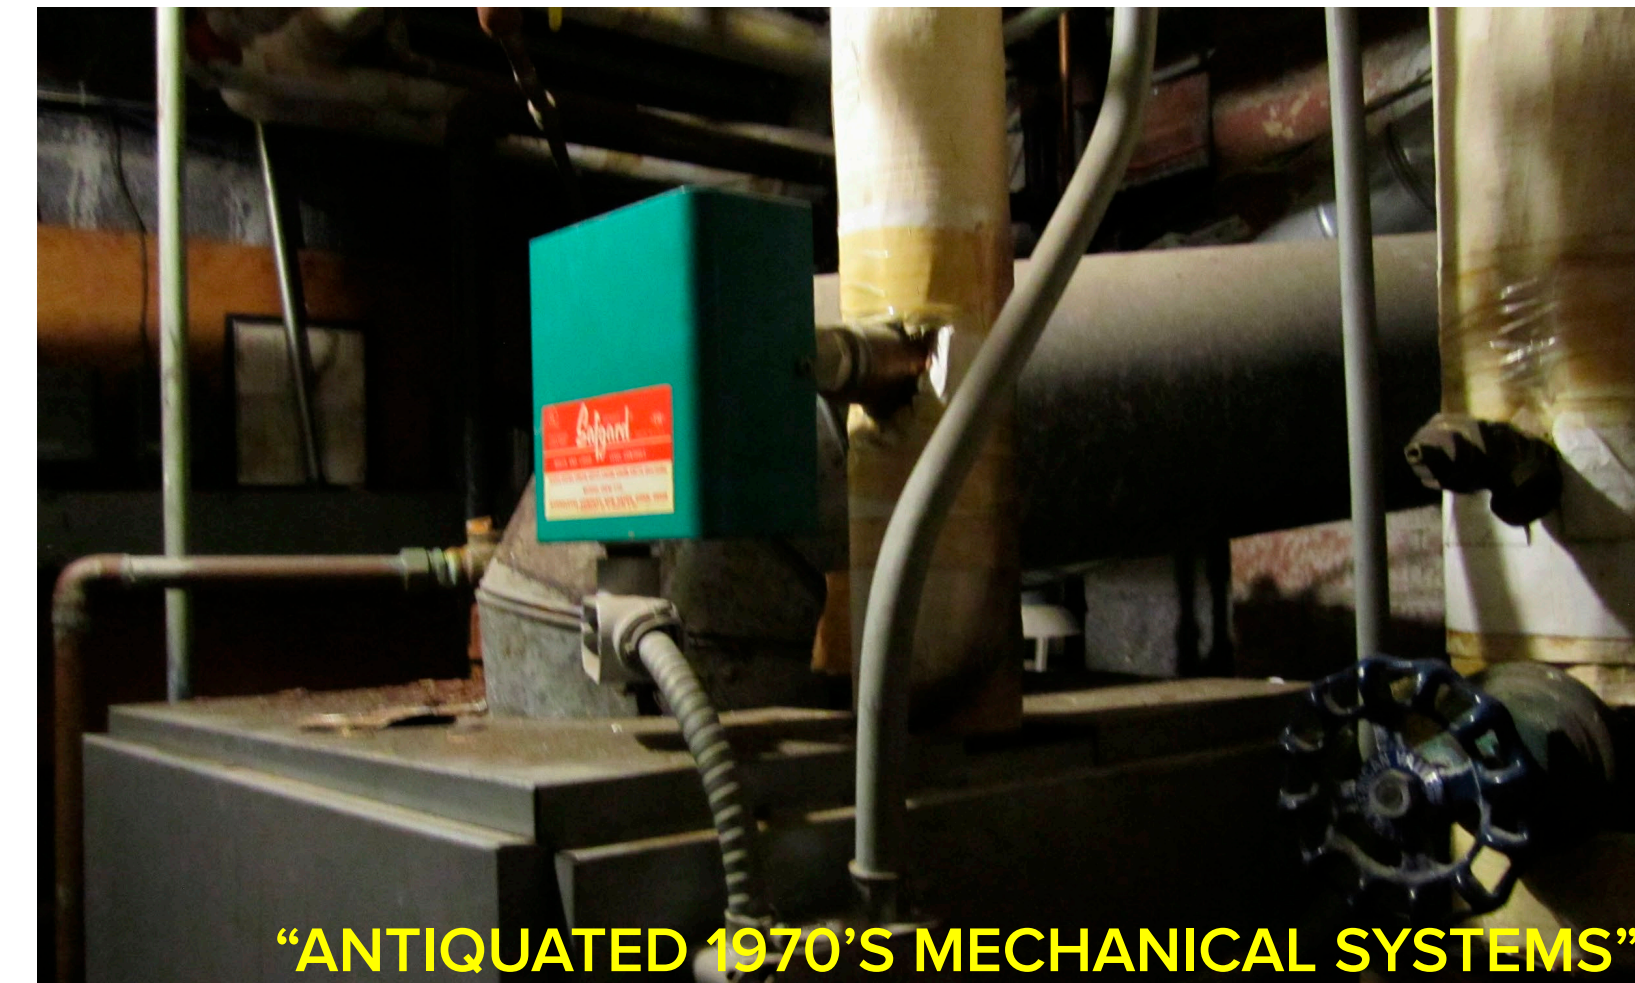
“ANTIQUATED 1970'S MECHANICAL SYSTEMS”
