THE NEED

VERONA EMERGENCY SERVICES COMPLEX

POLICE DEPARTMENT, FIRE DEPARTMENT - CO. #2, RESCUE SQUAD

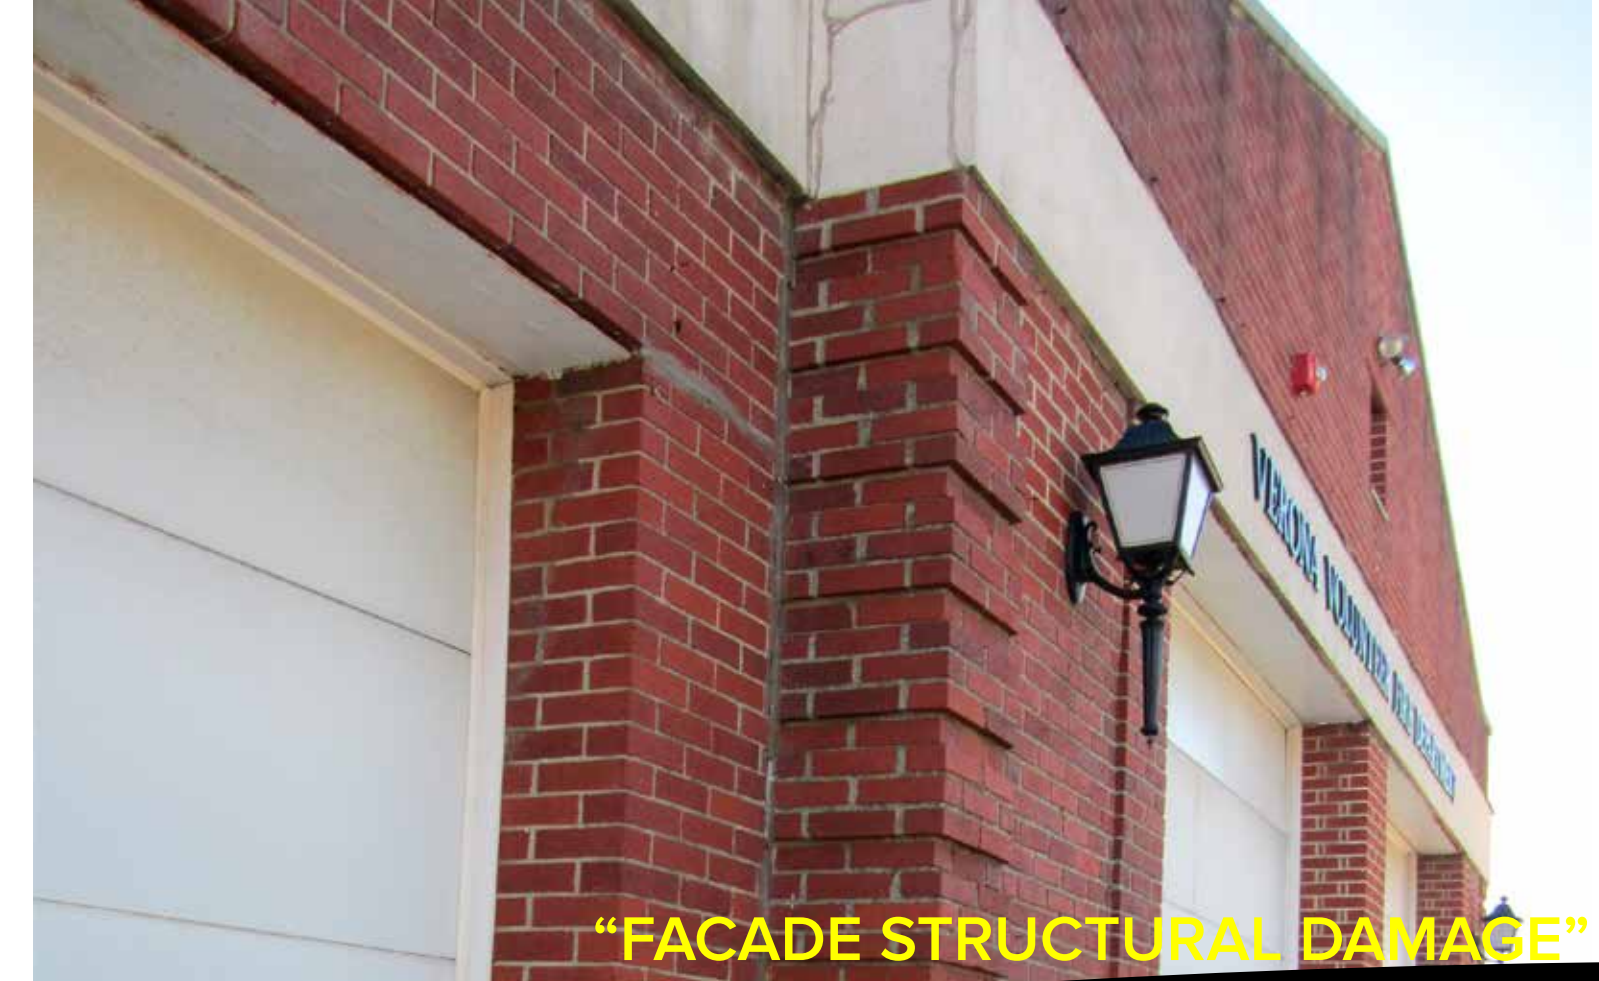
"FACADE STRUCTURAL DAMAGE"

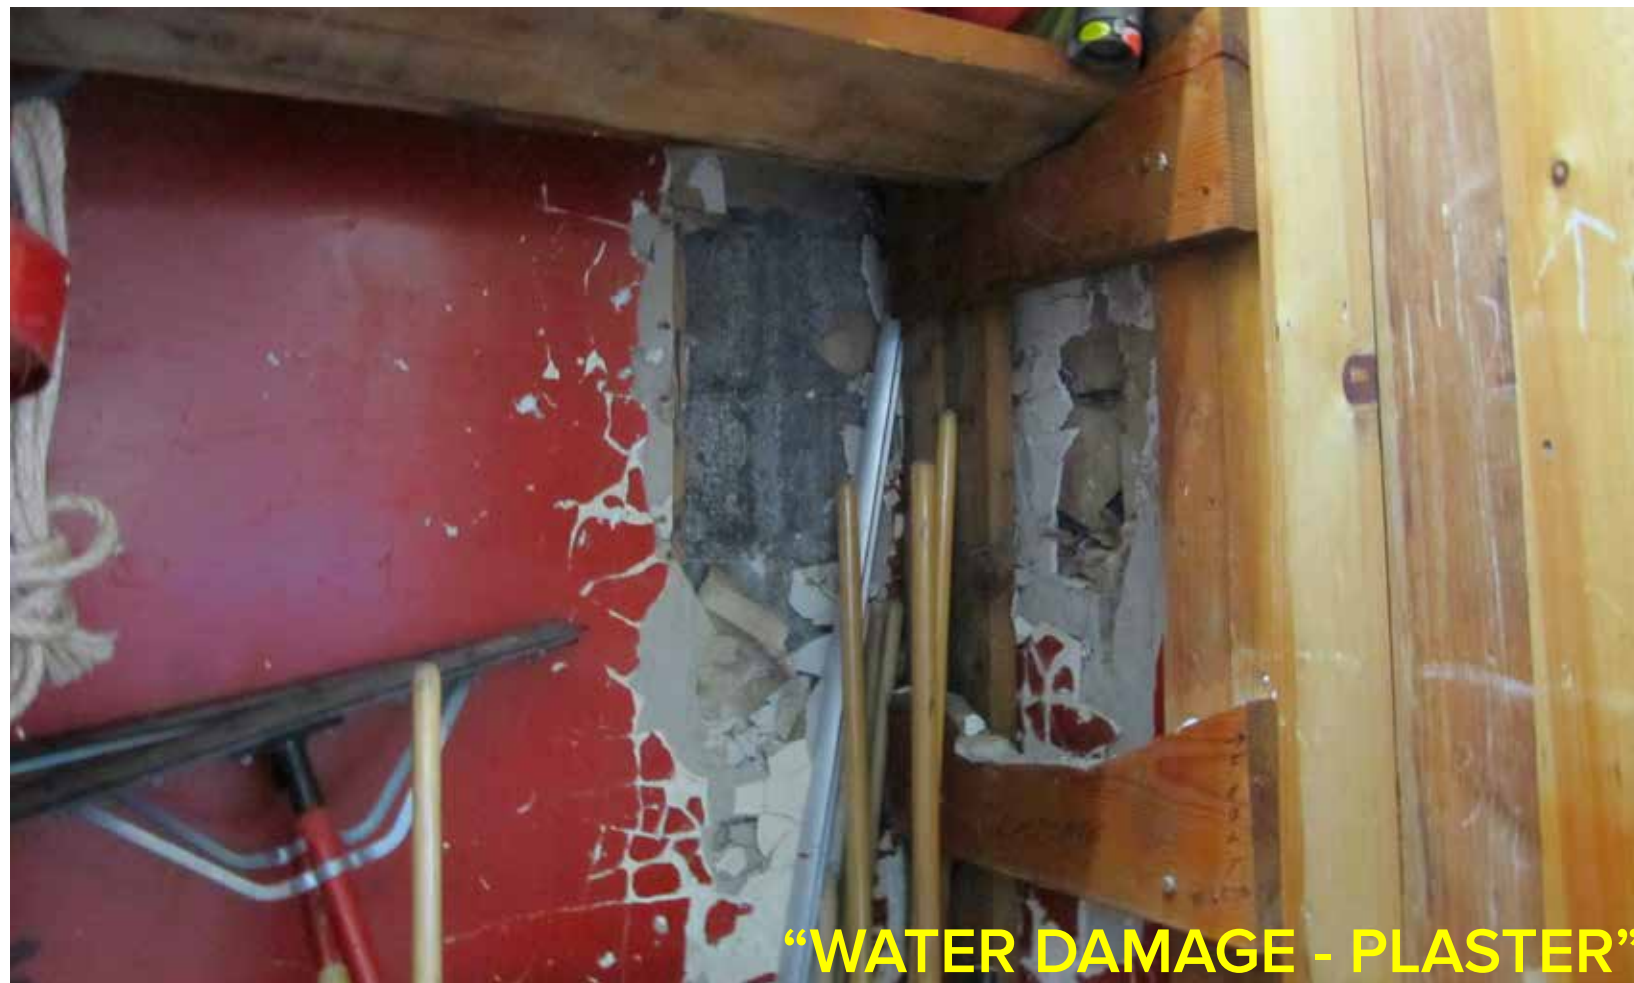
“WATER DAMAGE - PLASTER”

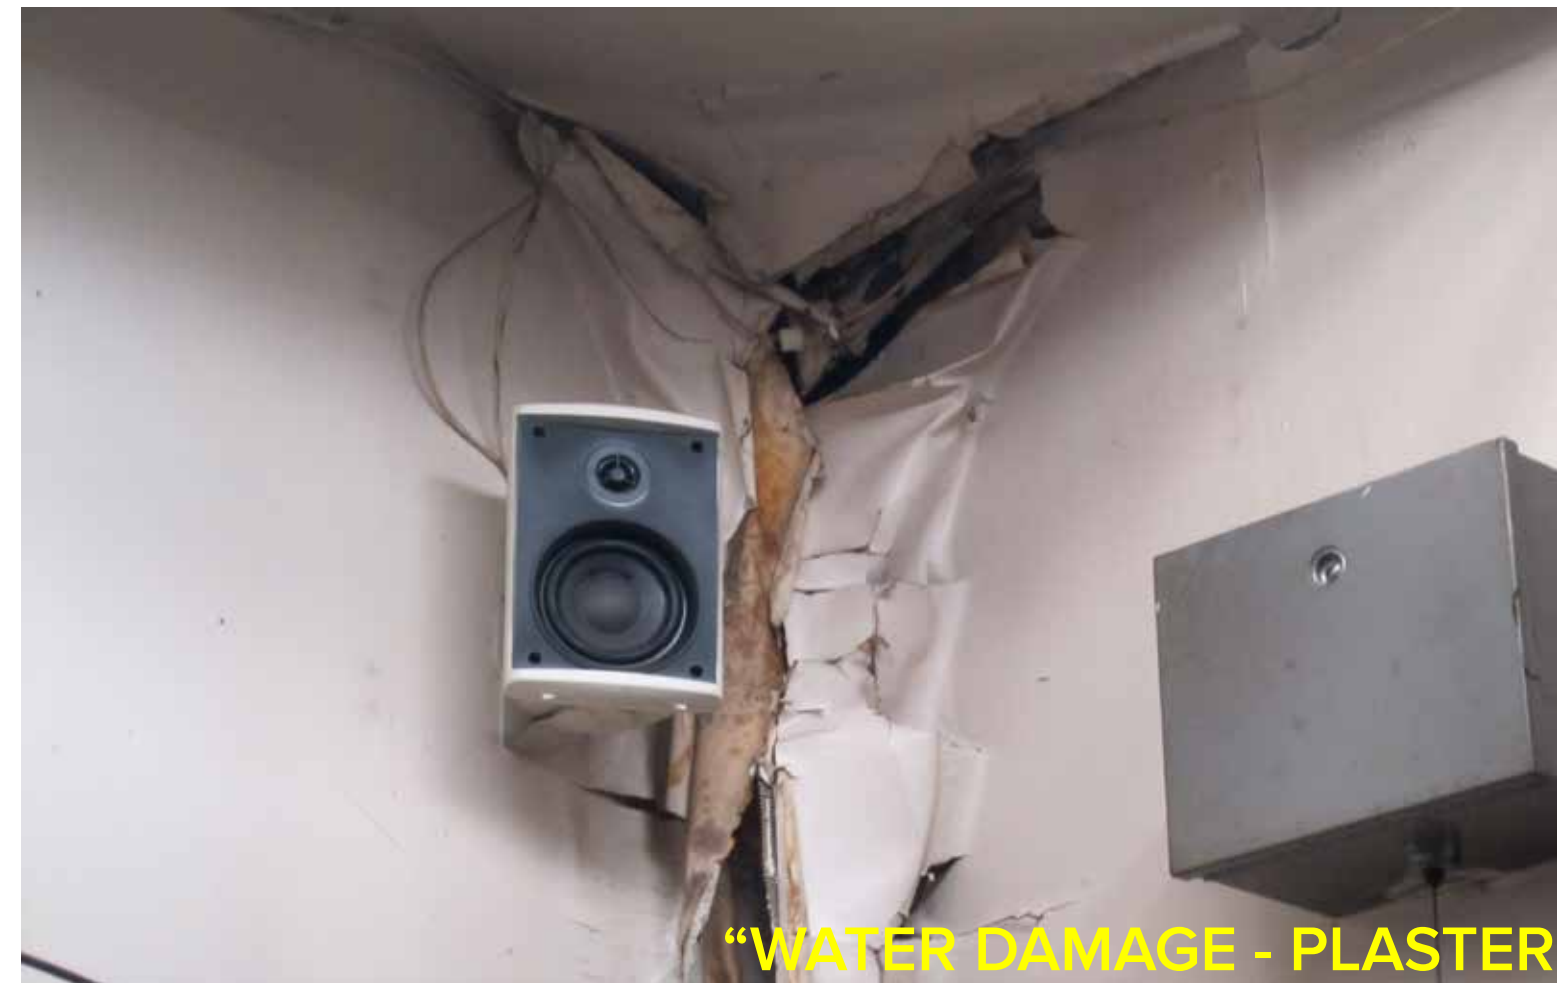
“WATER DAMAGE - PLASTER”

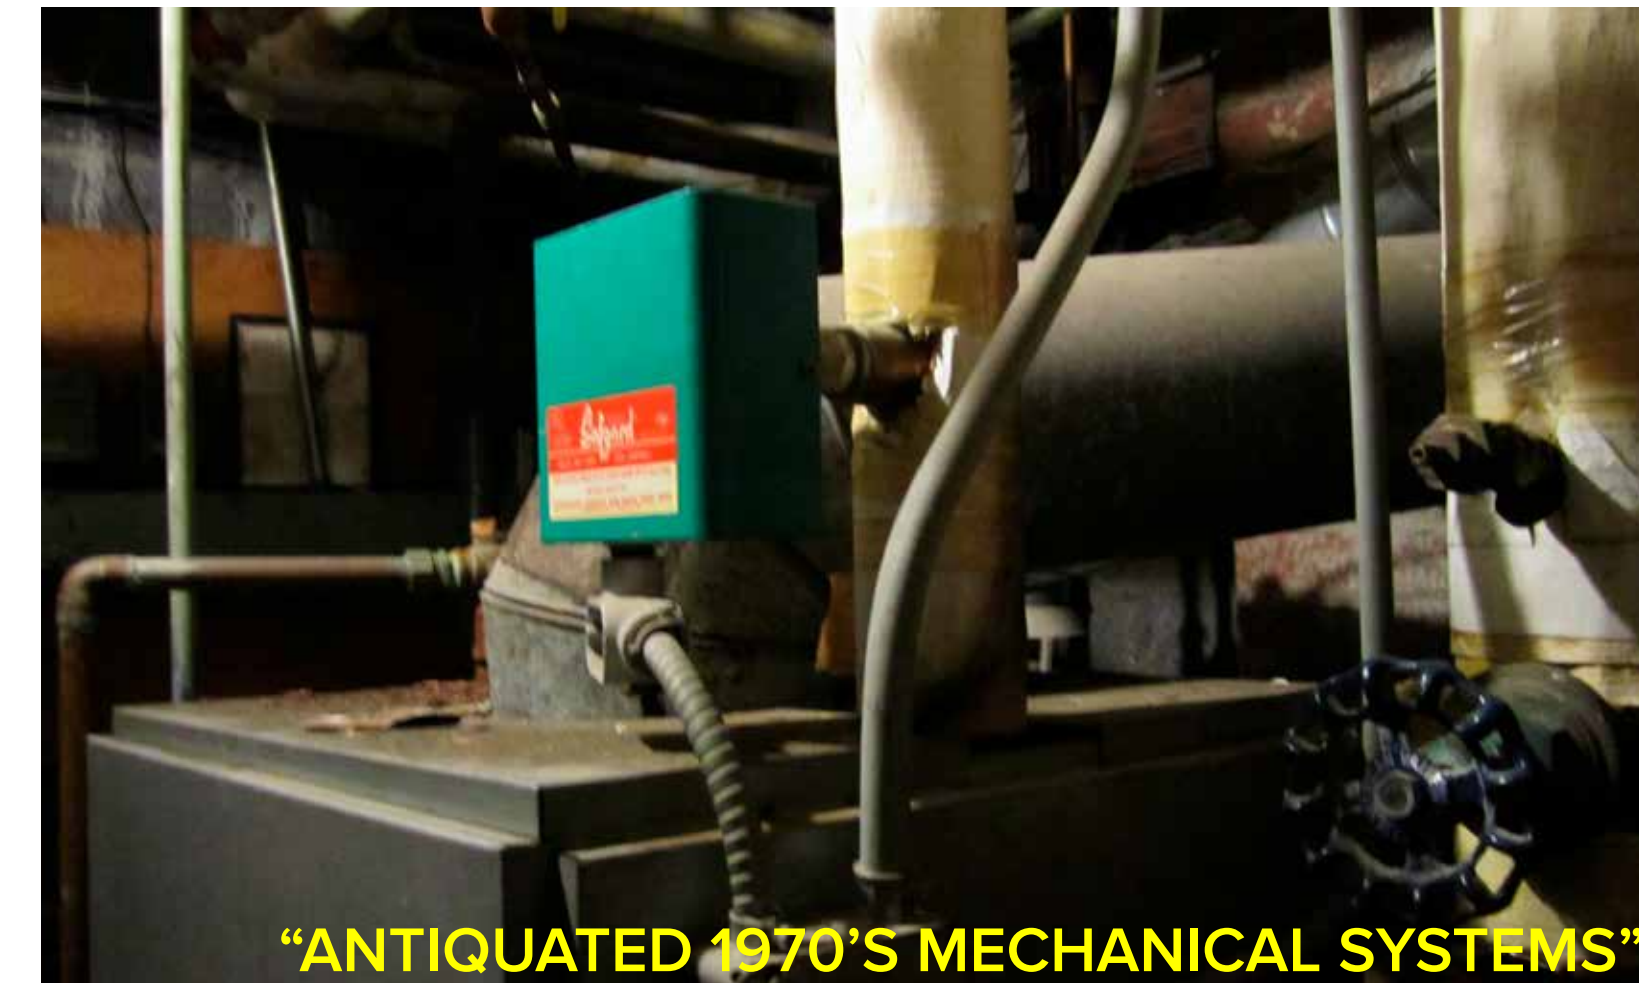
- » The air conditioning unit on the roof is irreparable. Building and Grounds had a company come in to assess the unit, and they estimated that it would be \$15,000 to replace it.
- » Heating system was overhauled in 2020, but the boiler that was installed 70's was never replaced in spite of extensive repairs, it is in need of replacement.
- » Major plumbing leaks throughout the facility, sediment found in the system. Apparatus bay floor drains do not appear to have an oil separator.
- » The basement entry stairwell floods during heavy rain. Basement door-deteriorated and does not open, posing a safety problem. Basement cannot be used.

“ANTIQUATED 1970'S MECHANICAL SYSTEMS”

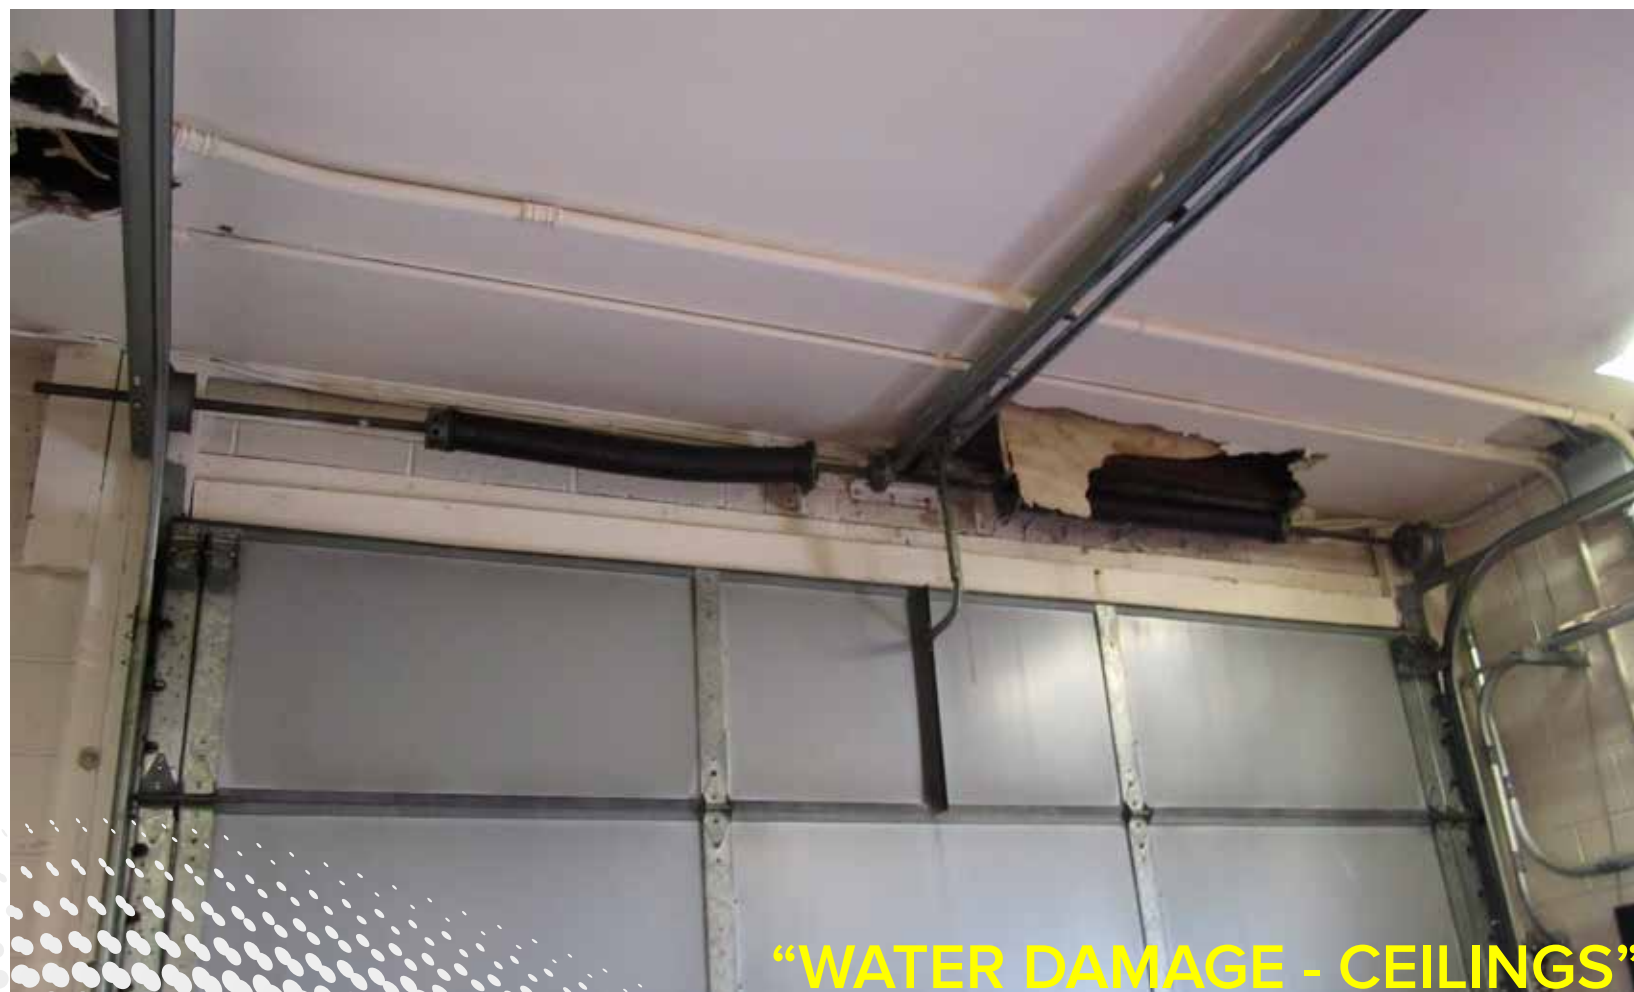
“WATER DAMAGE - CEILINGS”

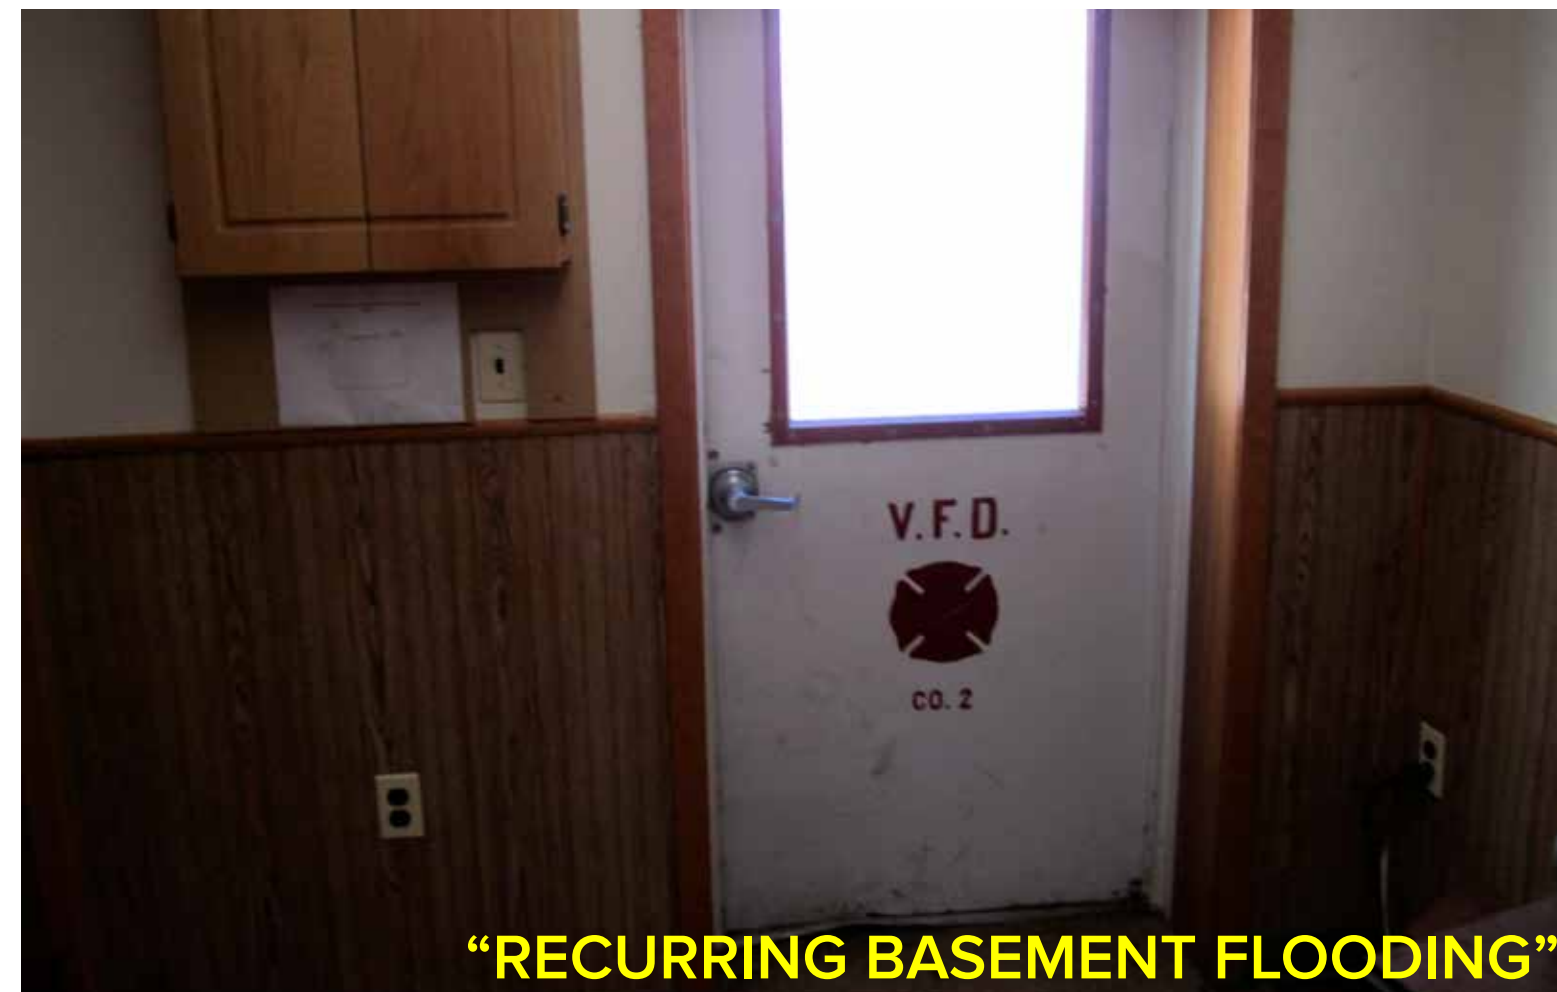
“RECURRING BASEMENT FLOODING”

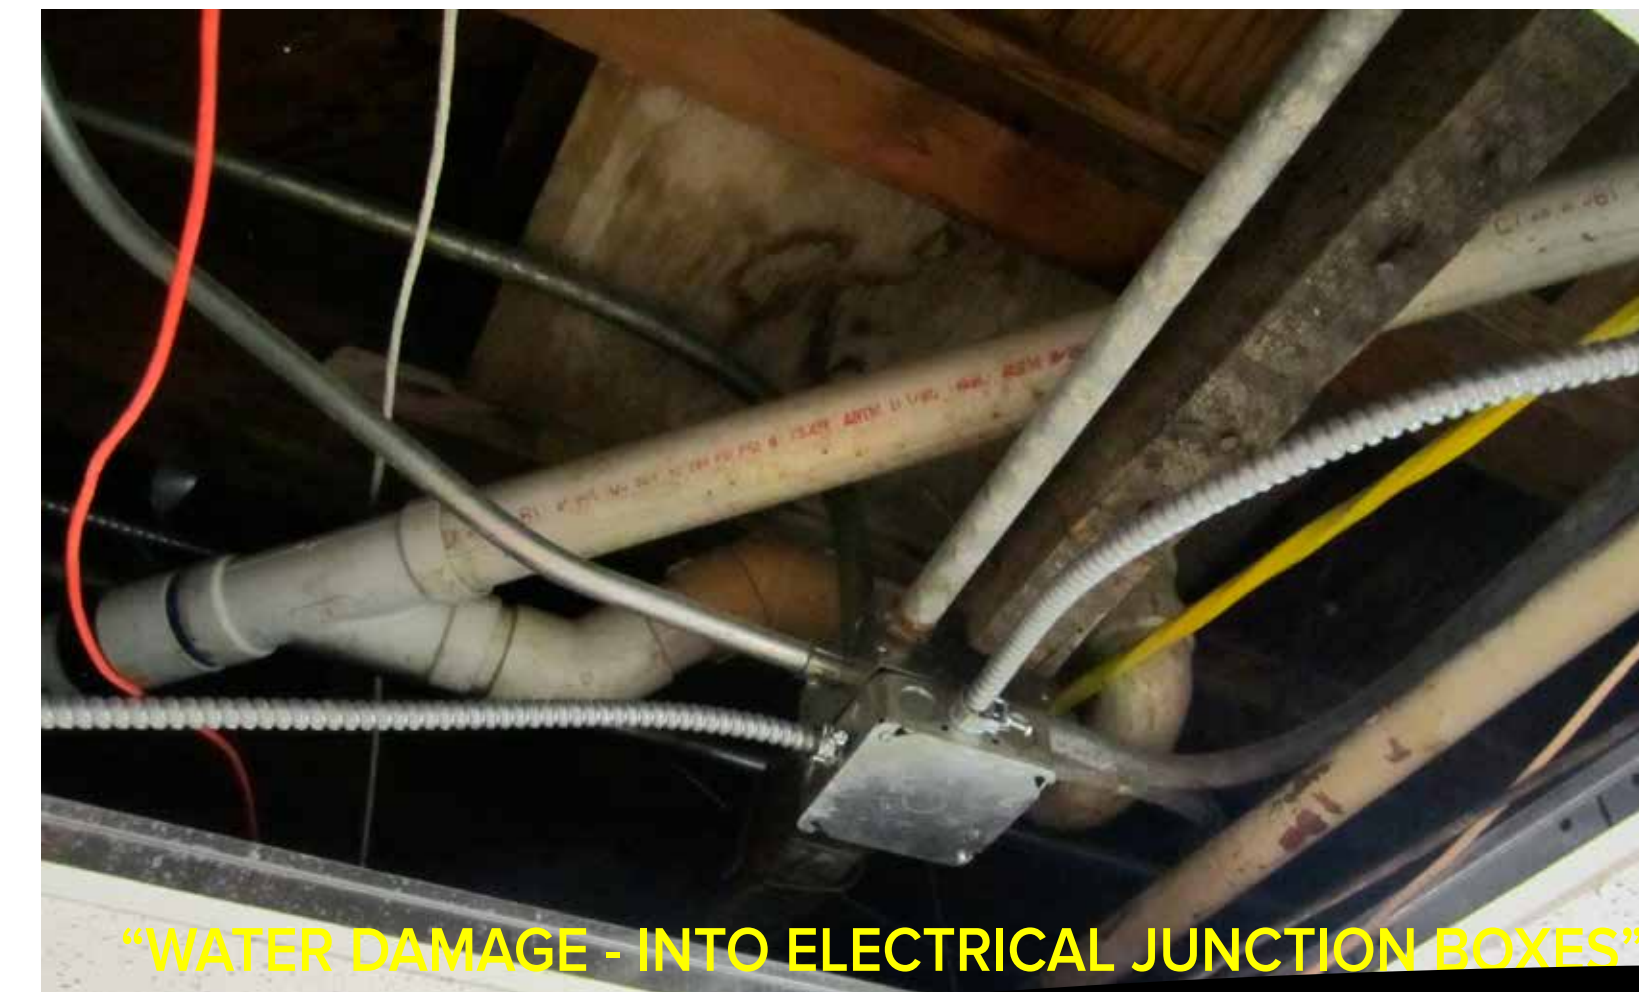
“WATER DAMAGE - INTO ELECTRICAL JUNCTION BOXES”

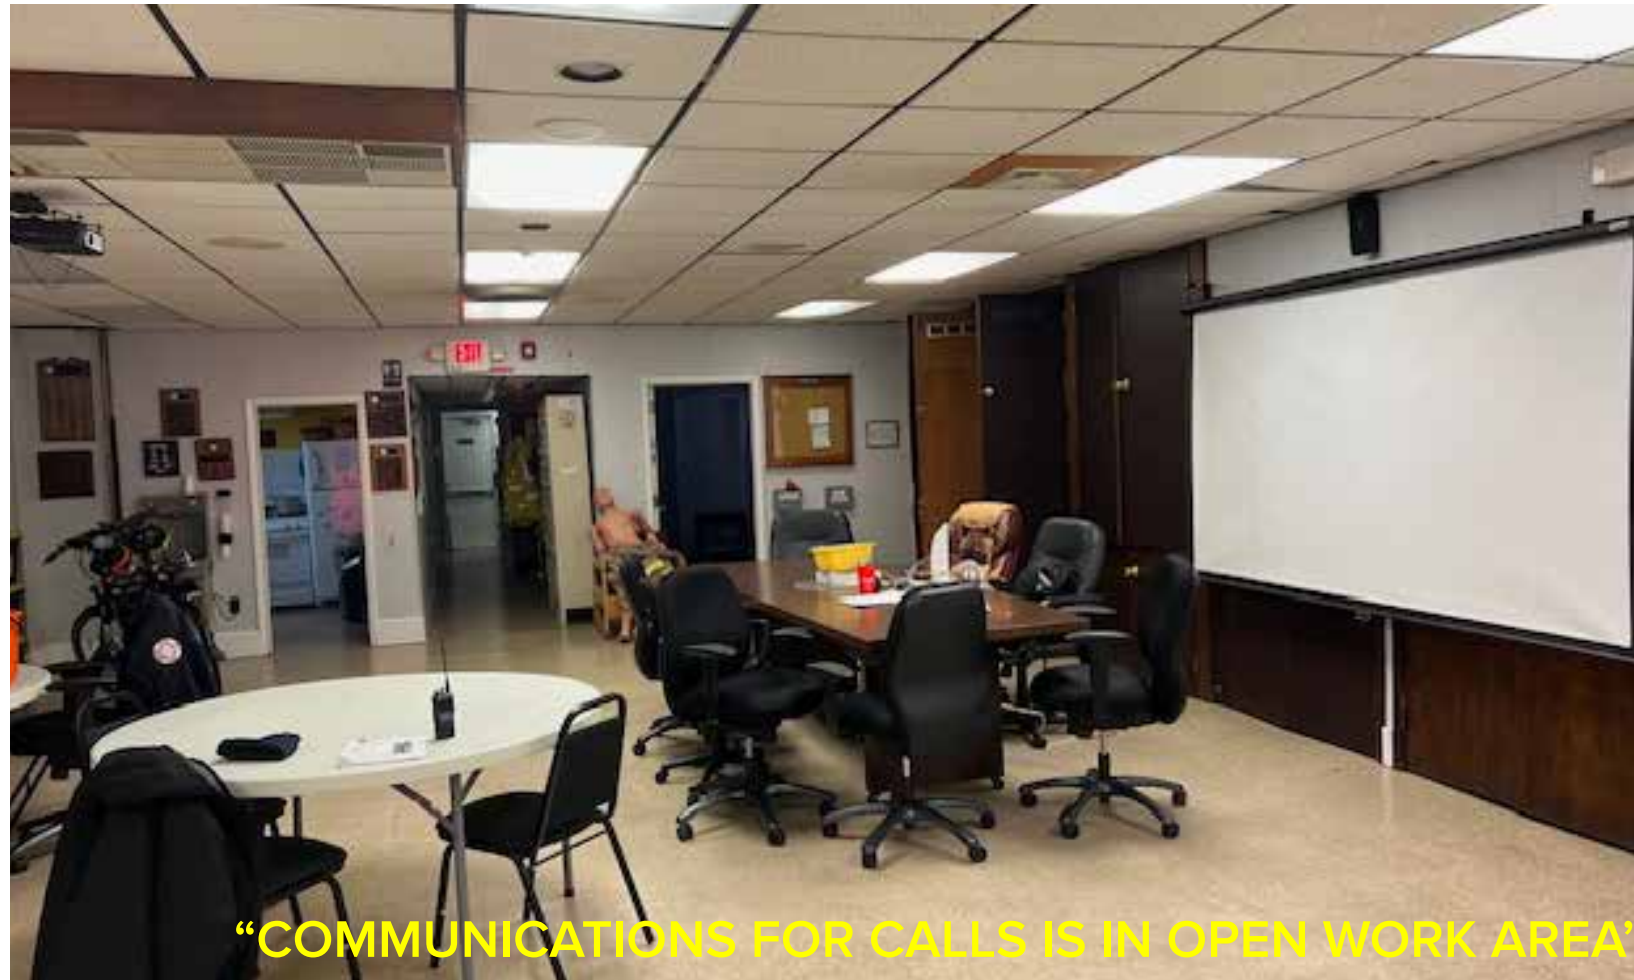
"COMMUNICATIONS FOR CALLS IS IN OPEN WORK AREA"

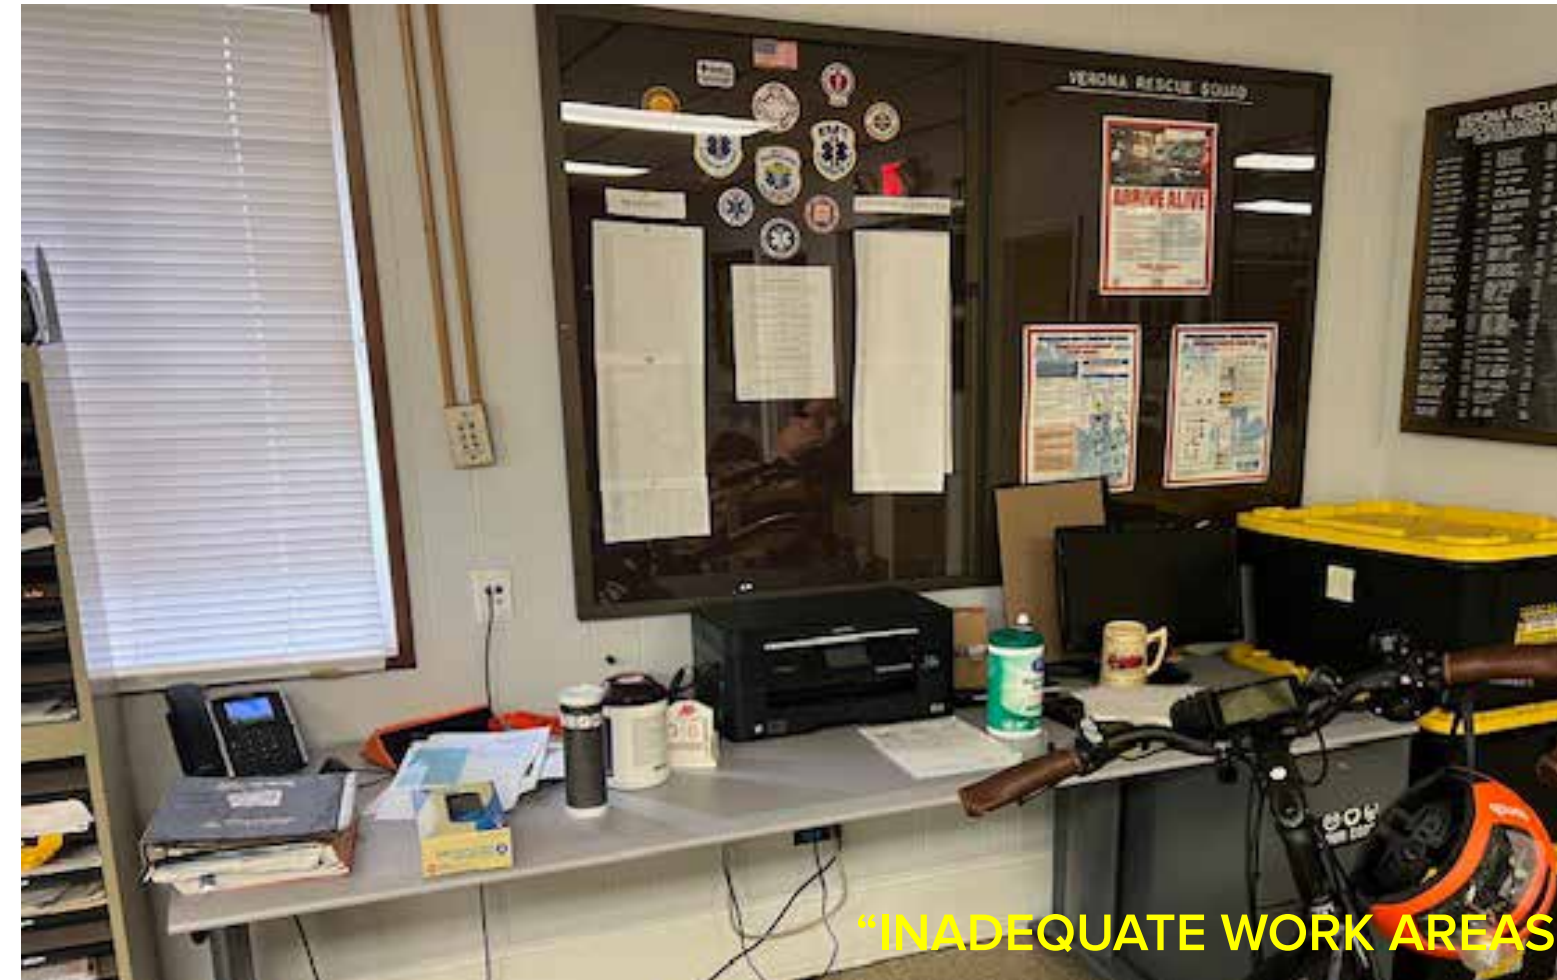
"INADEQUATE WORK AREAS"

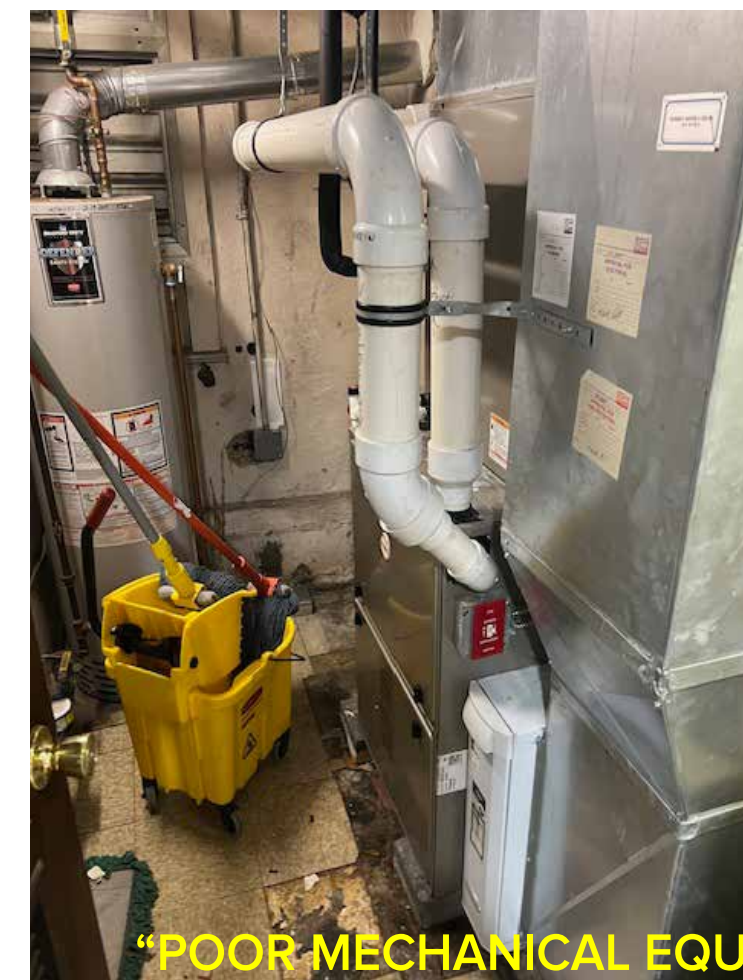
"POOR MECHANICAL EQUIP"

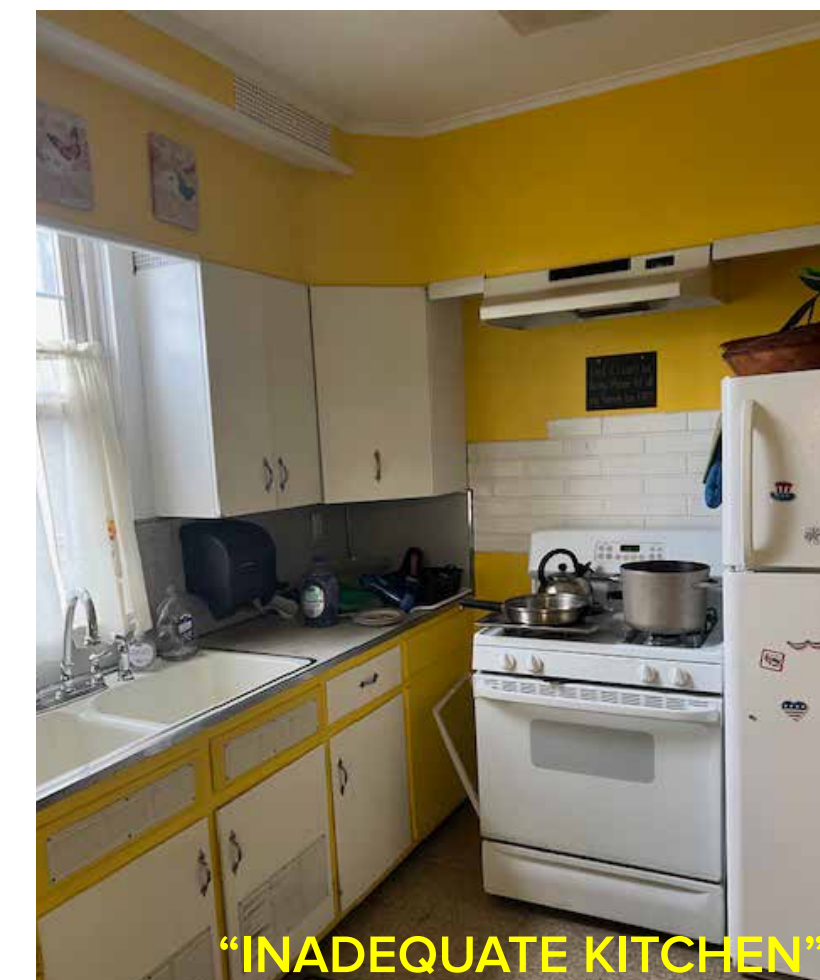
"INADEQUATE KITCHEN"

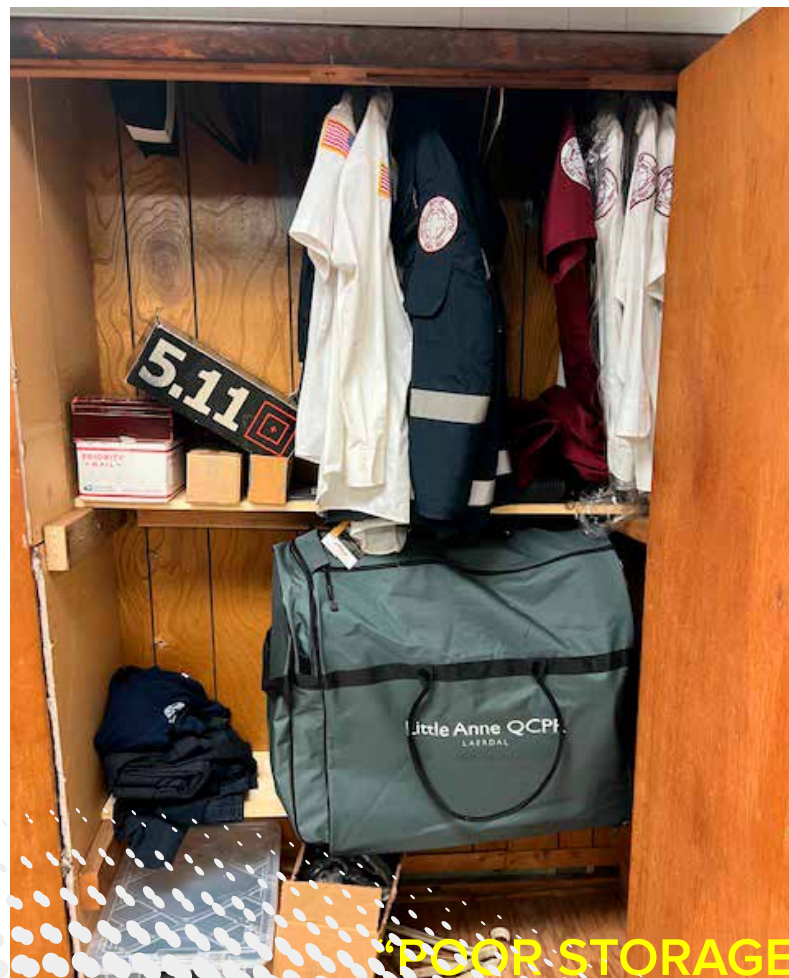
"POOR STORAGE"

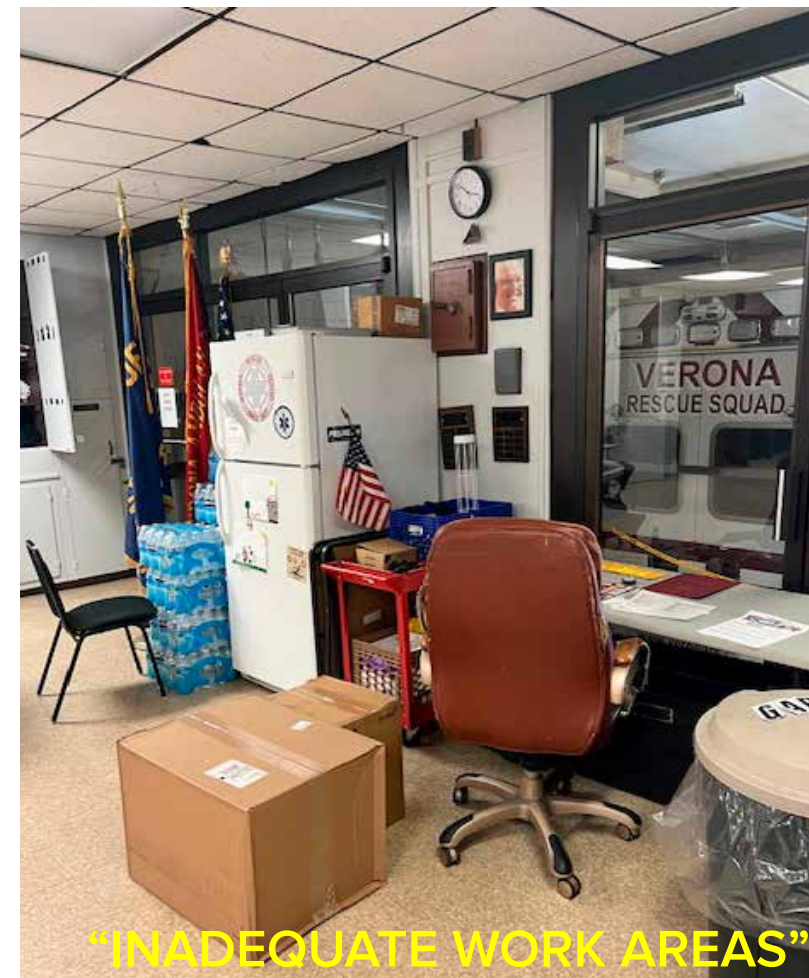
"INADEQUATE WORK AREAS"

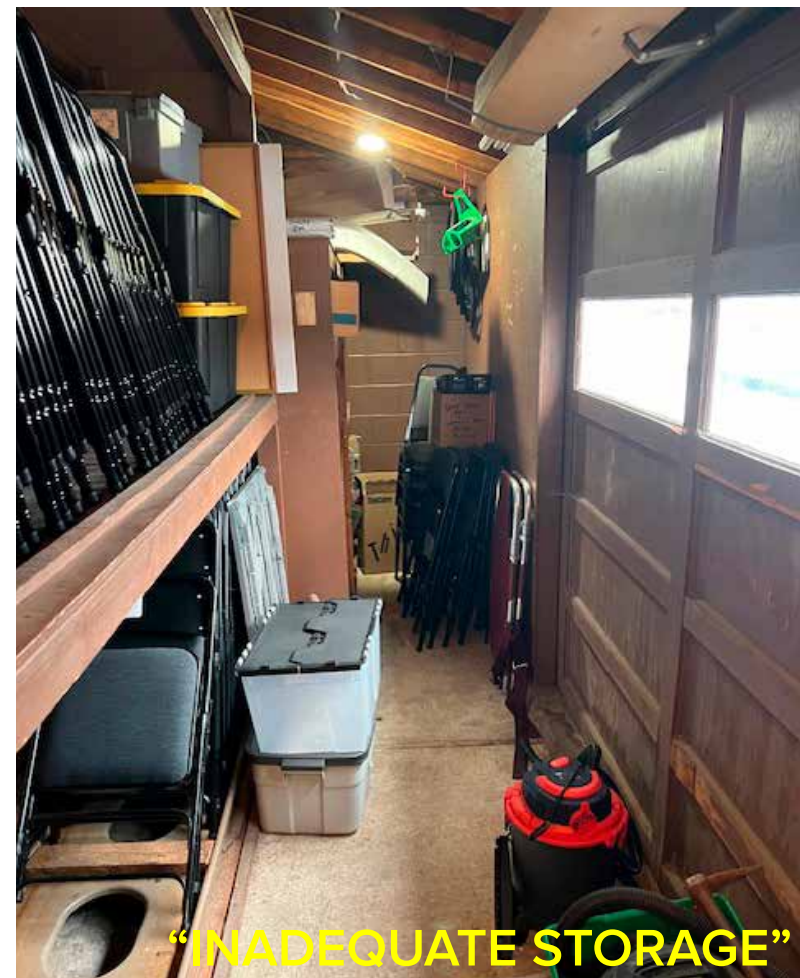
"INADEQUATE STORAGE"

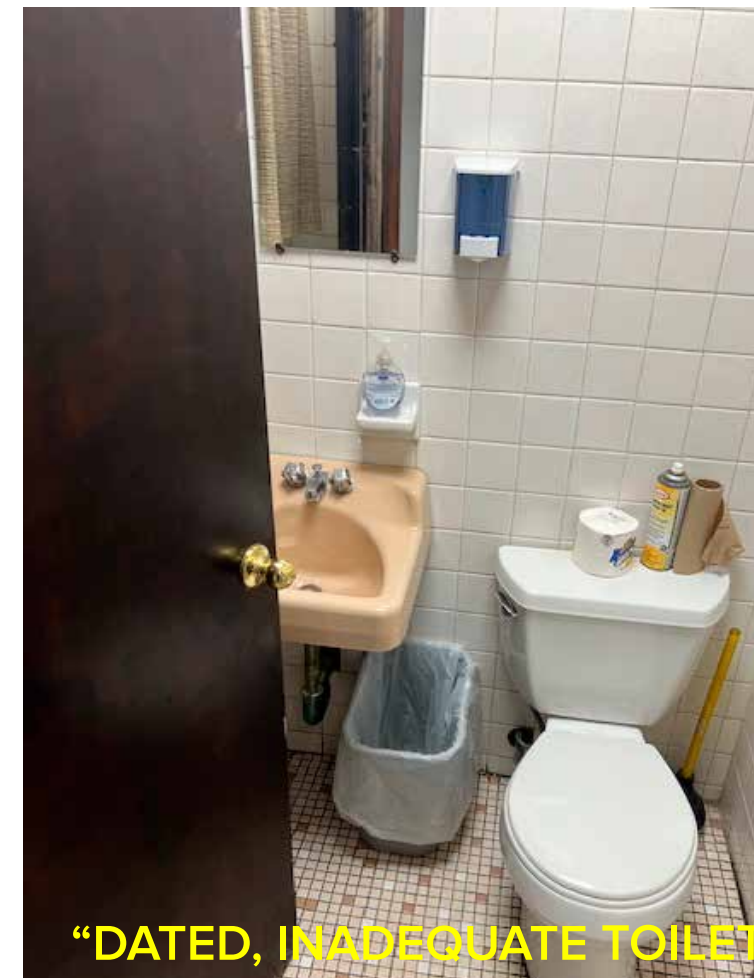
"DATED, INADEQUATE TOILET"

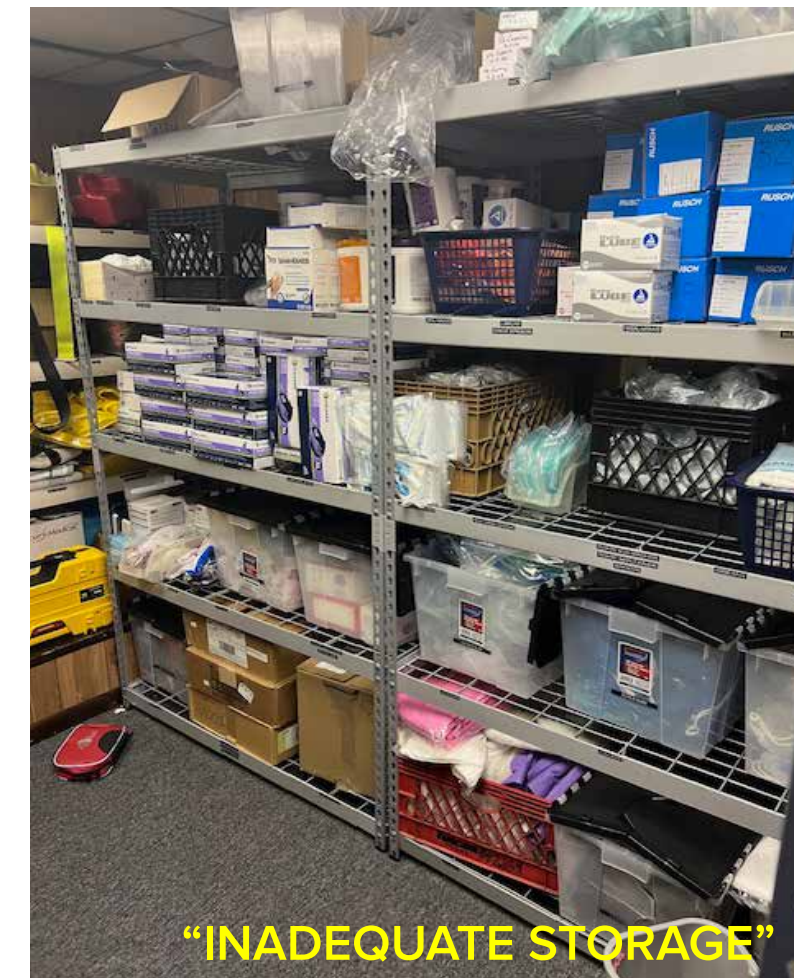
"INADEQUATE STORAGE"

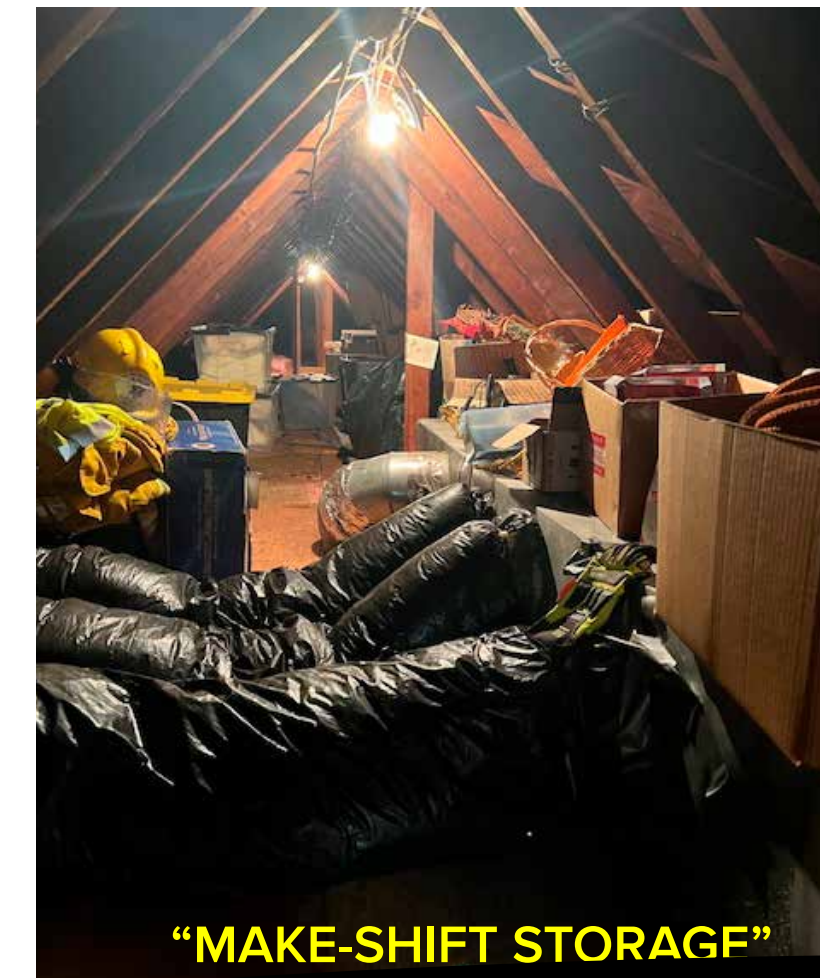
"MAKE-SHIFT STORAGE"
