PUBLIC PRESENTATION

VERONA EMERGENCY SERVICES COMPLEX

POLICE DEPARTMENT, FIRE DEPARTMENT - CO. #2, RESCUE SQUAD

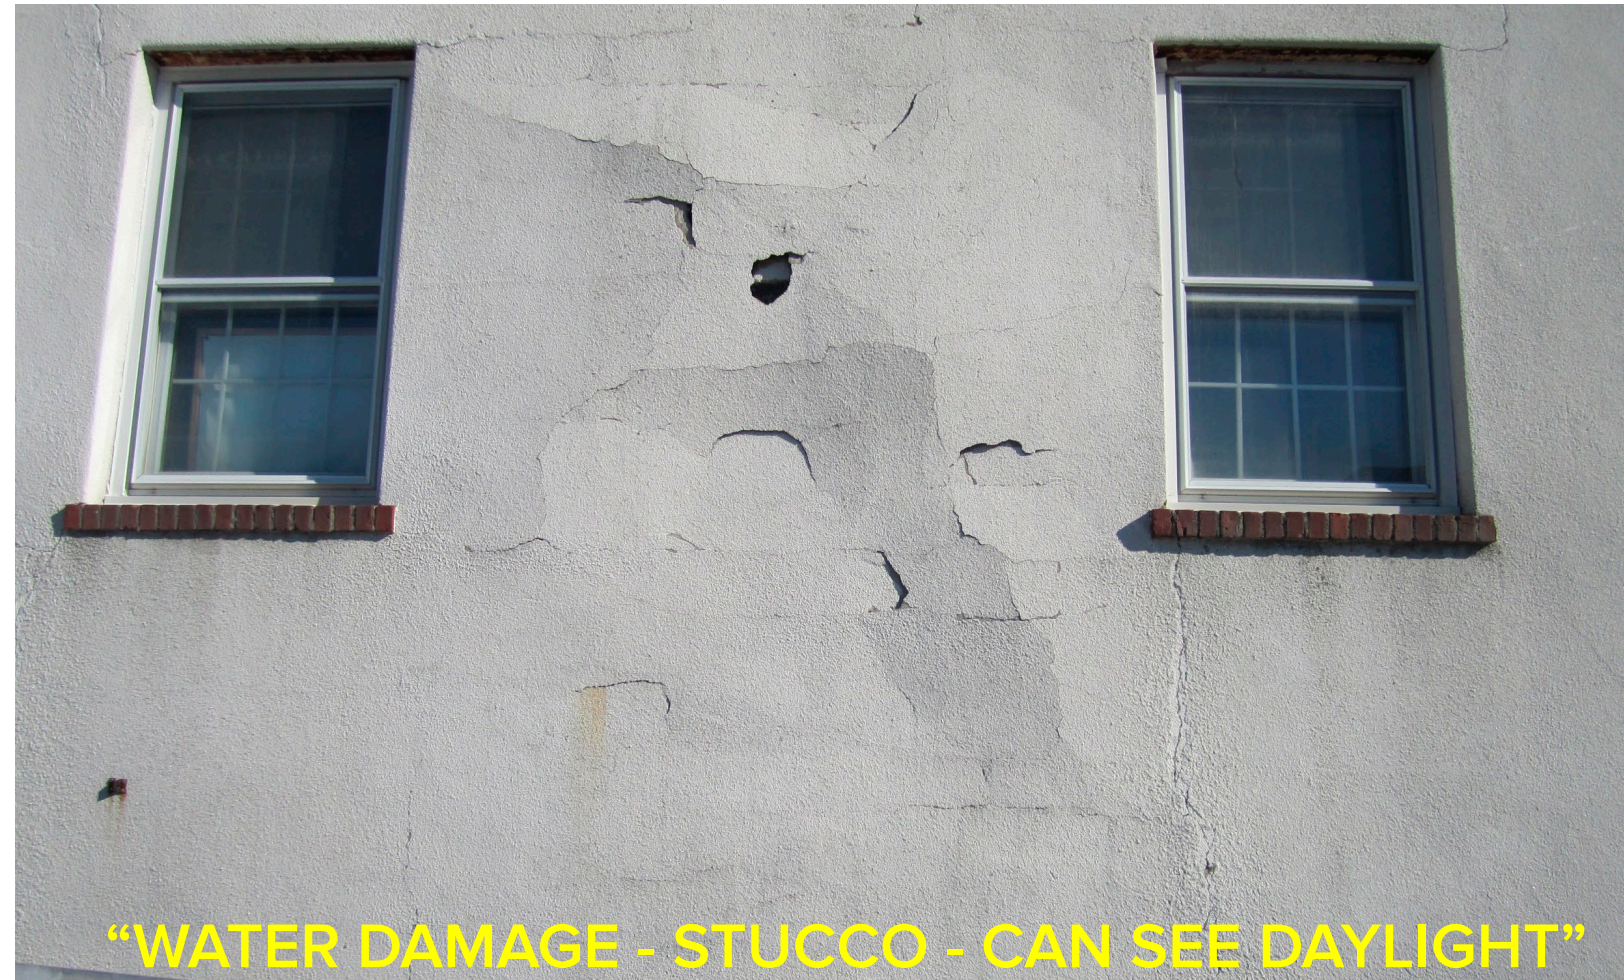
"WATER DAMAGE - STUCCO - CAN SEE DAYLIGHT"

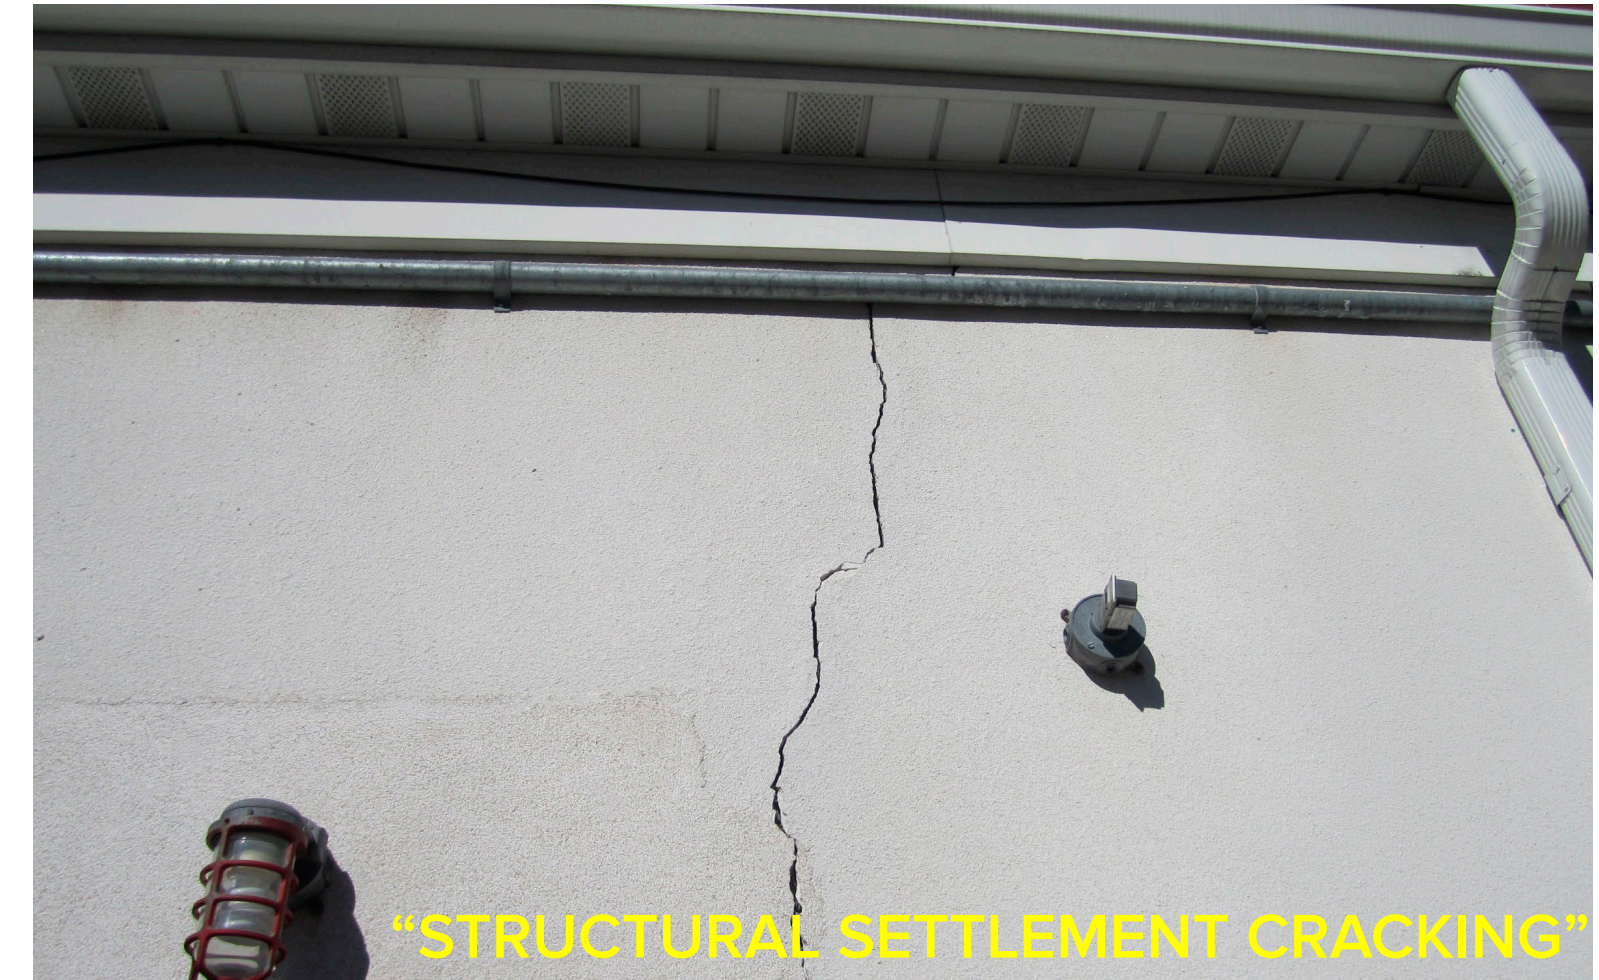
- » Major roofing/flashings issues allowing water infiltration causing facade separation, exterior wall, window and door issues/cracking + stucco/plaster damage.
- » Major structural issues due to building settling likely from the building being constructed over organic materials leftover from fire demolition in 1949.
- » Floor tiles popping, wood floors warping, window frames at meeting room / basement are rotted/leaking. Steel lintels are rusted and bowing.
- » August 2017 - Break in main sewer line, flooded the basement. Two sump pumps in basement are inadequate to keep up during heavy rain storms resulting in more water infiltration.

"STRUCTURAL SETTLEMENT CRACKING"

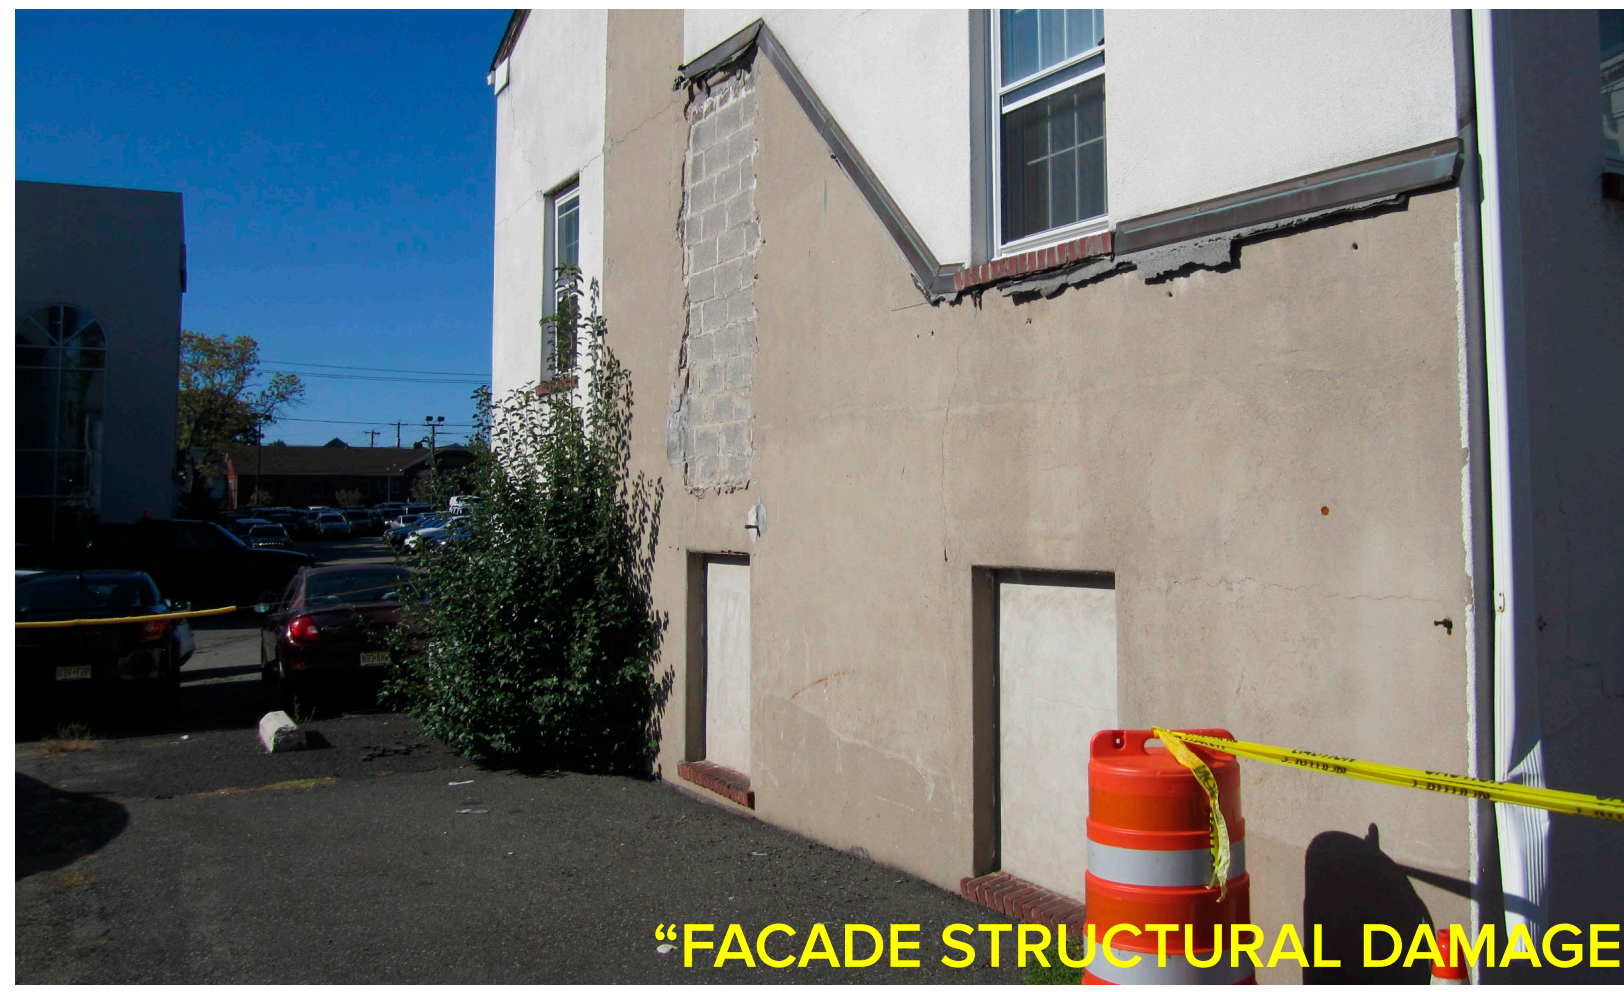
"FACADE STRUCTURAL DAMAGE"

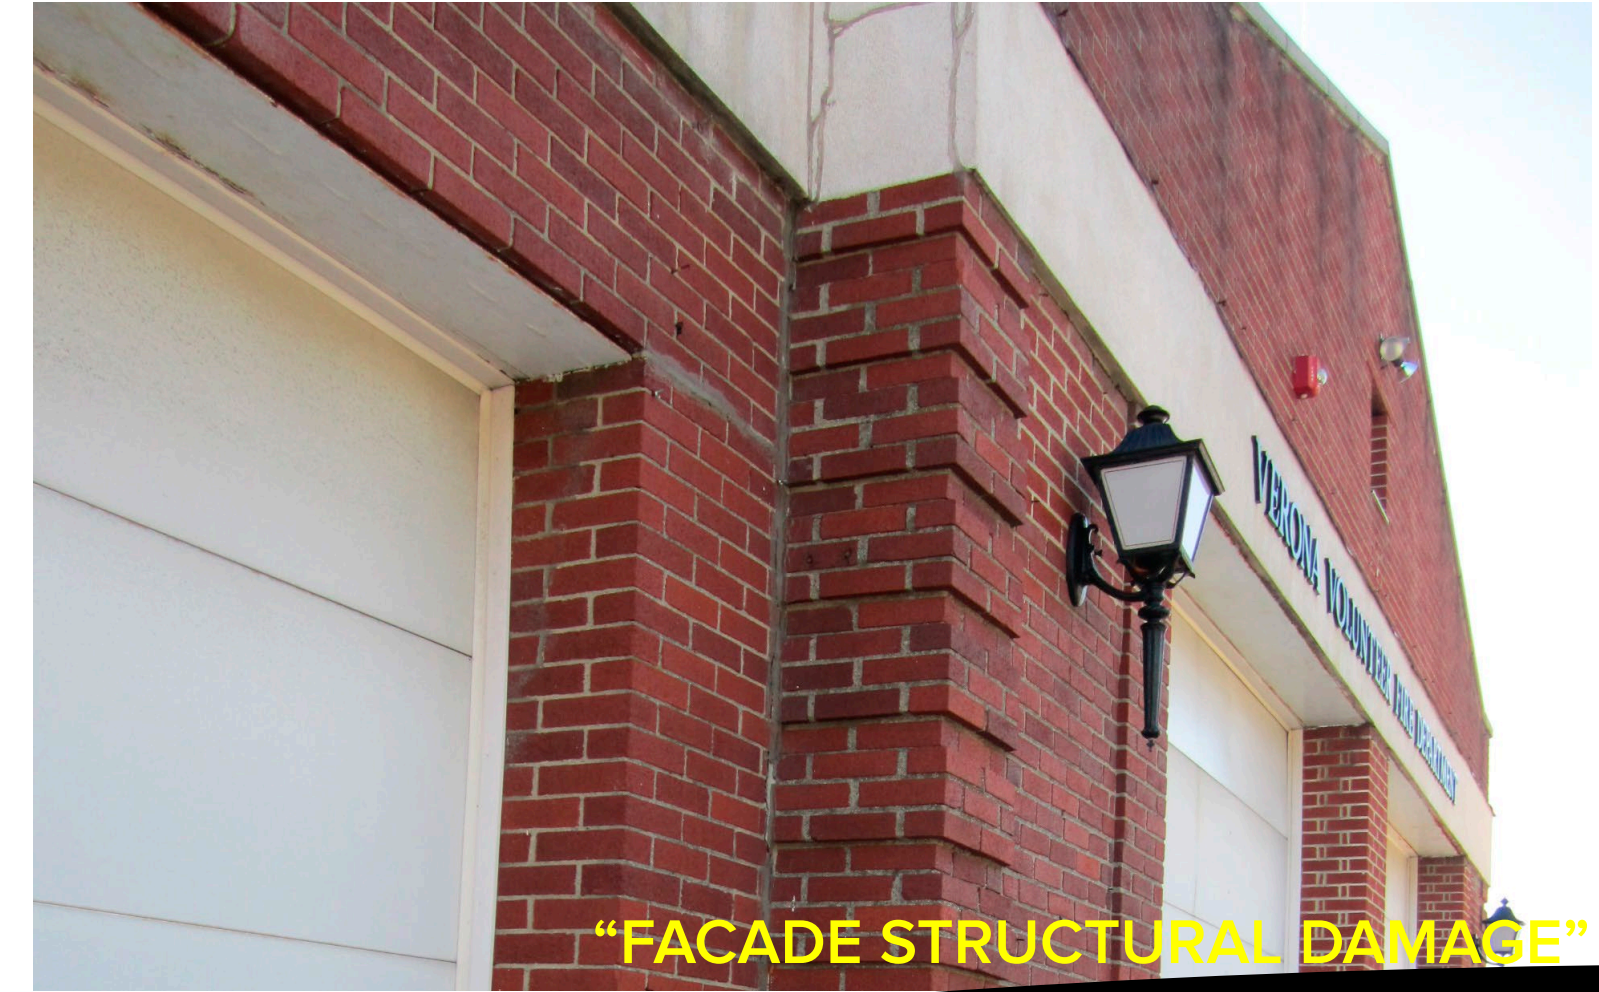
"FACADE STRUCTURAL DAMAGE"

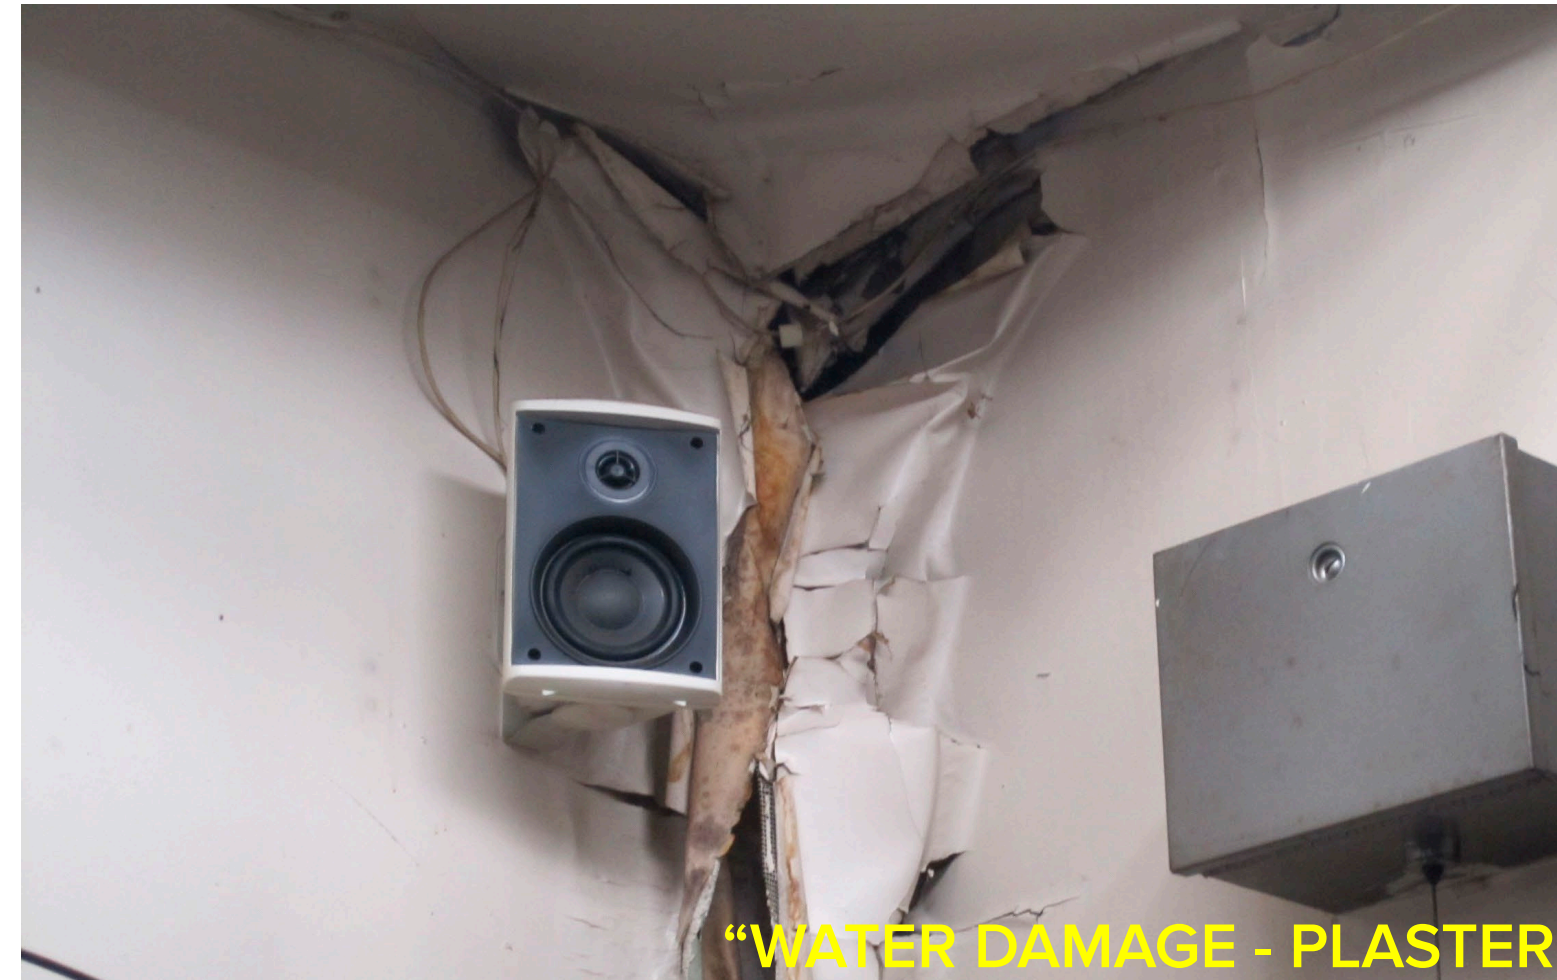
"WATER DAMAGE - PLASTER"

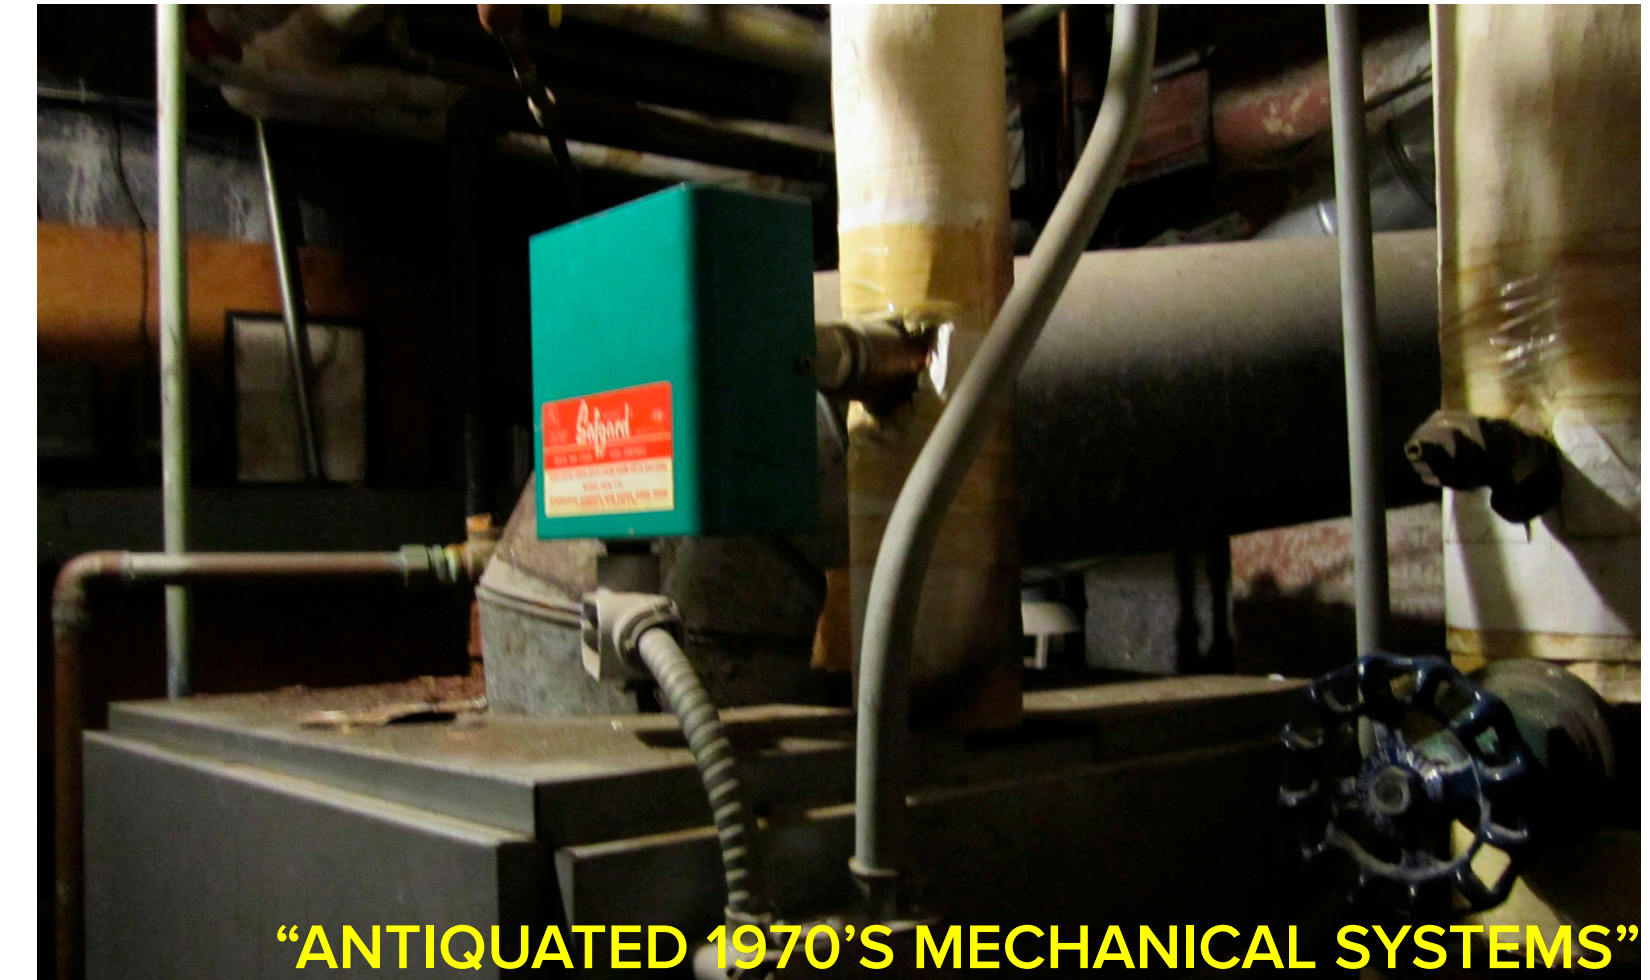
- » The air conditioning unit on the roof is irreparable. Building and Grounds had a company come in to assess the unit, and they estimated that it would be \$15,000 to replace it.
- » Heating system was overhauled in 2020, but the boiler that was installed 70's was never replaced in spite of extensive repairs, it is in need of replacement.
- » Major plumbing leaks throughout the facility, sediment found in the system. Apparatus bay floor drains do not appear to have an oil separator.
- » The basement entry stairwell floods during heavy rain. Basement door-deteriorated and does not open, posing a safety problem. Basement cannot be used.

"ANTIQUATED 1970'S MECHANICAL SYSTEMS"

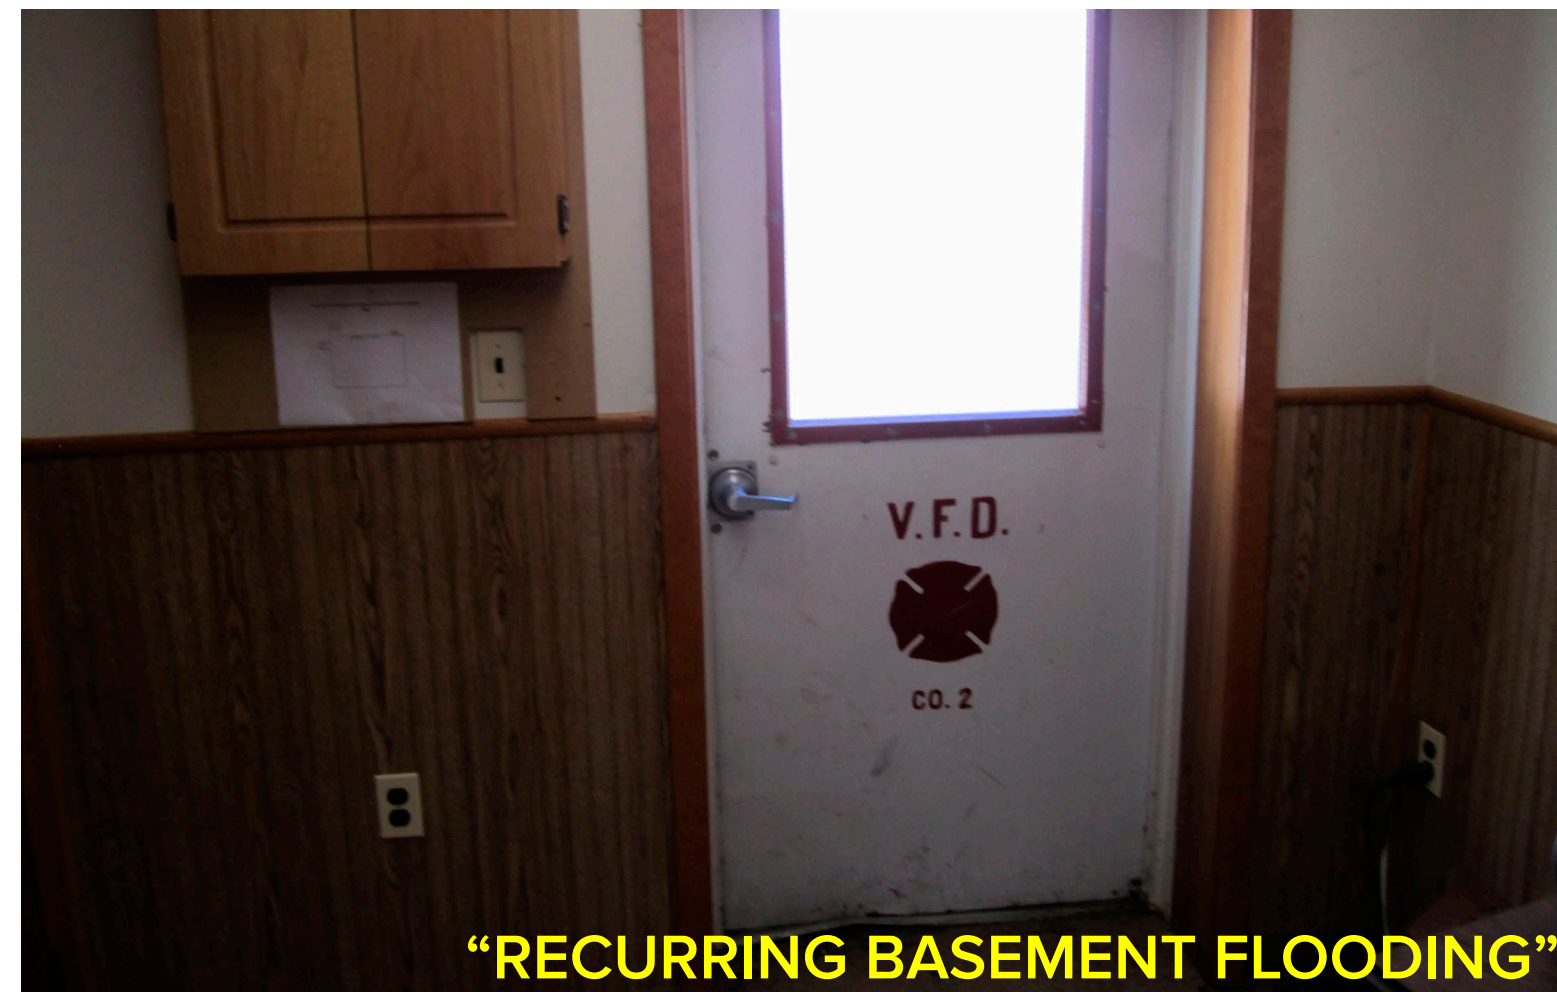
"RECURRING BASEMENT FLOODING"

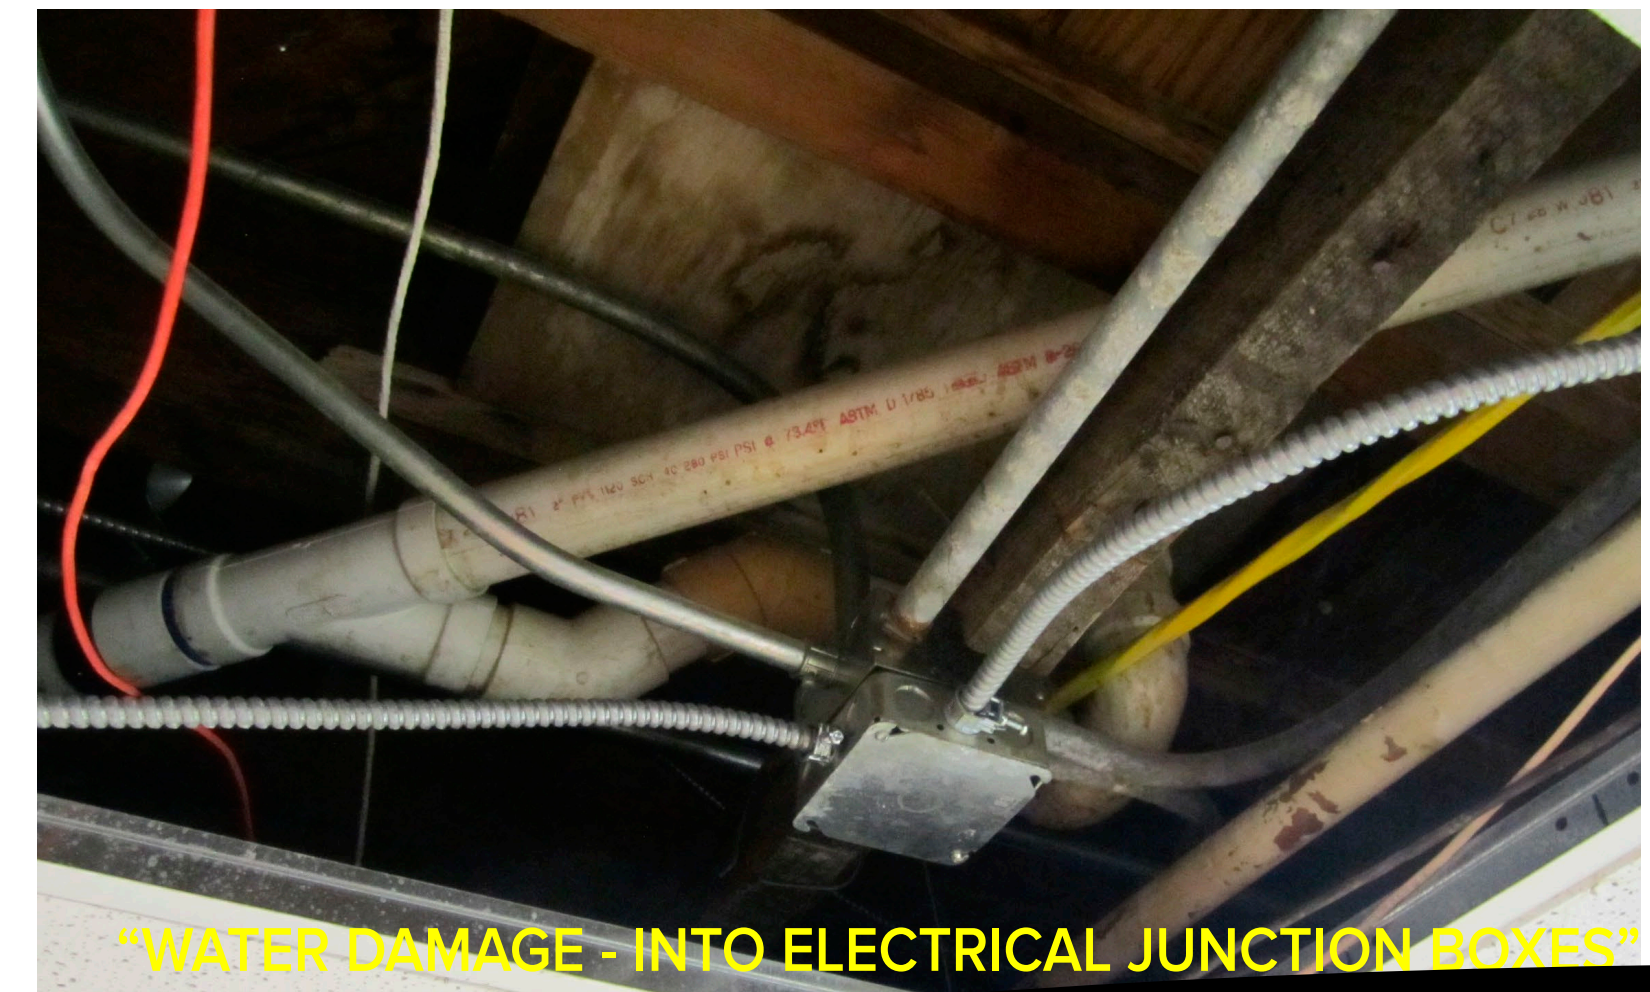
"WATER DAMAGE - INTO ELECTRICAL JUNCTION BOXES"

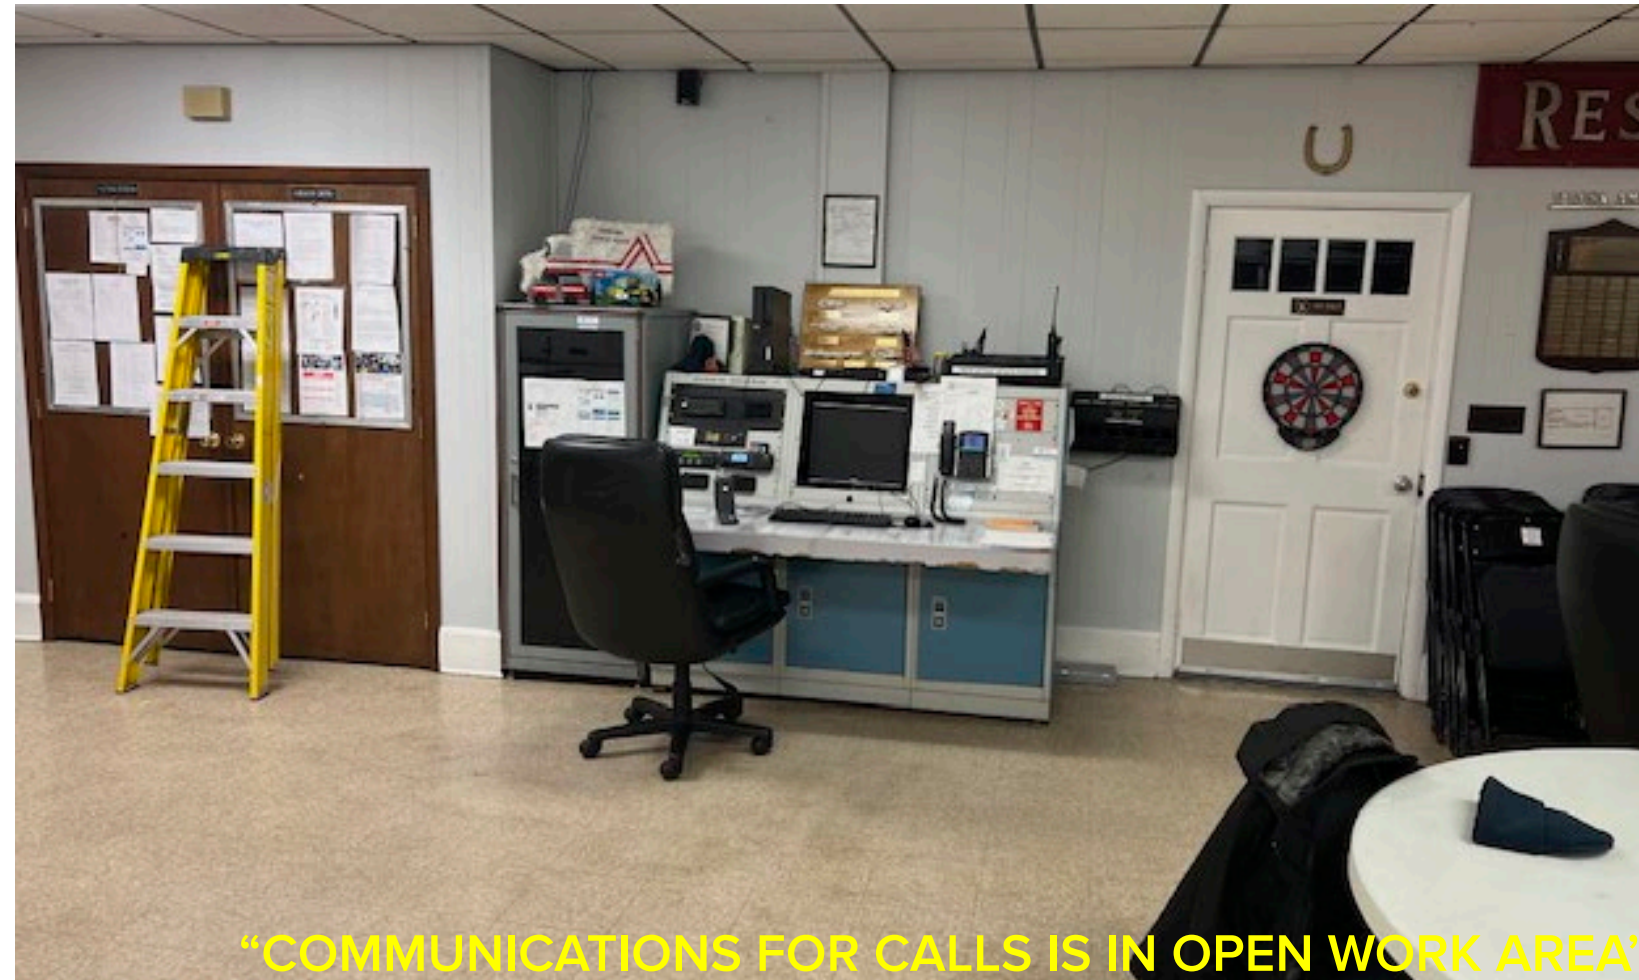
"COMMUNICATIONS FOR CALLS IS IN OPEN WORK AREA"

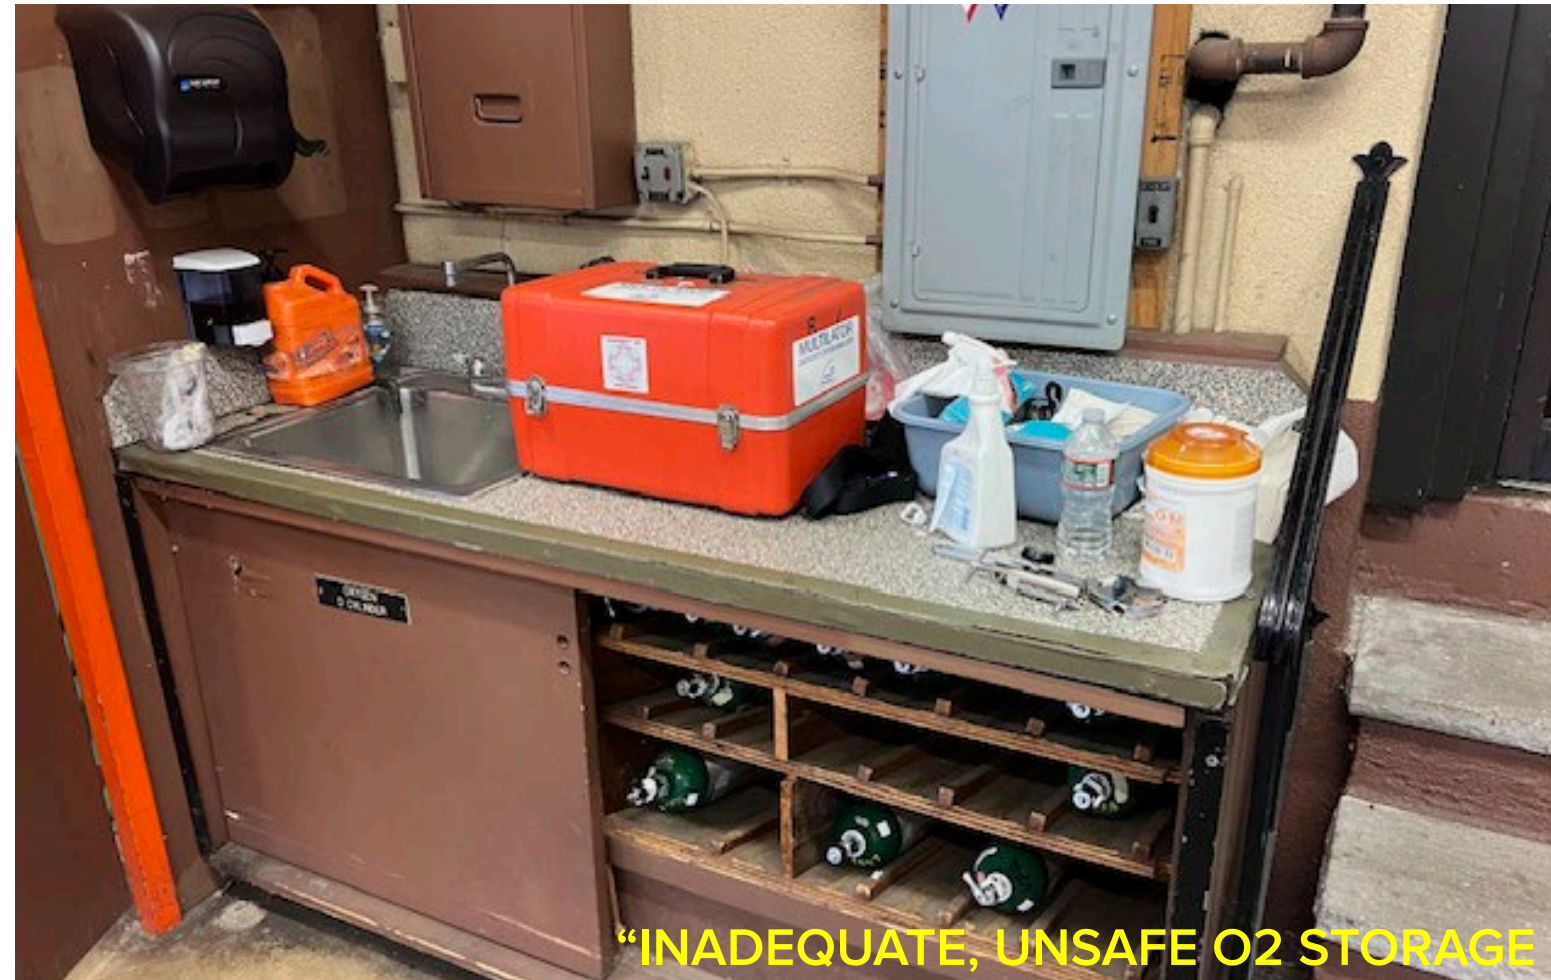
"INADEQUATE, UNSAFE O2 STORAGE"

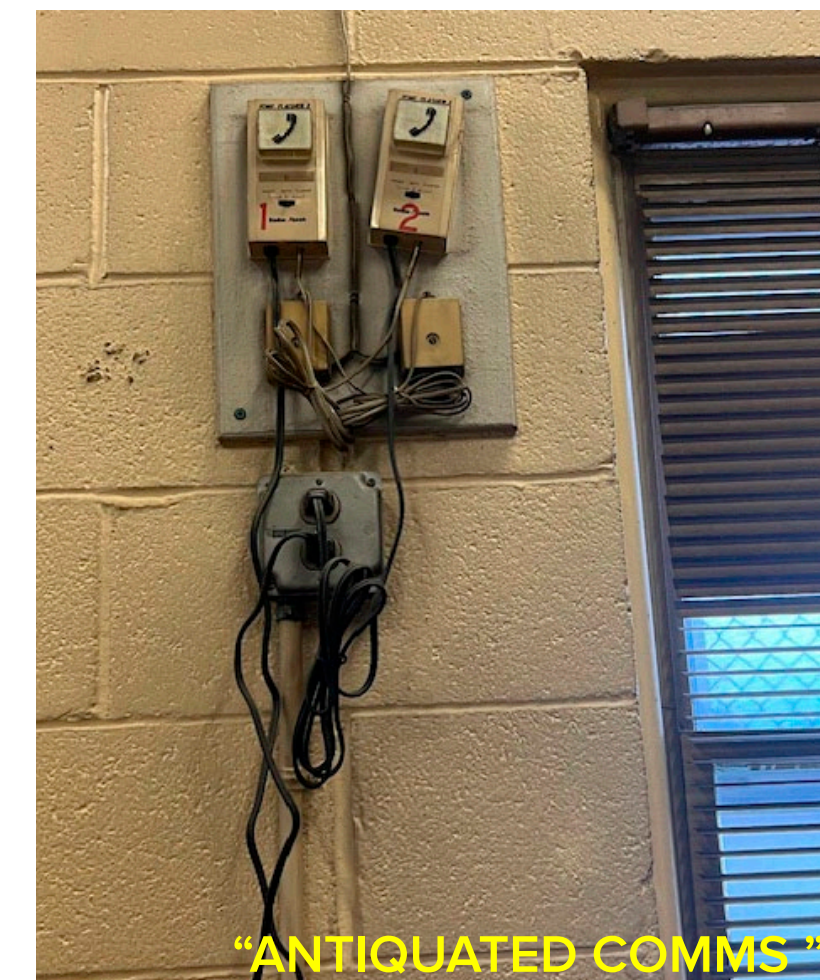
"ANTIQUATED COMMS"

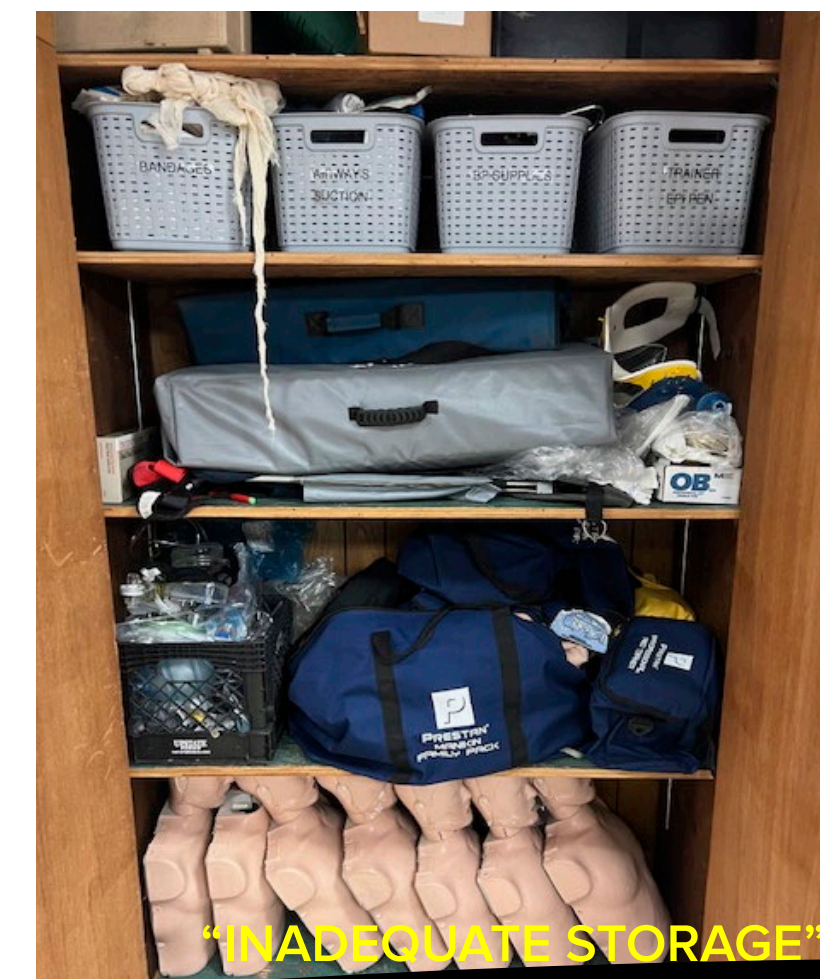
"INADEQUATE STORAGE"
