PUBLIC PRESENTATION

VERONA EMERGENCY SERVICES COMPLEX

POLICE DEPARTMENT, FIRE DEPARTMENT - CO. #2, RESCUE SQUAD

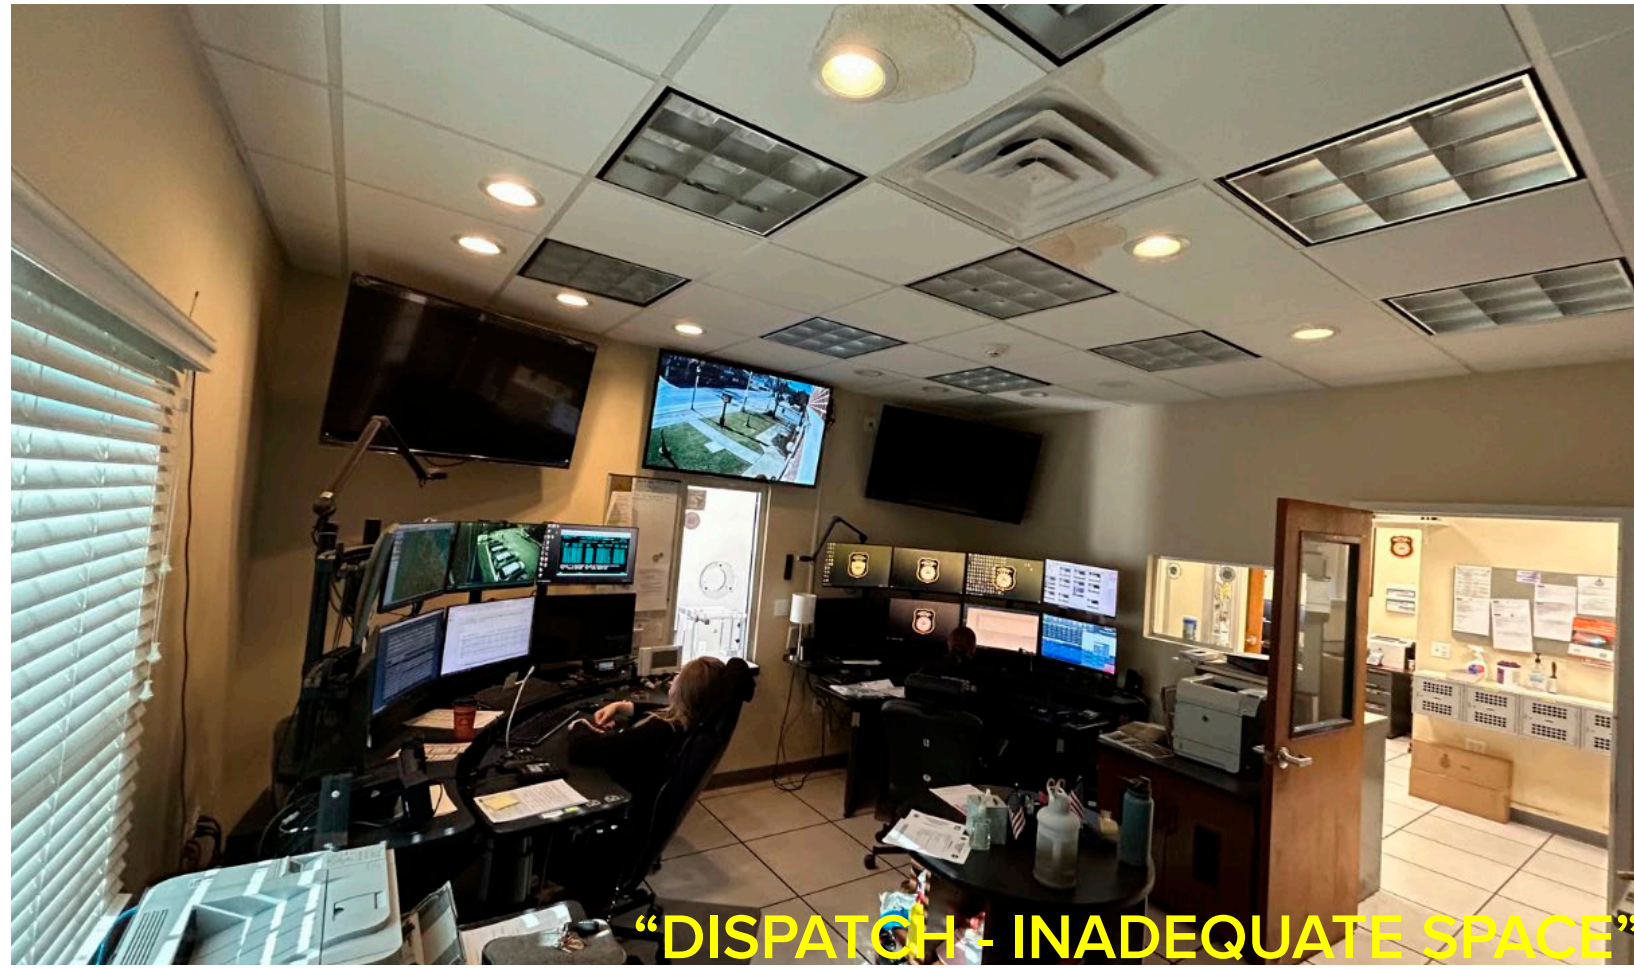
"DISPATCH - INADEQUATE SPACE"

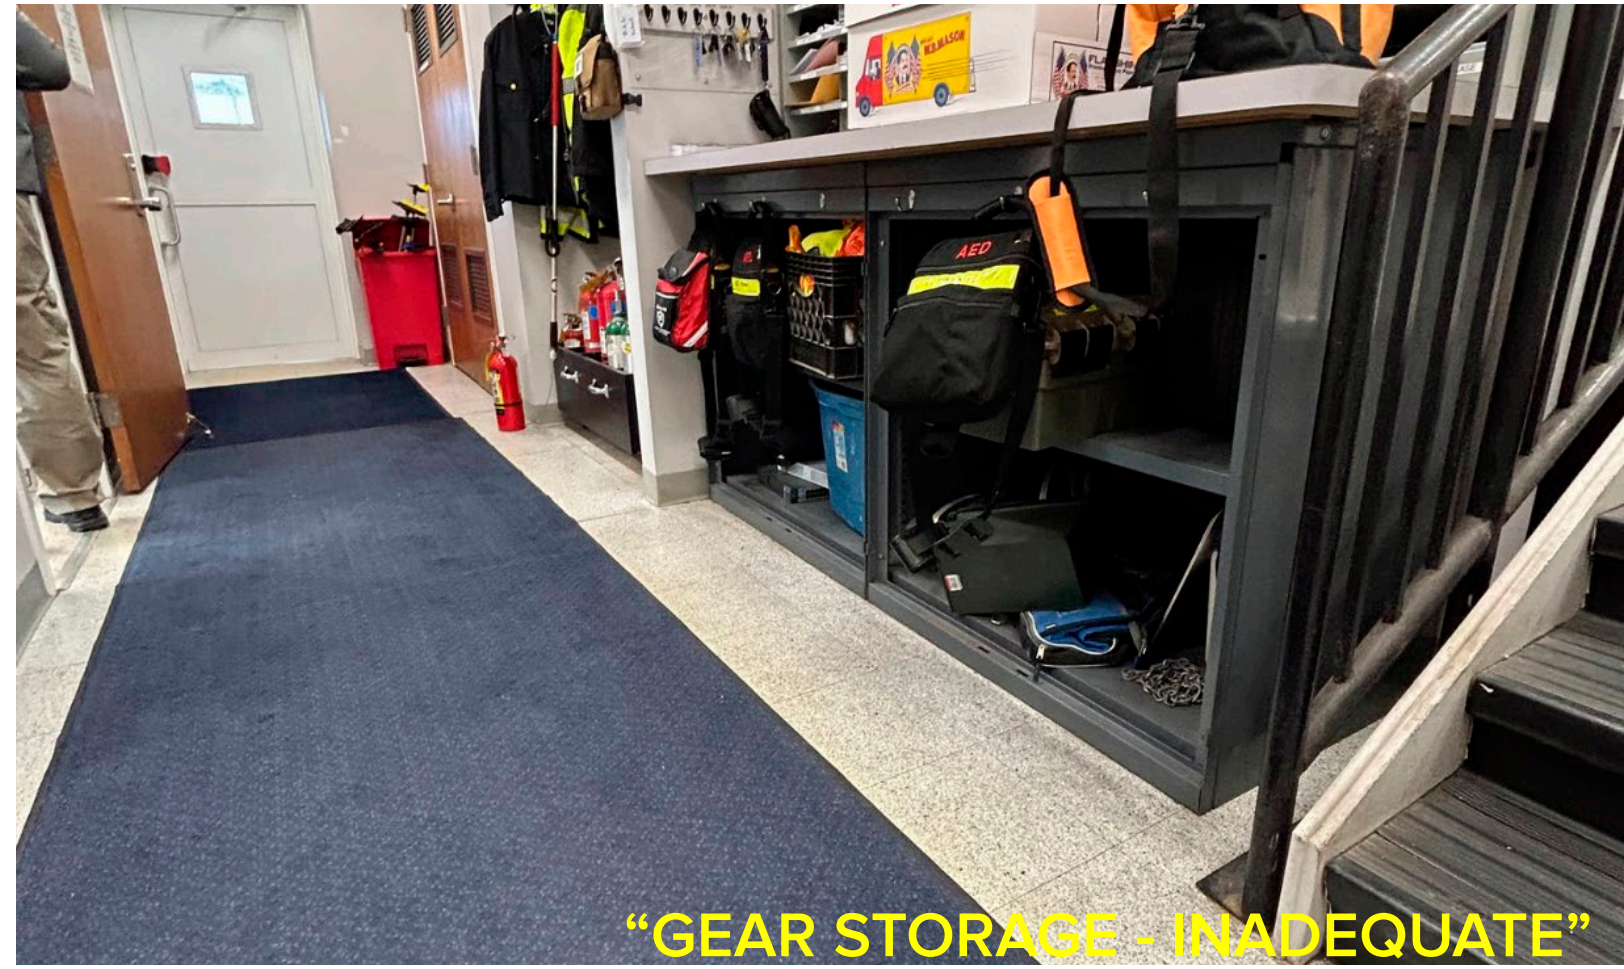
"GEAR STORAGE - INADEQUATE"

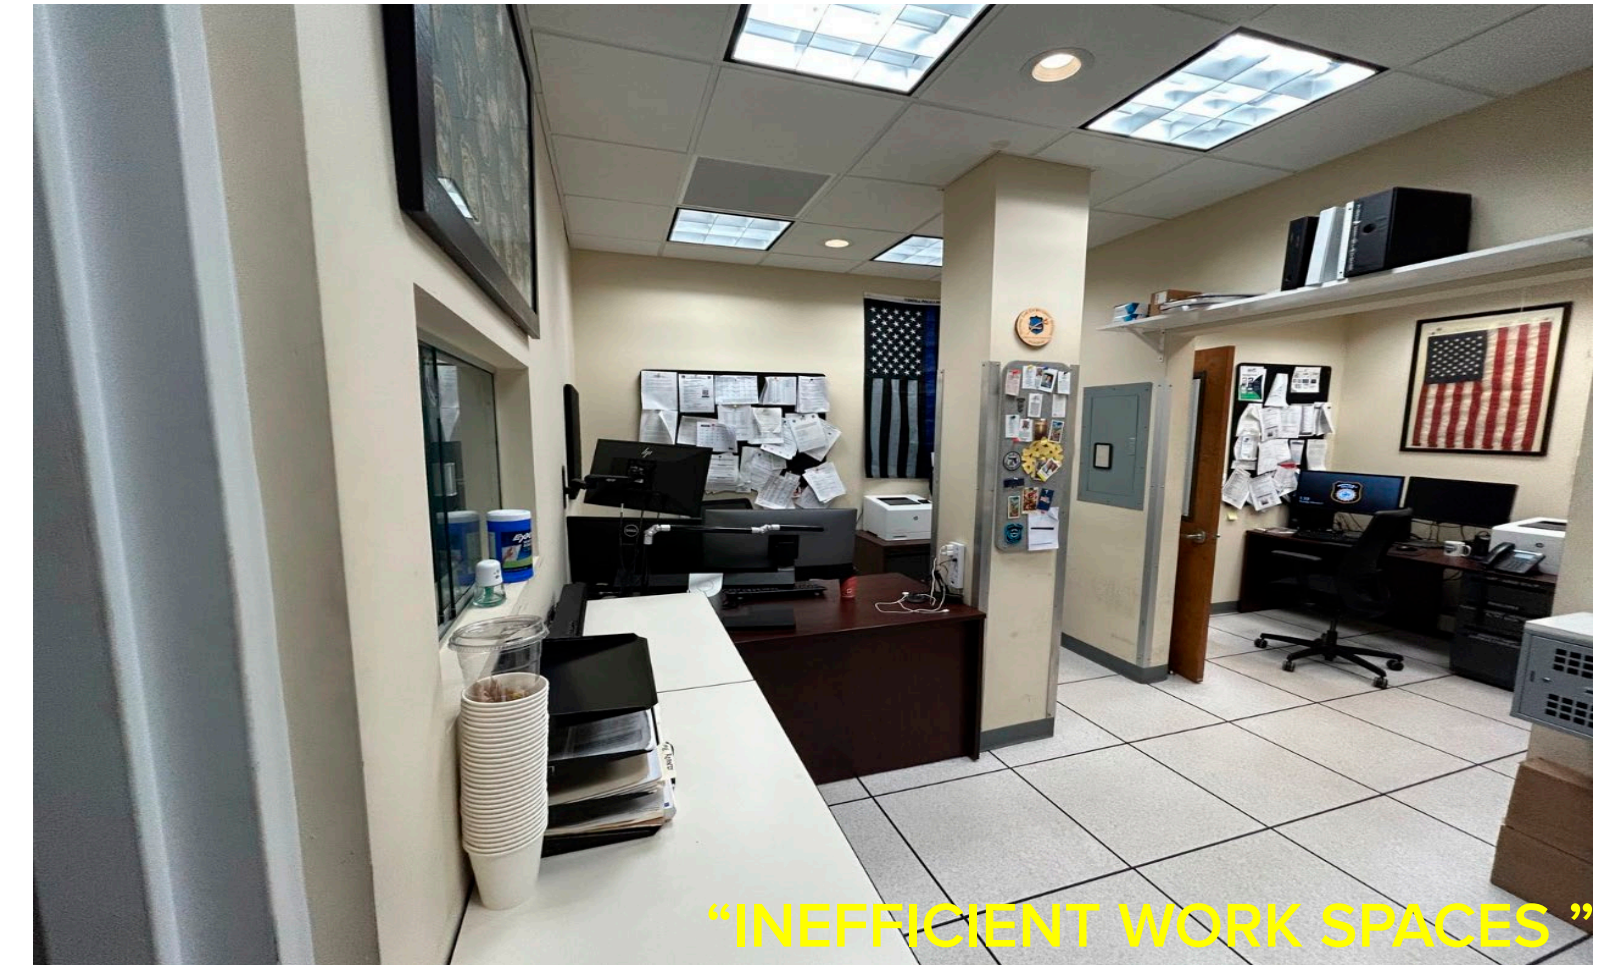
"INEFFICIENT WORK SPACES"

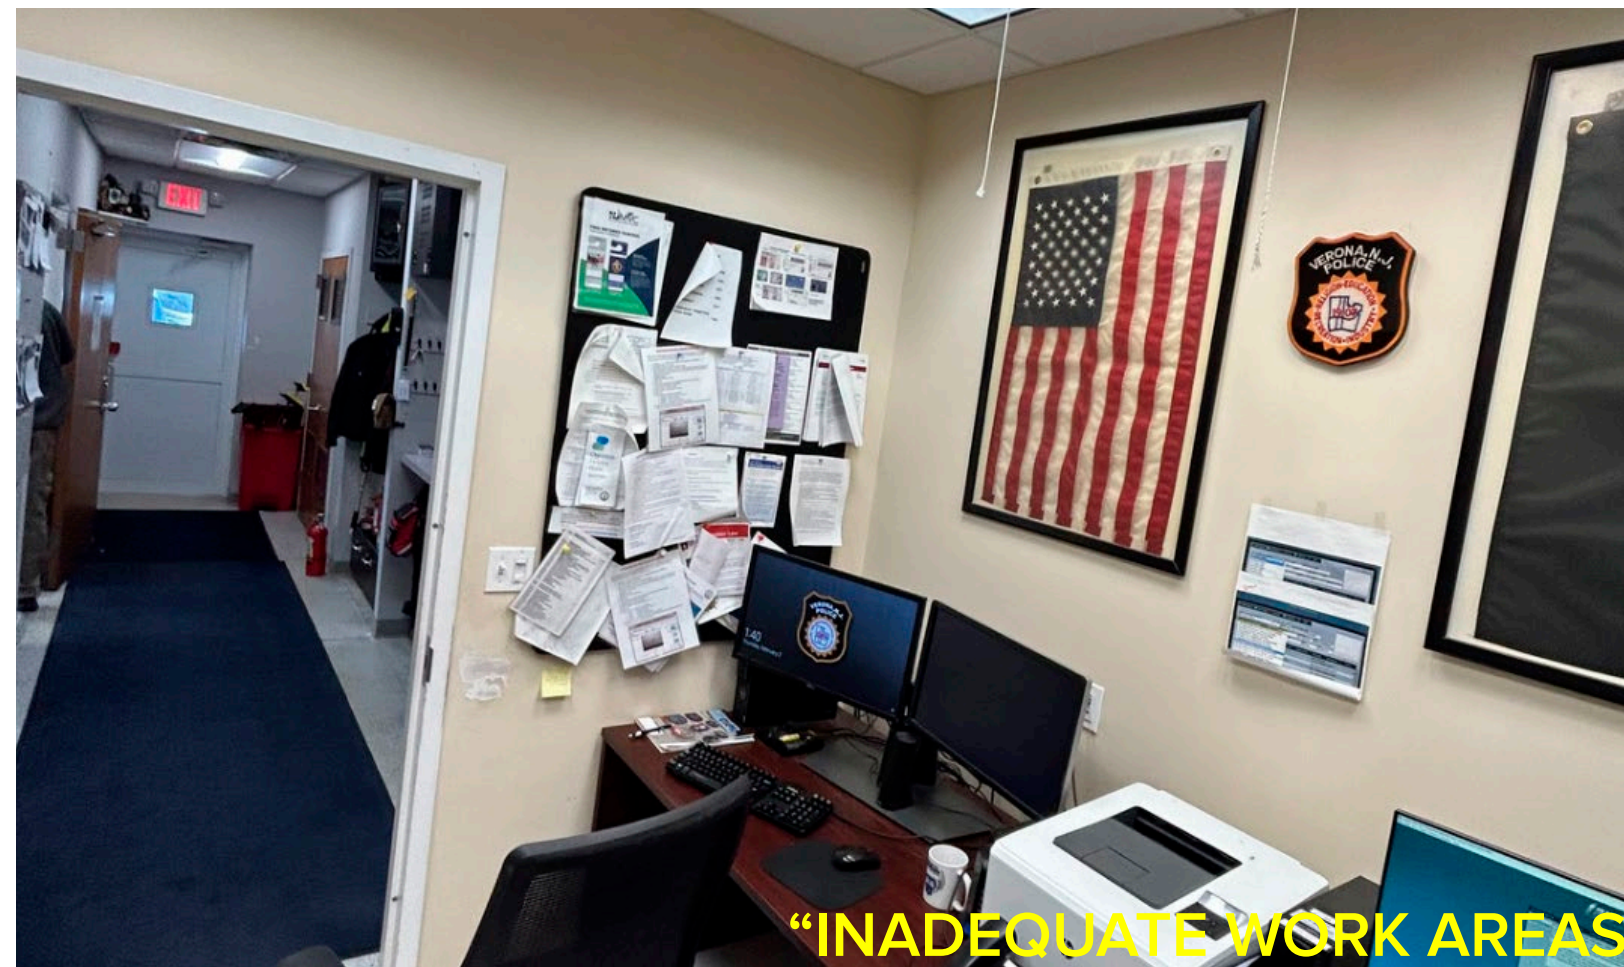
"INADEQUATE WORK AREAS"

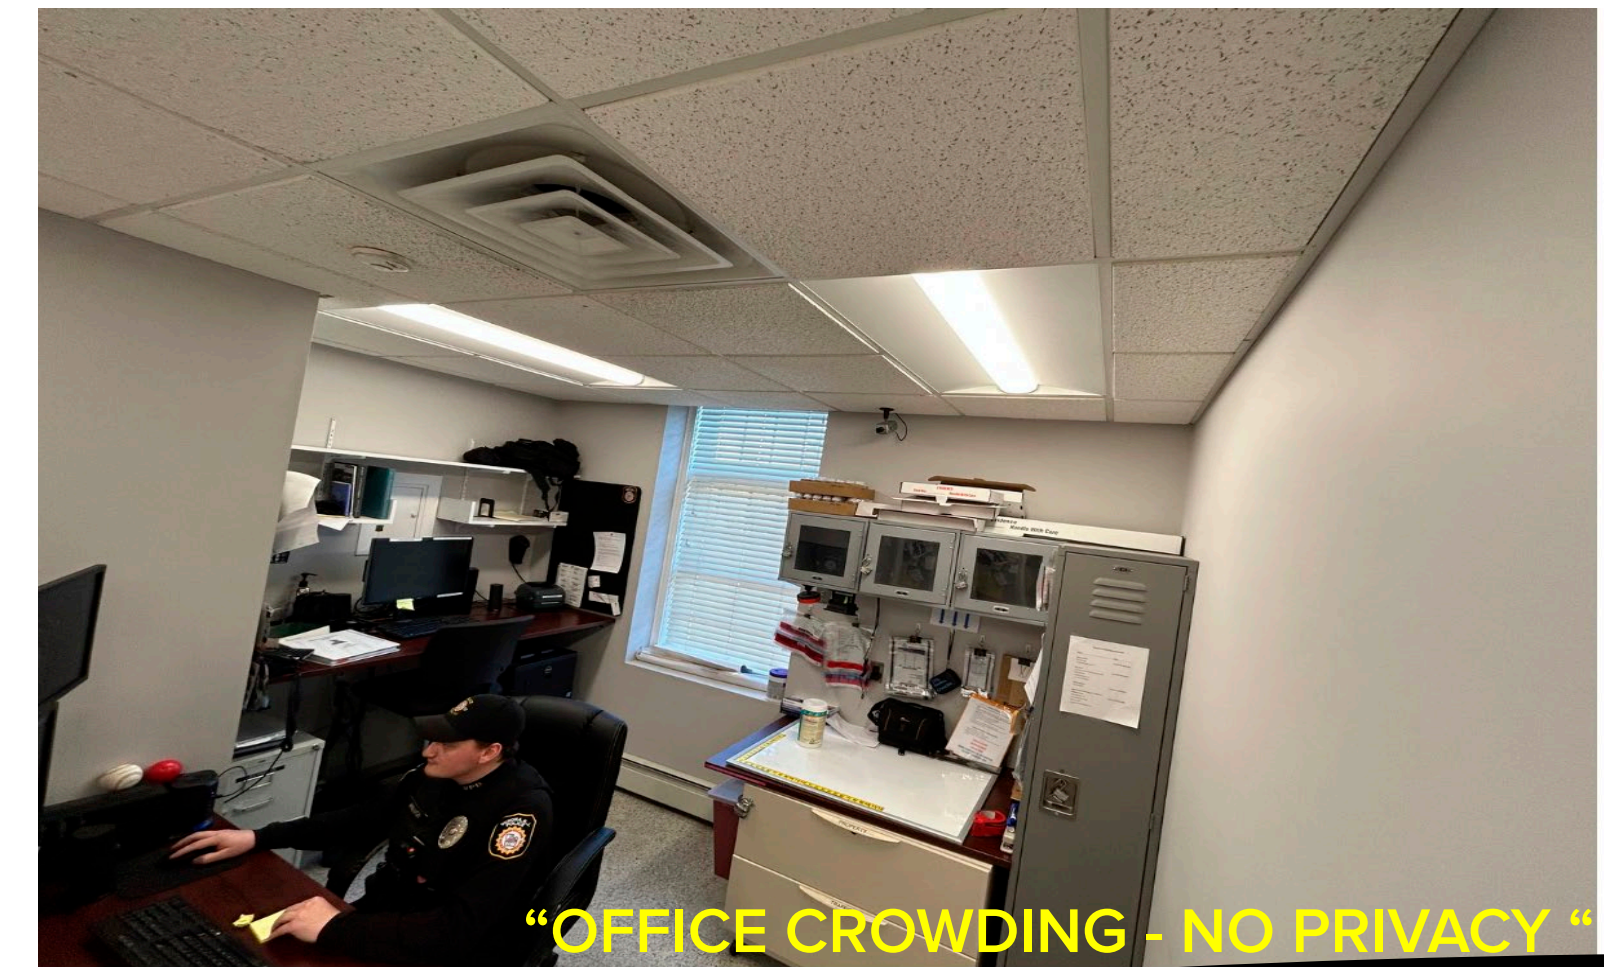
"OFFICE CROWDING - NO PRIVACY"

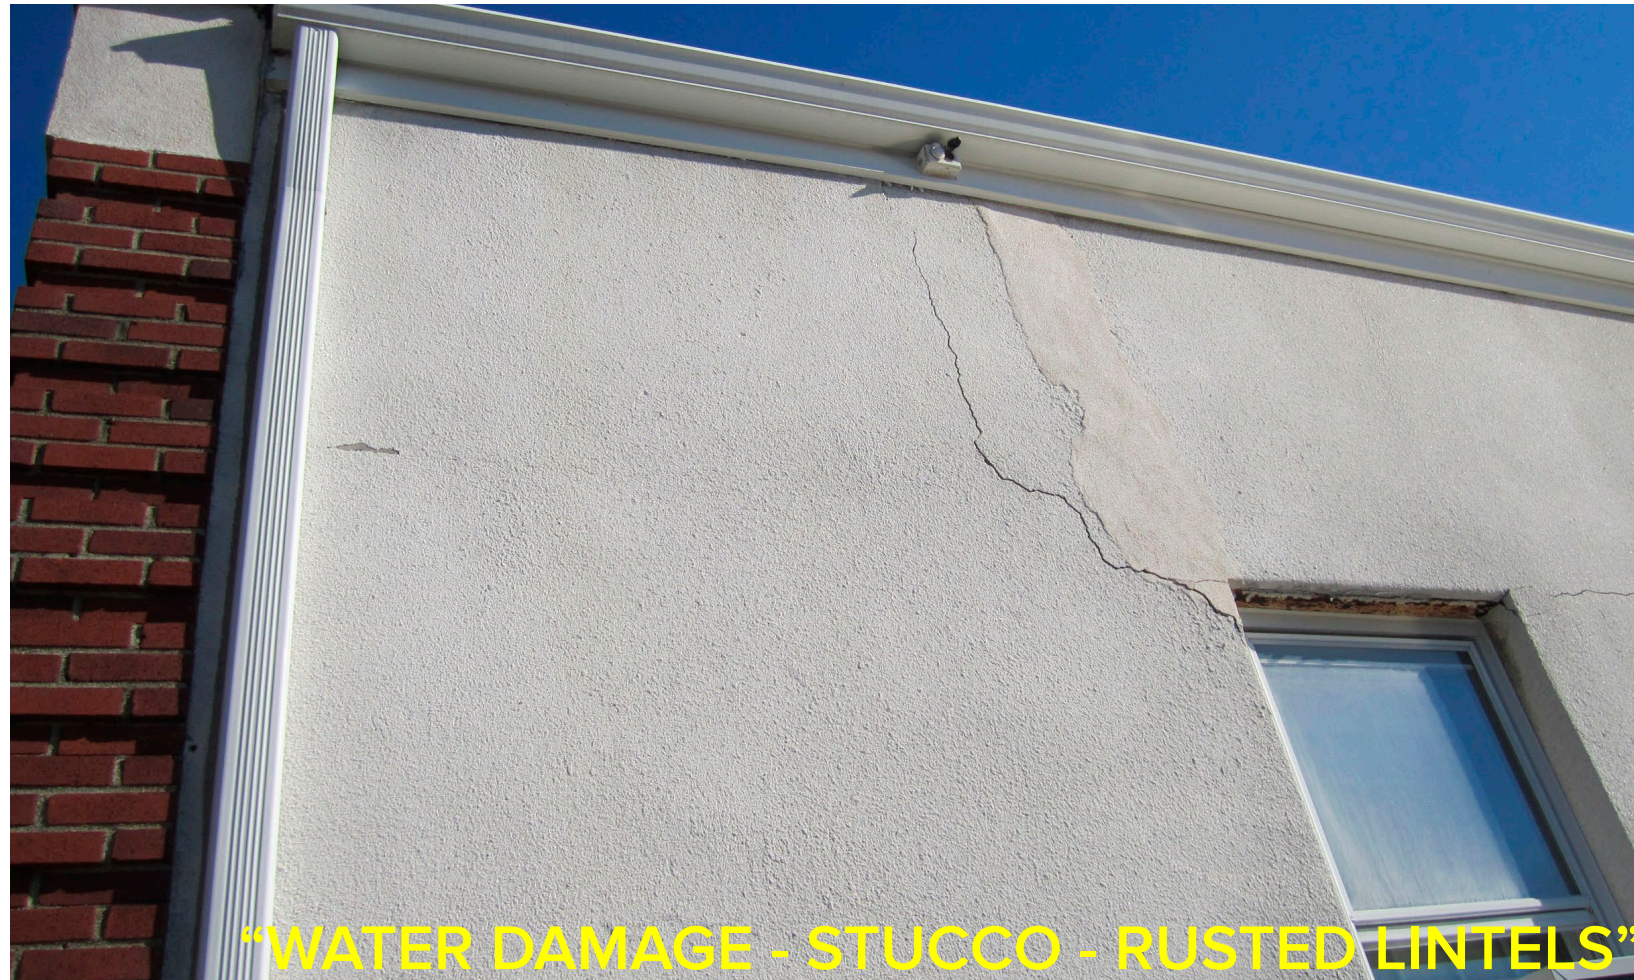
- » Major roofing/flashings issues allowing water infiltration causing exterior wall, window and door issues/ cracking + stucco/plaster damage.
- » Major structural issues due to building settling. Walls cracking and masonry facade separation.
- » Floor tiles popping, wood floors warping, window frames at meeting room / basement are rotted/leaking. Steel lintels are rusted and bowing.
- » Two sump pumps in basement are inadequate to keep up during heavy rain storms resulting in more water infiltration. Basement door-deteriorated/does not open, posing a safety problem. Basement cannot be used.

"WATER DAMAGE - STUCCO - RUSTED LINTELS"

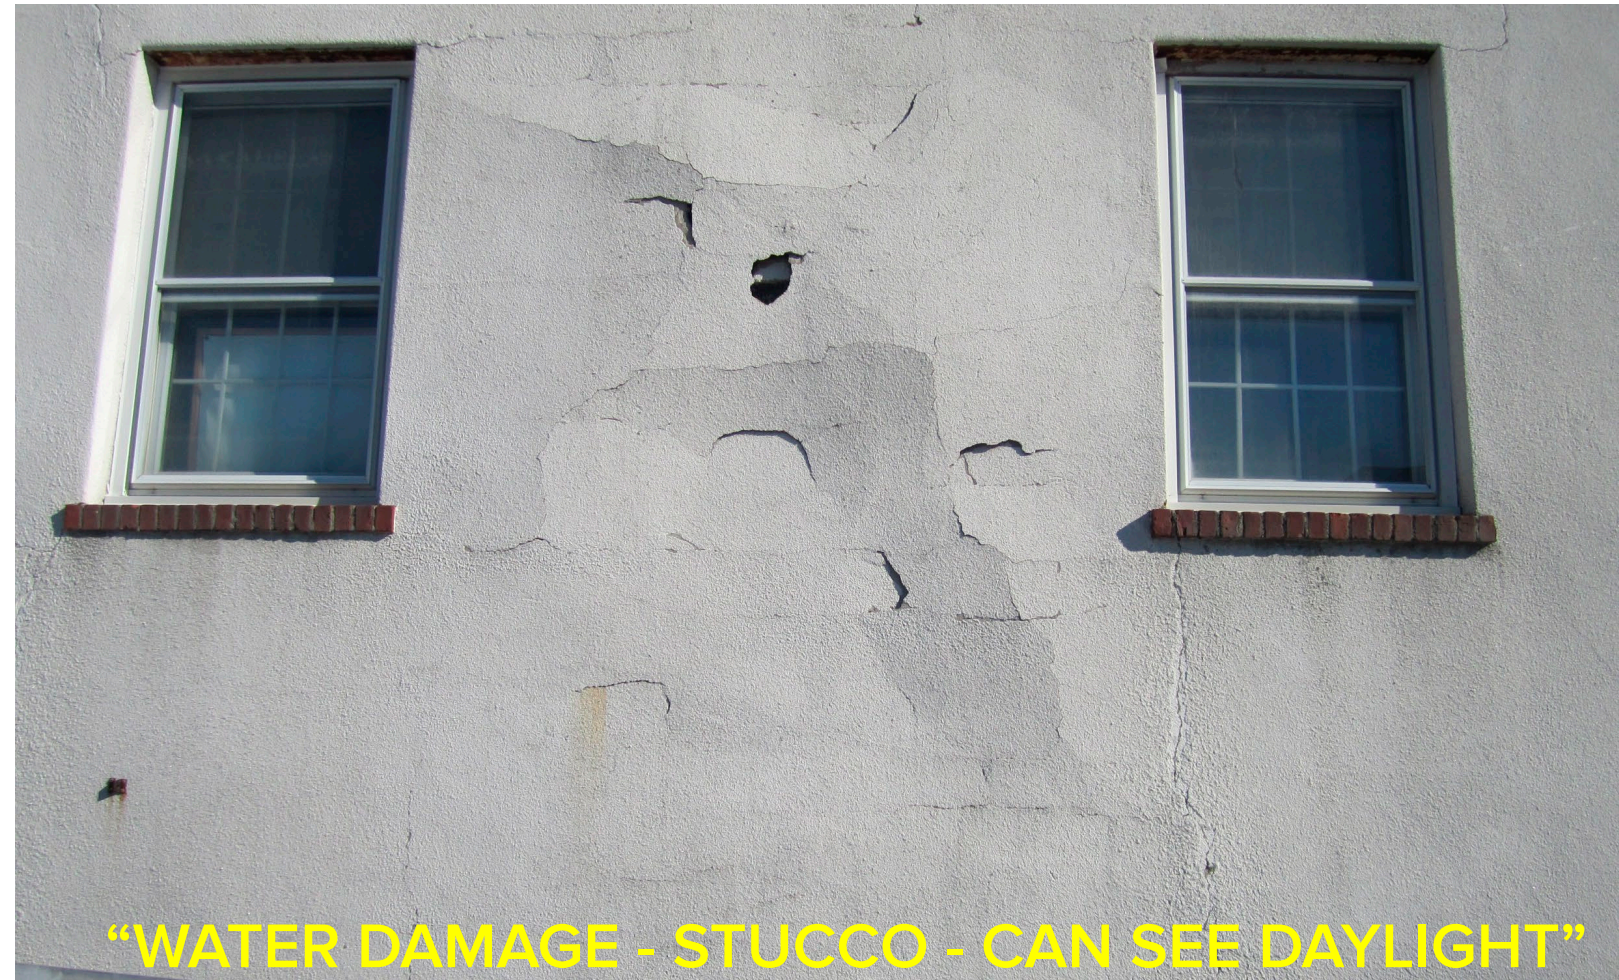
"WATER DAMAGE - STUCCO - CAN SEE DAYLIGHT"

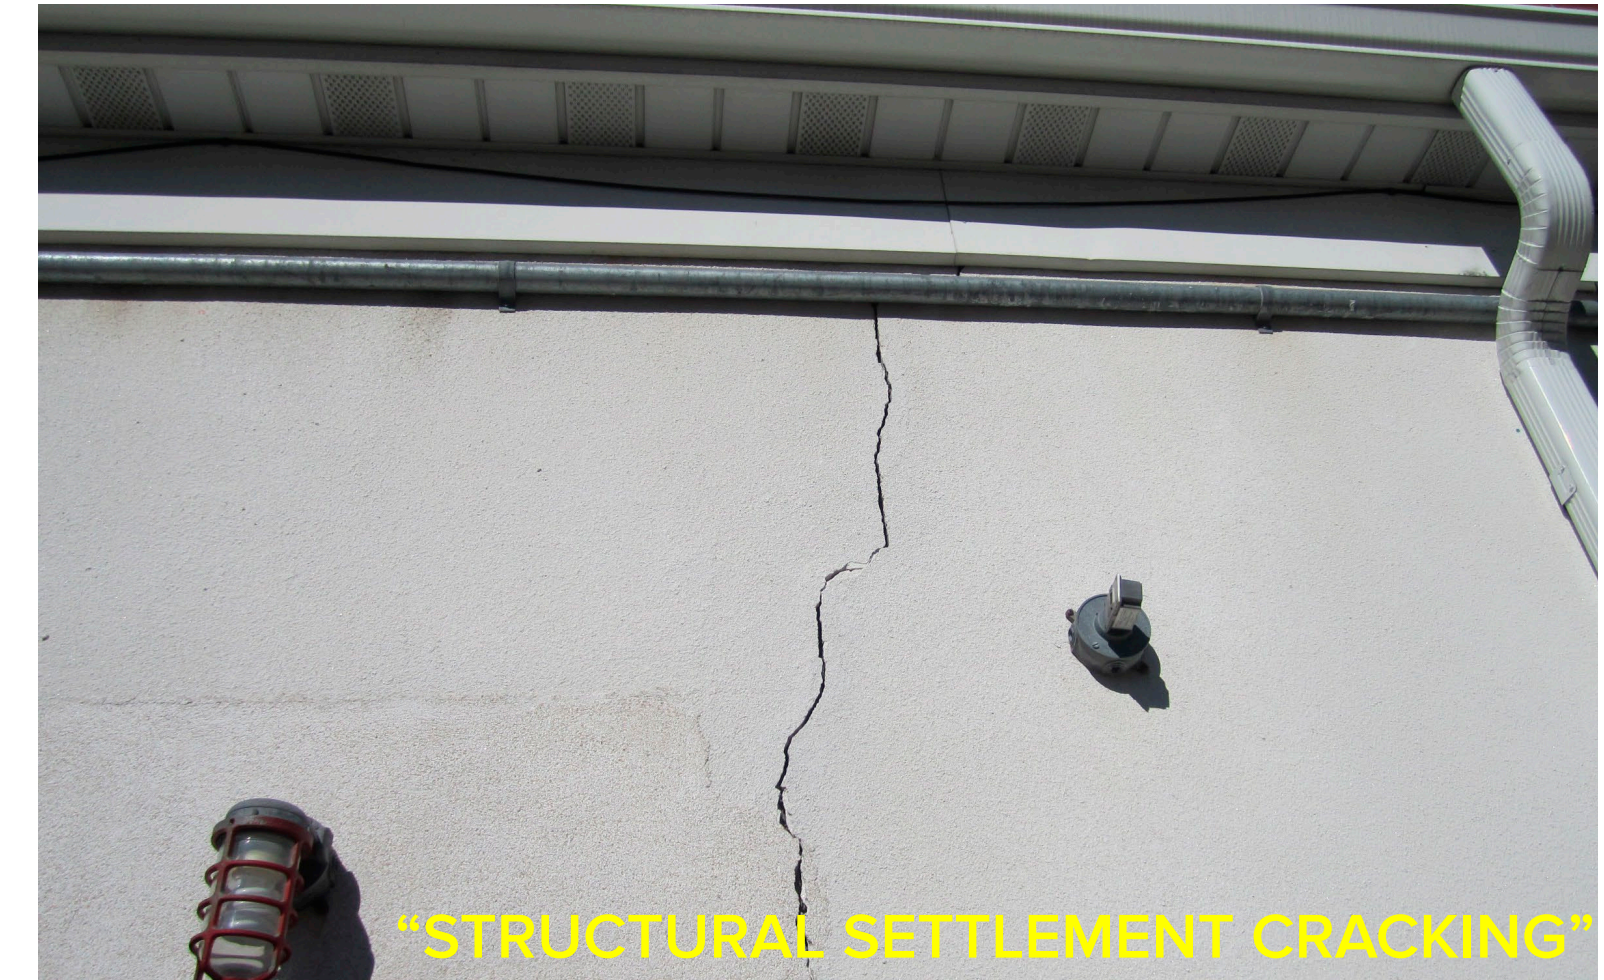
"STRUCTURAL SETTLEMENT CRACKING"

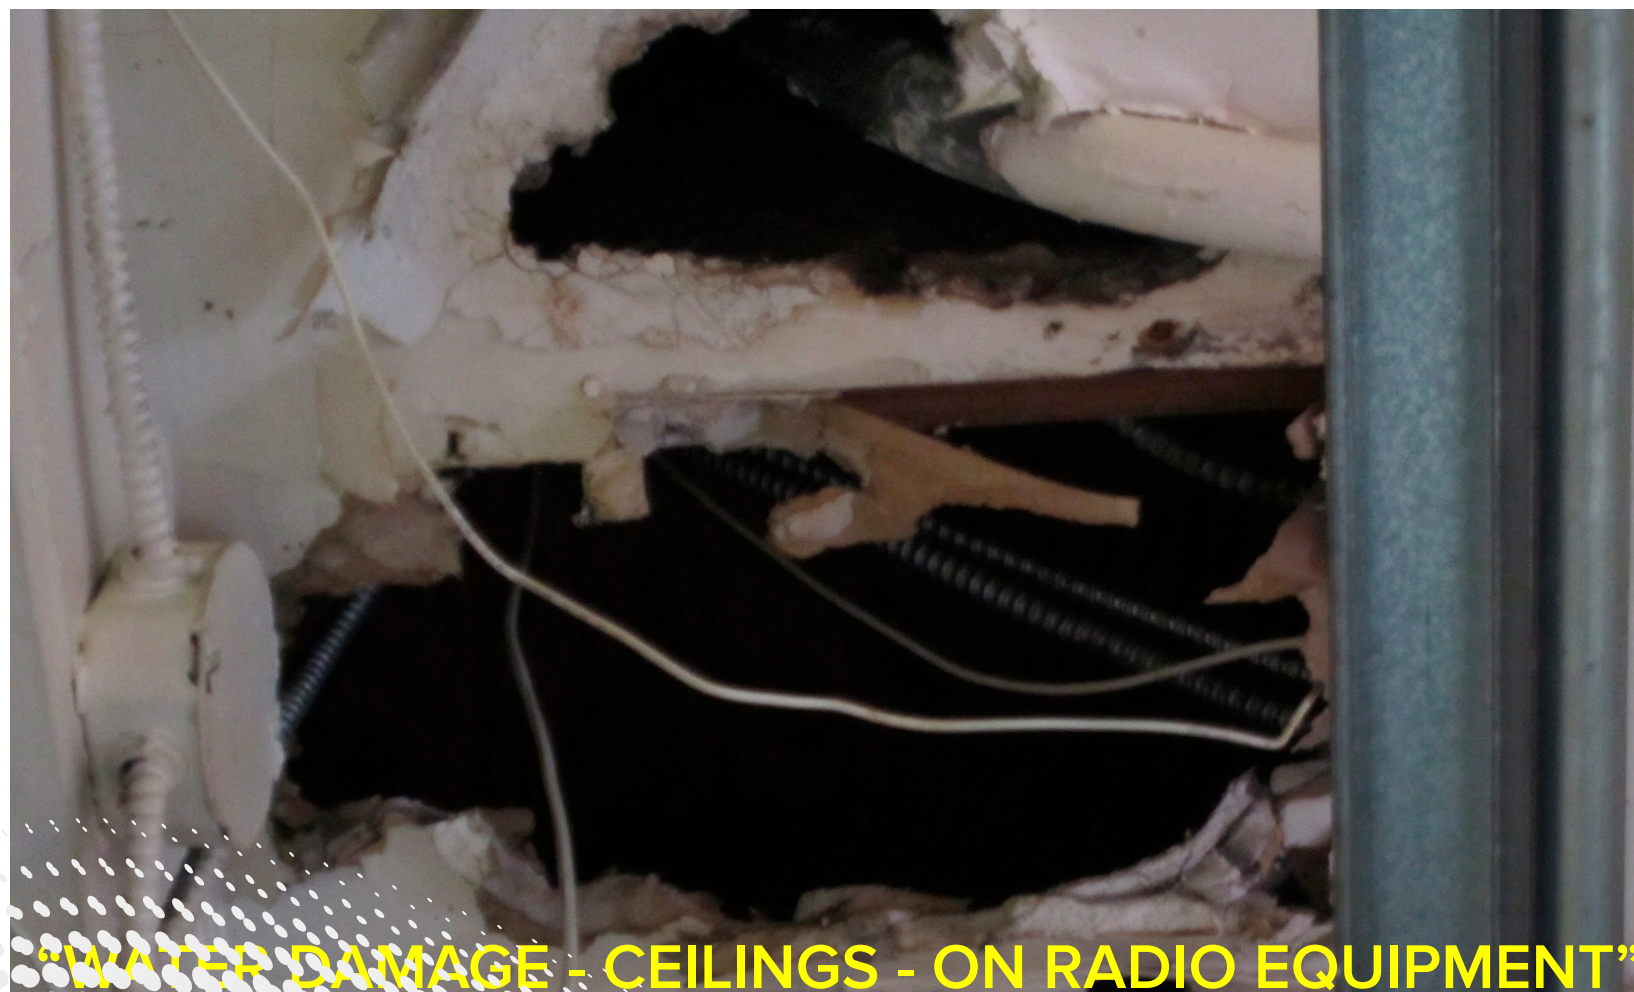
"WATER DAMAGE - CEILINGS - ON RADIO EQUIPMENT"

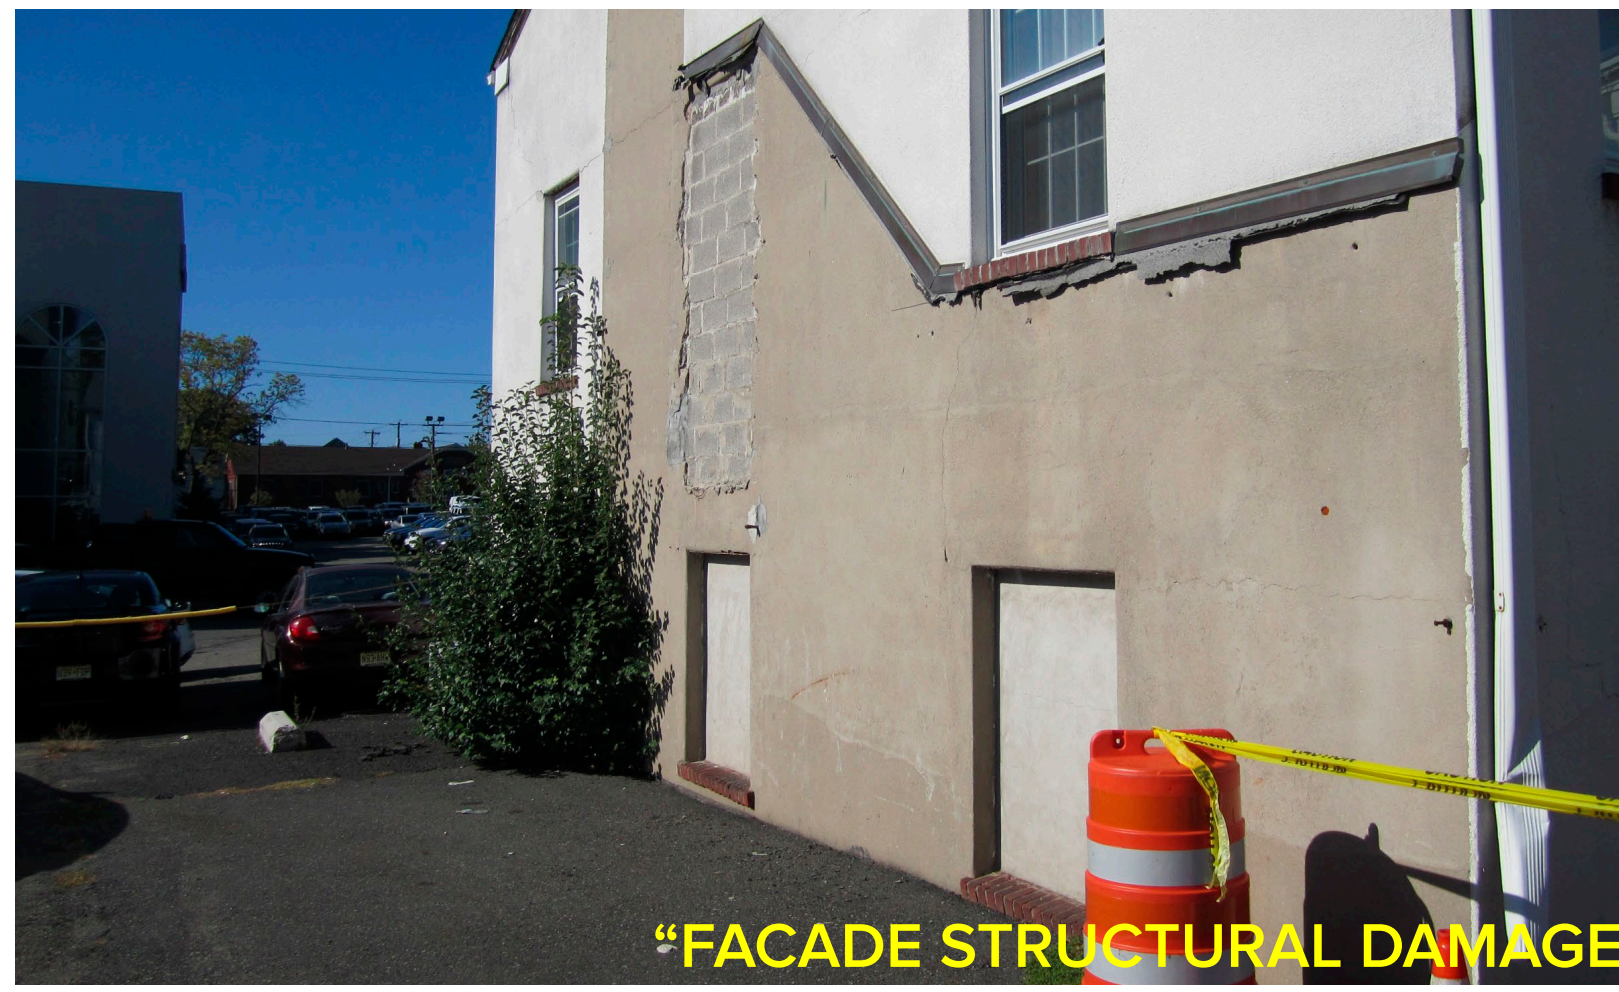
"FACADE STRUCTURAL DAMAGE"

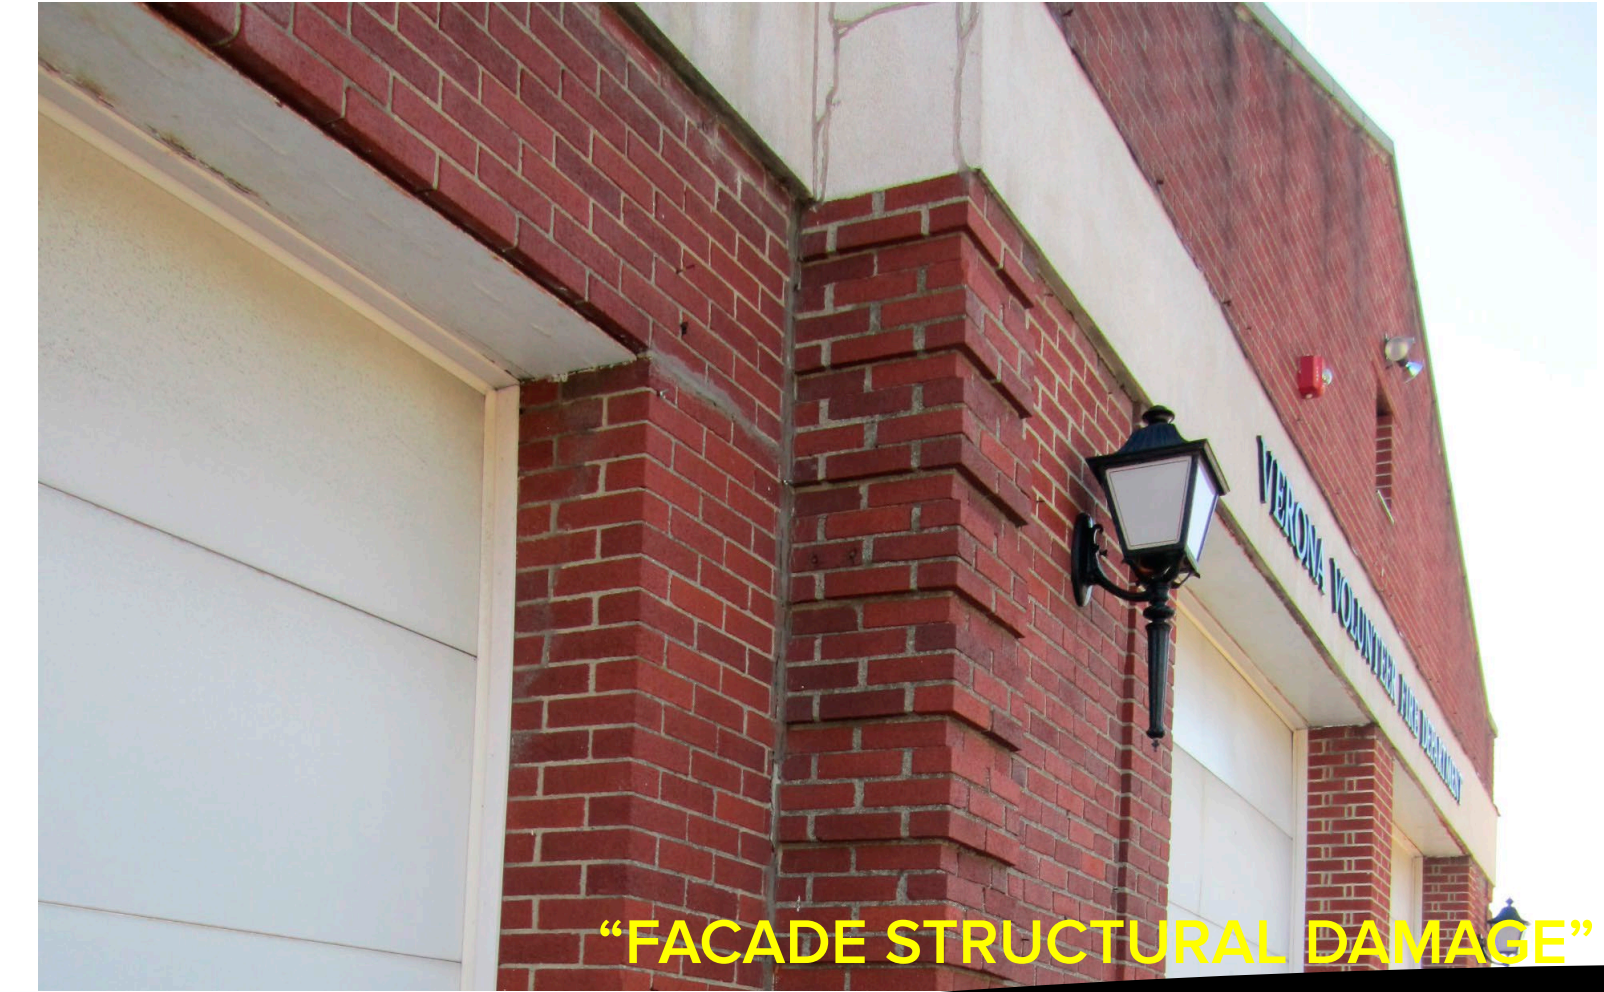
"FACADE STRUCTURAL DAMAGE"

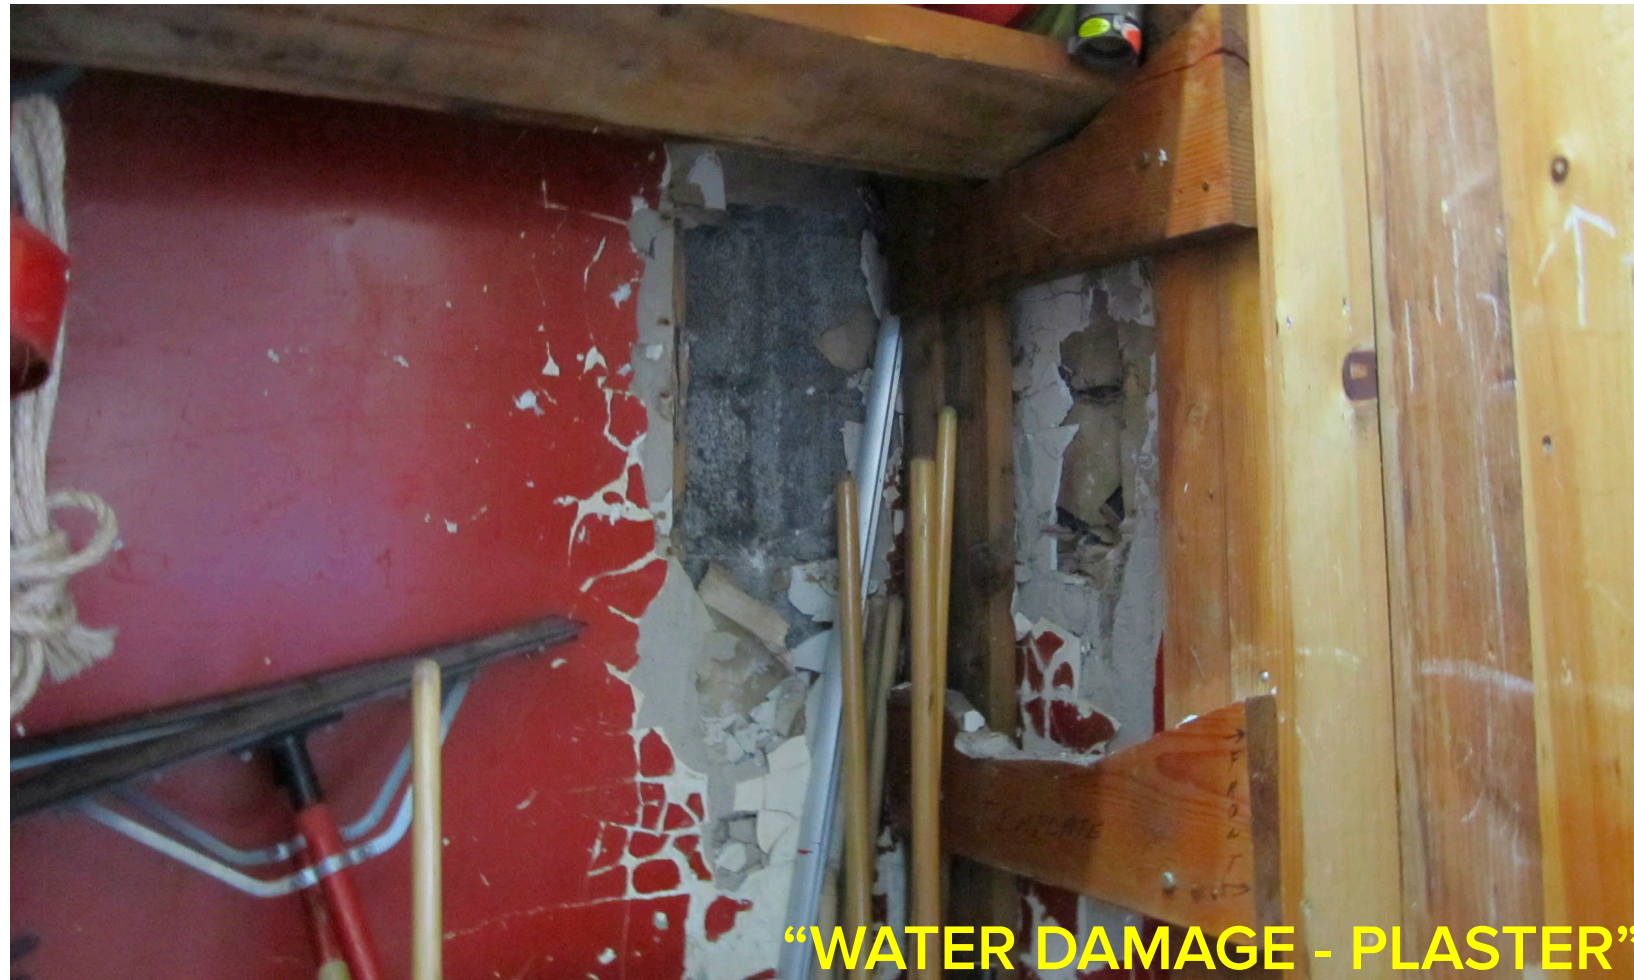
"WATER DAMAGE - PLASTER"

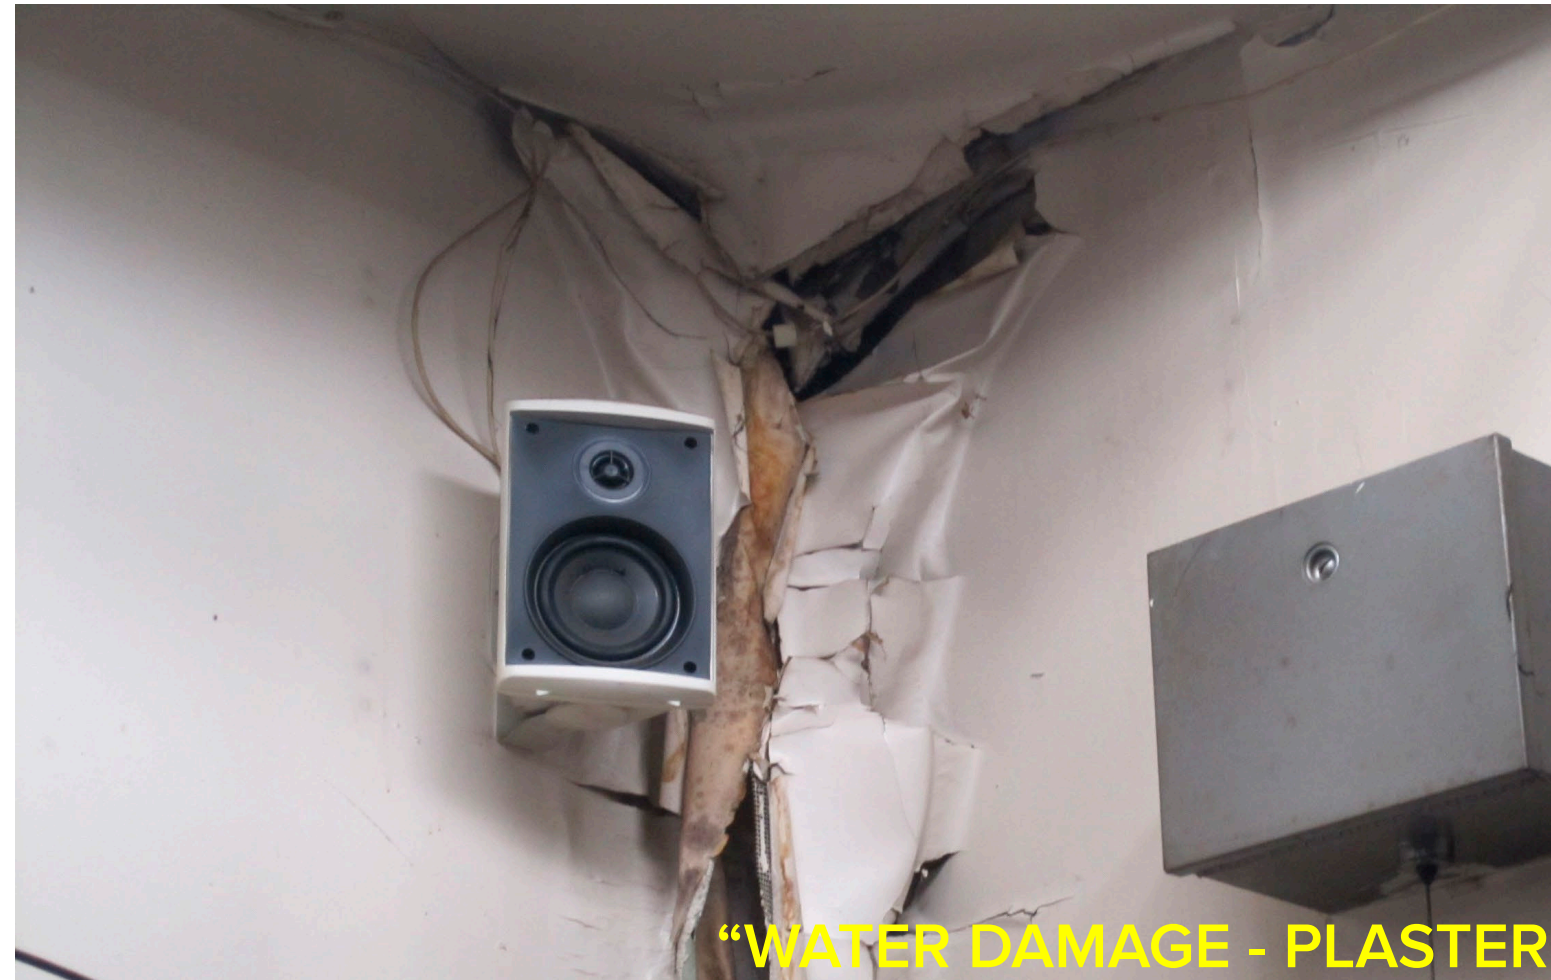
"WATER DAMAGE - PLASTER"

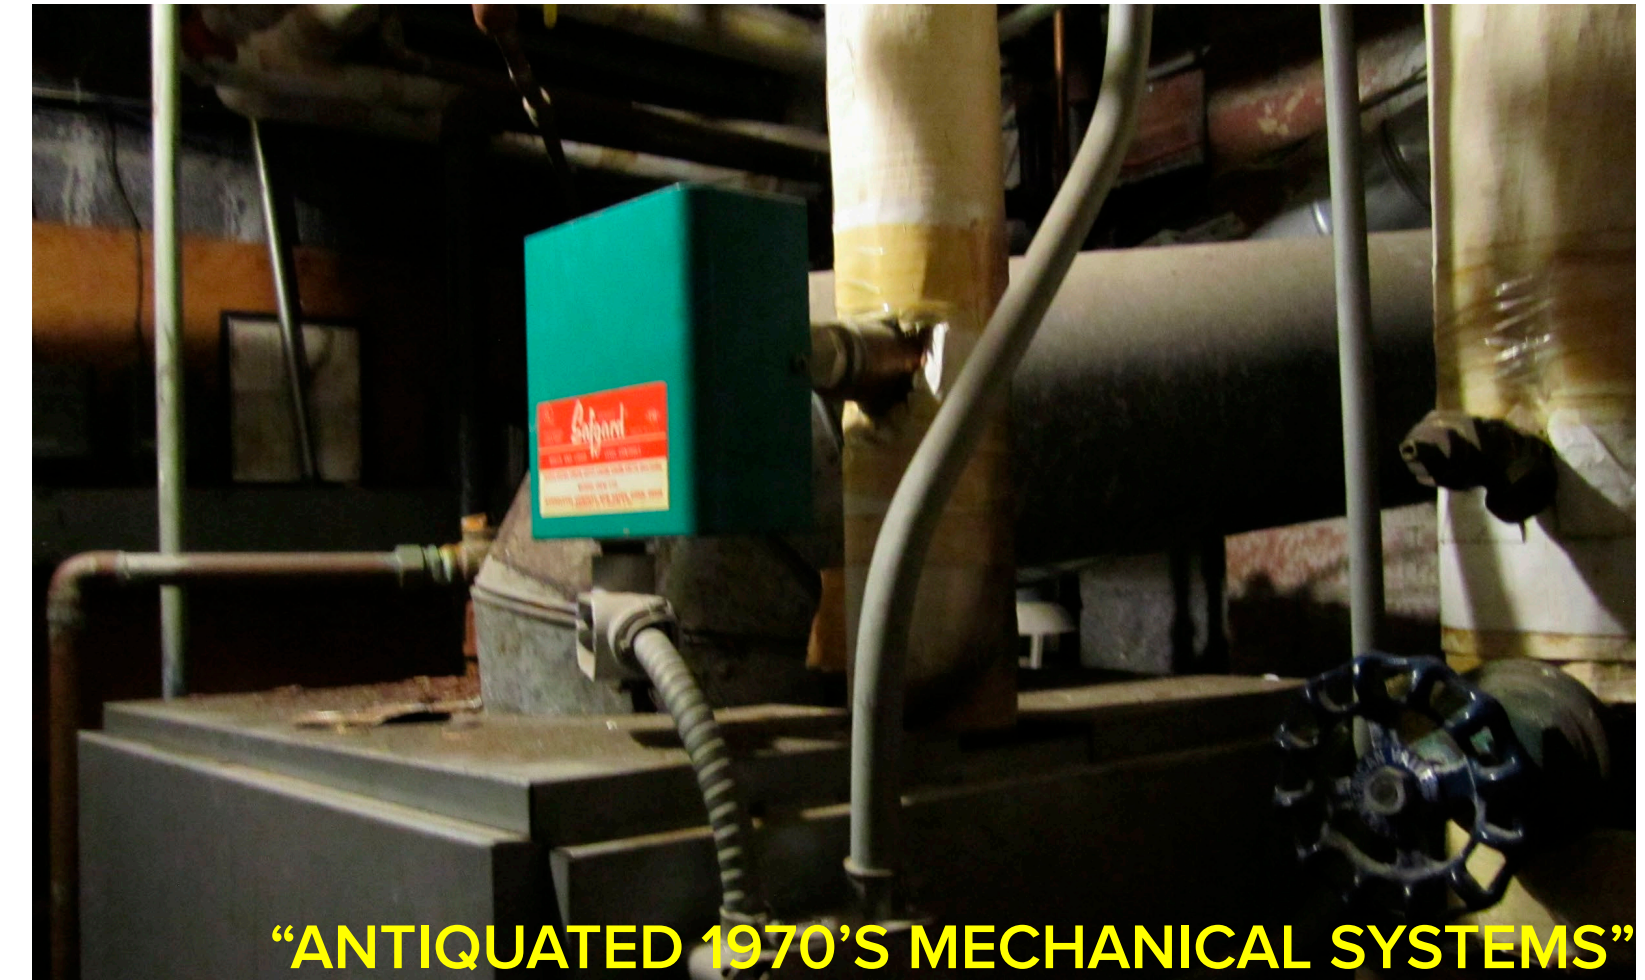
"ANTIQUATED 1970'S MECHANICAL SYSTEMS"
