PUBLIC PRESENTATION

VERONA EMERGENCY SERVICES COMPLEX

POLICE DEPARTMENT, FIRE DEPARTMENT - CO. #2, RESCUE SQUAD

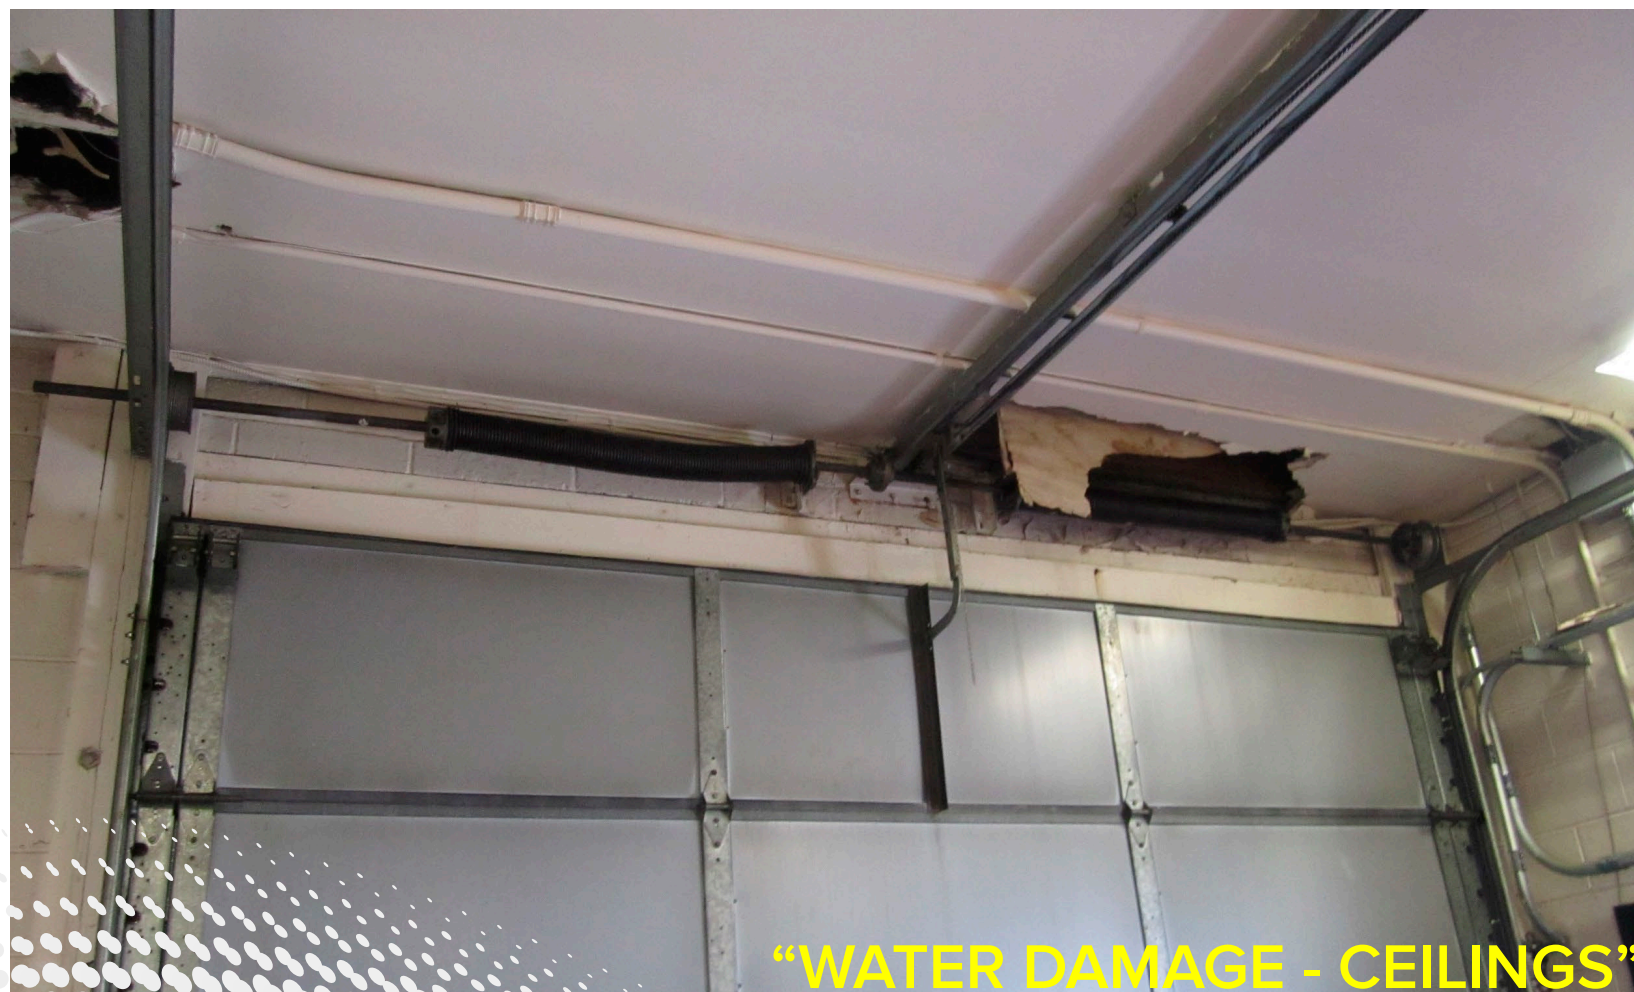
"WATER DAMAGE - CEILINGS"

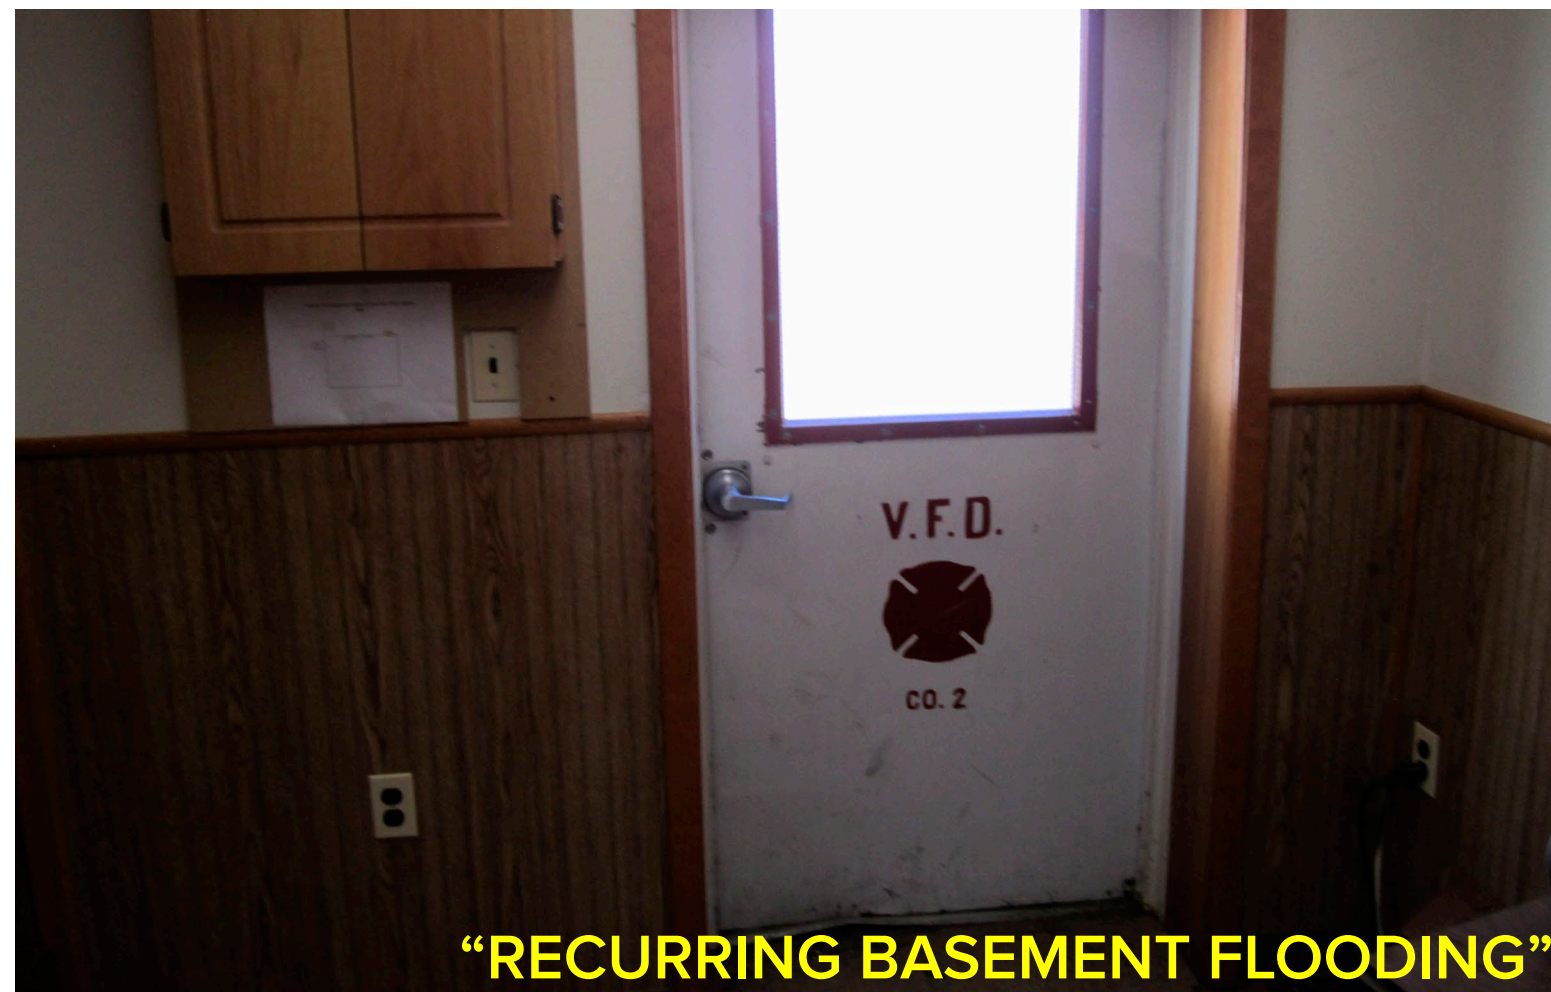
"RECURRING BASEMENT FLOODING"

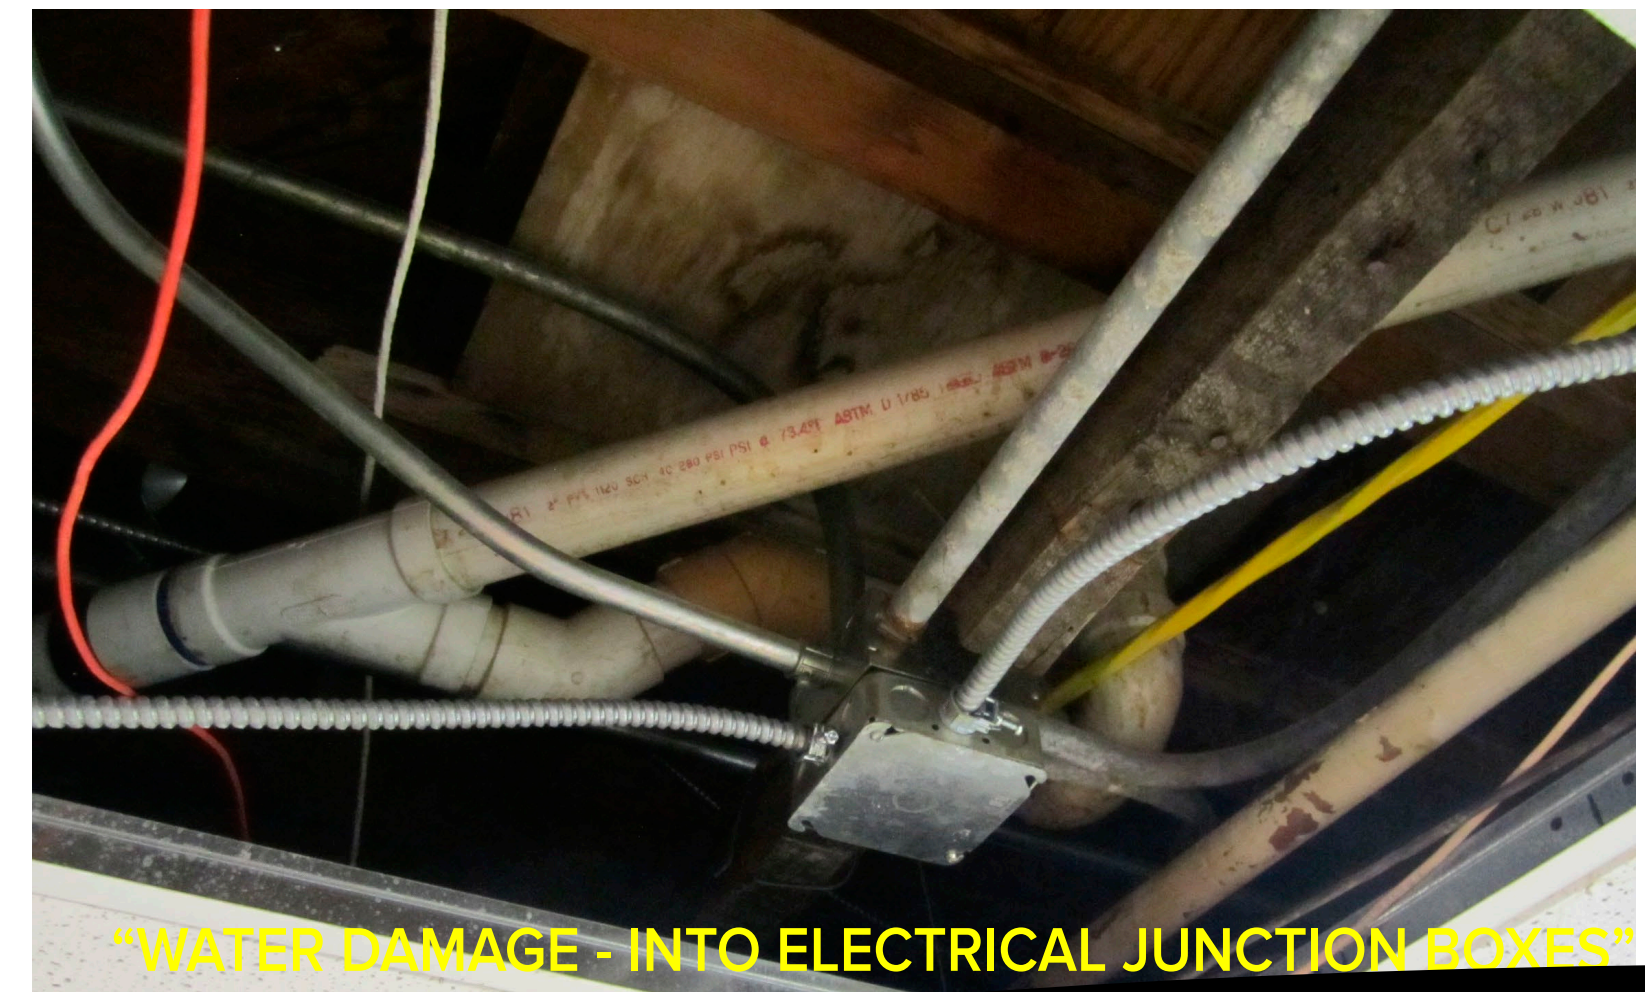
"WATER DAMAGE - INTO ELECTRICAL JUNCTION BOXES"
