Re: **Multi-Way STOP Analysis**
Forest Ave & Pease Ave
Township of Verona, Essex County, NJ
Project No.: 192552

Bright View Engineering, LLC, was tasked by The Township of Verona (*the Township here-in*) with performing an evaluation of the existing traffic pattern at the intersection of Forest Ave & Pease Ave. This analysis was performed to assess the implementation of a Multi-Way STOP control at the subject intersection and to assess the necessity for any additional traffic treatments which could be considered in the study area.

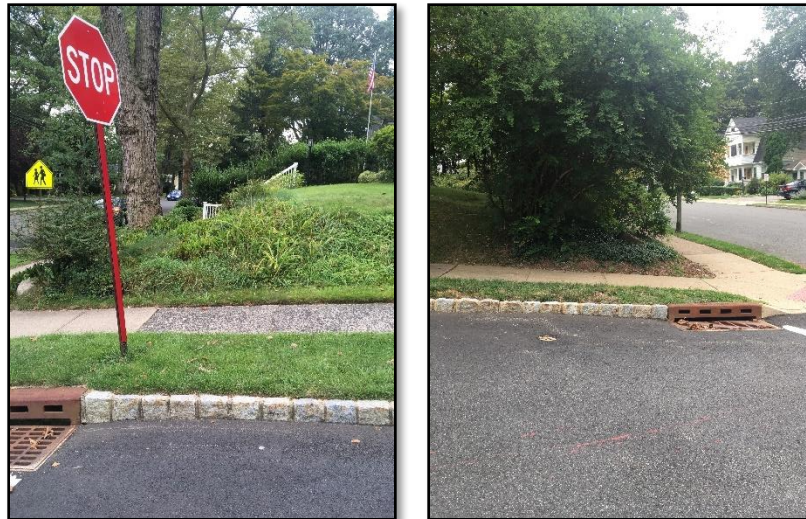
We found both the Stopping Sight Distance for an approaching vehicle on Forest Ave (*200' min. req.*) and Intersection Sight Distance for stopped vehicles on Pease Ave (*335' min. req. for left; 290' for a through/ right*) to be insufficient. The Sight Triangles at the study intersections contained obstructions, which included both foliage and fence along the corner properties, and foliage within the grass strips between the sidewalk and roadway. While we did not observe any parked vehicles along the street for any of the approaches, we did note that on-street parking did not appear to be restricted. Additionally, we did not observe any parking prohibition signs or striping at any of the corners to the intersection. So, while residents did not appear to be parked on the street during our site observations the potential for parked vehicles to create site obstructions remains present as there is not parking prohibition guidance in place.

(from left to right) The first image represents a car stopped at the STOP Sign/ STOP Bar along the west leg of Pease Ave facing southbound; The second image represents a car stopped at the STOP Sign along the west leg of Pease Ave facing northbound.

The results of our analysis indicate that a Multi-Way STOP **is recommended** at the intersection of Forest Ave & Pease Ave due to the existing geometric conditions. Additionally, foliage along the north and south corners of this approach should be trimmed back in order to improve sight distance at the intersection and help prevent any turning conflicts. A Multi-Way STOP control should be signed properly at this intersection.

- The sight triangles along the corners at the study intersections were obstructed due to foliage, fencing, sign poles, utility poles, changes in grade, and landscaping features adjacent to the travel way along adjacent property frontage. The Township should work with its residents to address some of these issues, within reason;

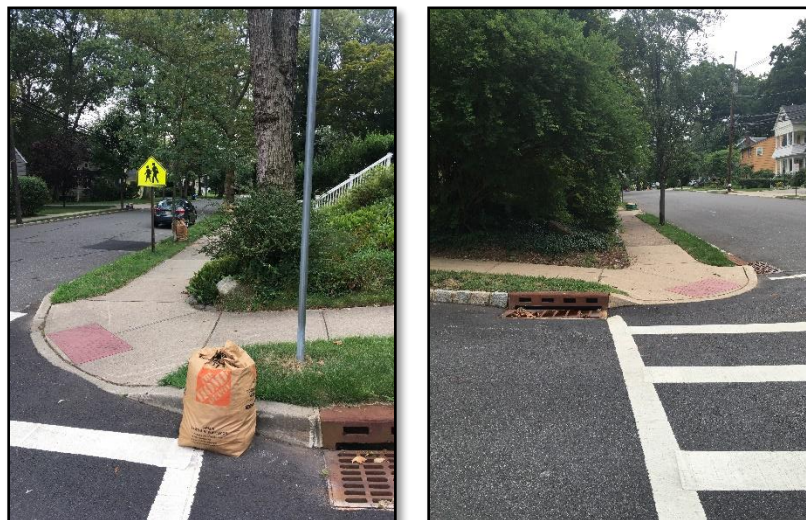
We observed that visibility was somewhat improved when motorists pulled their vehicles forward into the crosswalk area and observed traffic, however, sight obstruction at the corners still remained. We noted that the Forest Avenue Elementary School is located approximately 3 blocks south of the study intersection and that this intersection is located on a school route. Stopping sight distance was also affected by the sight obstructions on the corners. Approaching vehicles would have difficulty observing stopped vehicles until they began pulling into the crosswalk area along the side streets.

(from left to right) The first image represents a car stopped at the crosswalk along the west leg of Pease Ave facing southbound; The second image represents a car stopped at the crosswalk along the west leg of Pease Ave facing northbound.

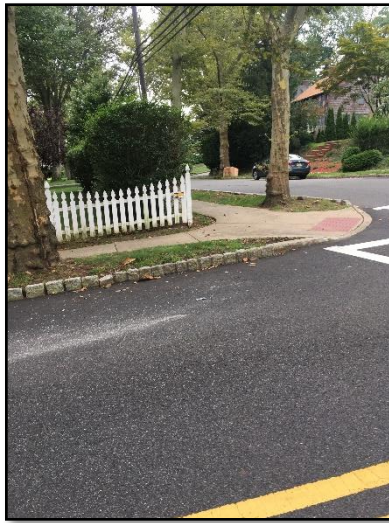
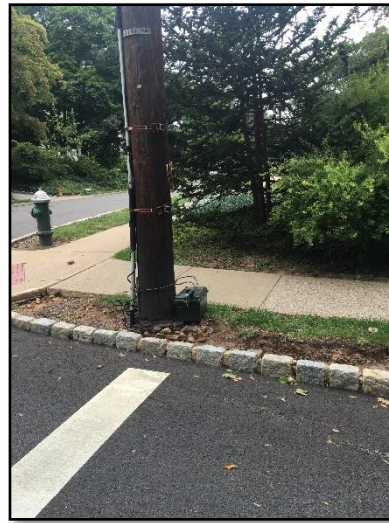
(from left to right) The first image represents a car stopped at the STOP Bar along the east leg of Pease Ave facing southbound; The second image represents a car stopped at the STOP Bar along the east leg of Pease Ave facing northbound.

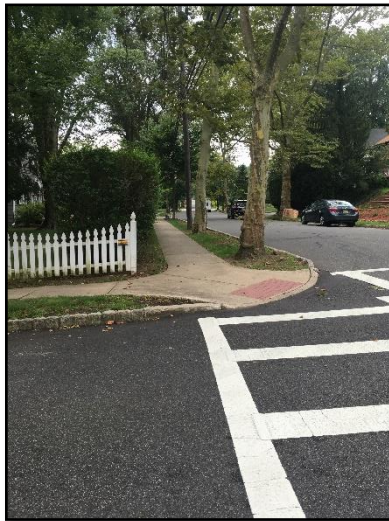
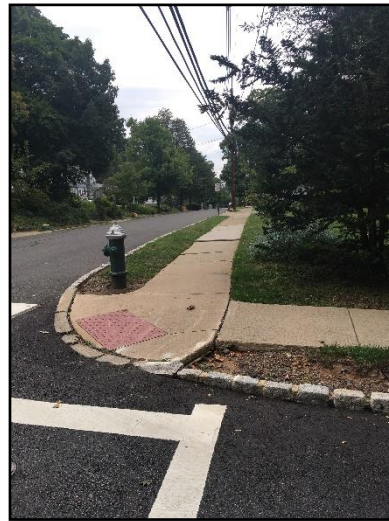
(from left to right) The first image represents a car stopped at the crosswalk along the east leg of Pease Ave facing southbound; The second image represents a car stopped at the crosswalk along the east leg of Pease Ave facing northbound.
