Township of Verona
251½ Grove Avenue
Area in Need of Redevelopment
Preliminary Investigation Report

Date: March 12, 2026

**Preliminary Investigation for a Determination of an
Area in Need of Redevelopment Designation
for 251 ½ Grove Avenue**

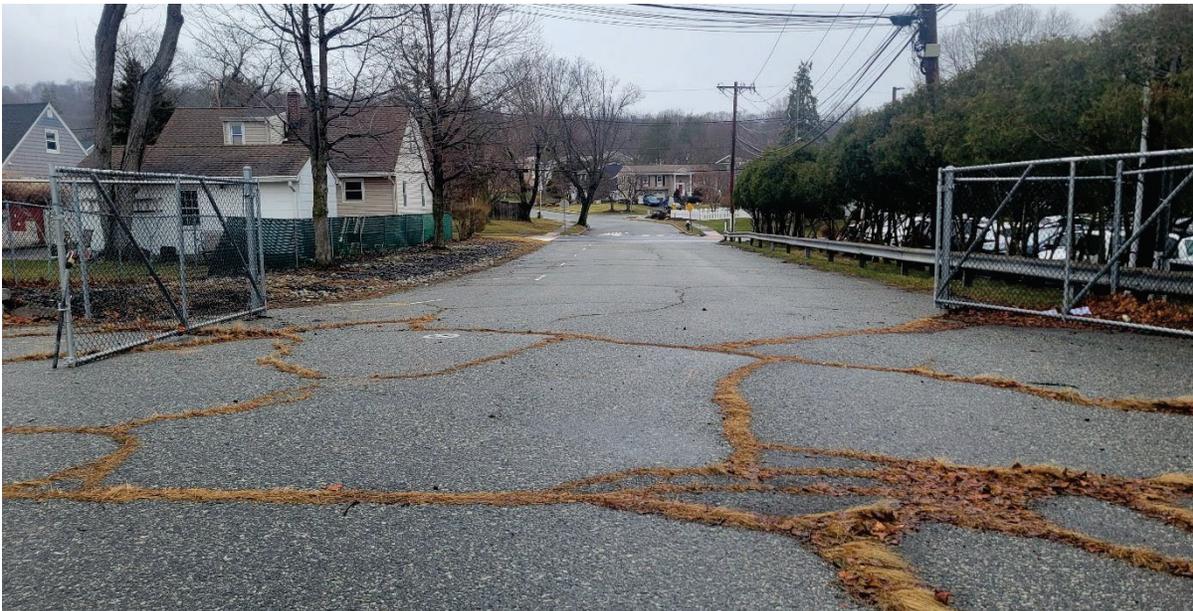
View of the asphalt driveway which provides access to the site from Grove Avenue. The site visit on March 12, 2026, clearly reveals the dilapidated condition of the pavement.

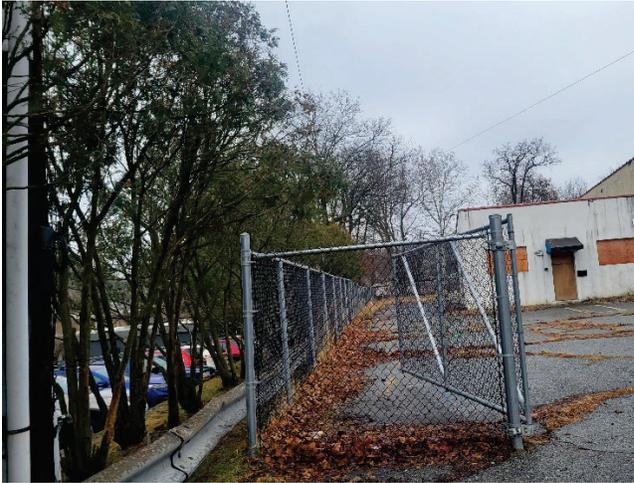
View of northerly side of Building A and the chain link fence that encloses the property.

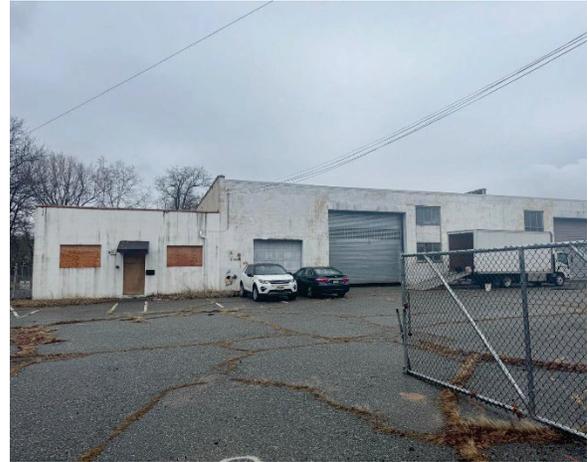
View of Building A from the entrance gate. The pavement is cracked with overgrowth.

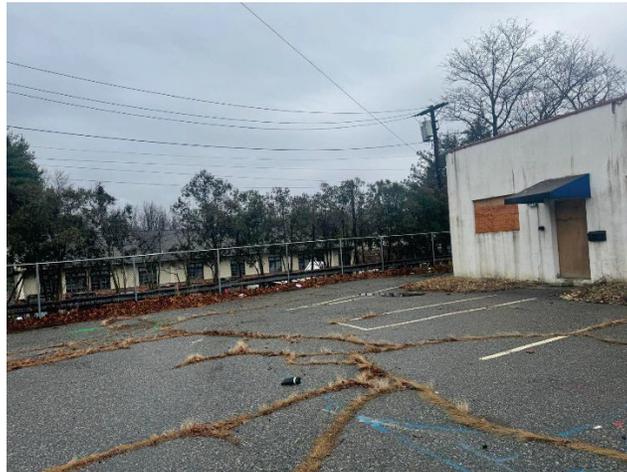
Additional view of Building A and fence along the northerly property line depicting the dilapidated building and parking area.

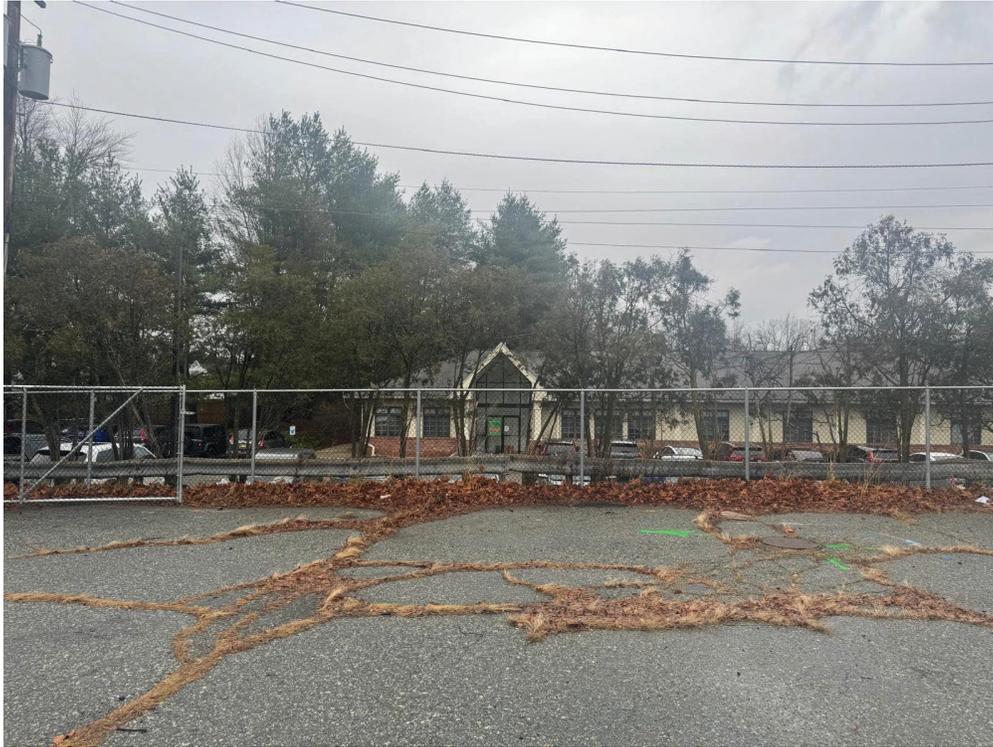
Additional view of the cracked pavement and the chainlink fence along the northerly property line. Also pictured is the commercial building on the adjacent property (271 Grove Avenue).

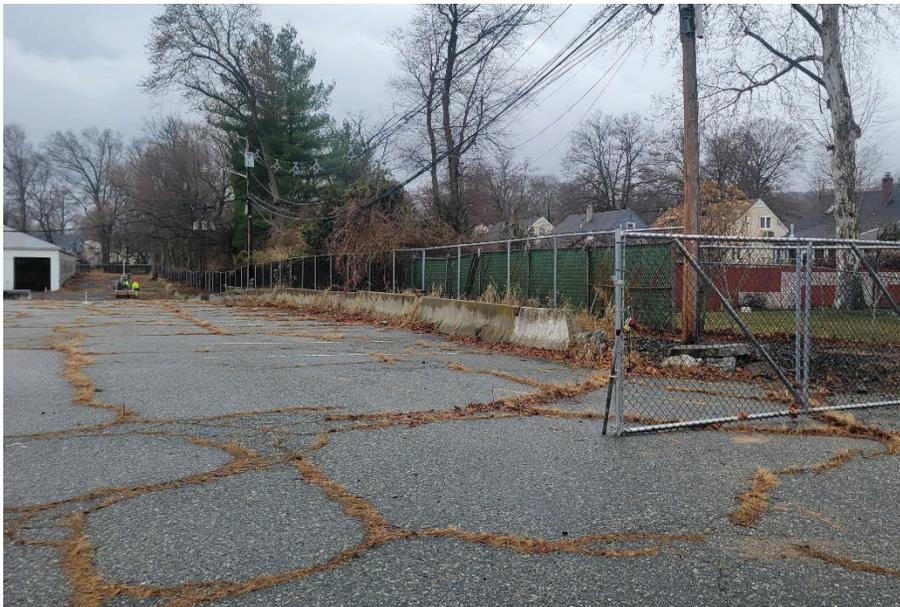
Another view of the gate at the entrance to the property. The pavement is cracked and overgrown, and parking is undefined. As seen in the above image, the site slopes downwards towards Building E.

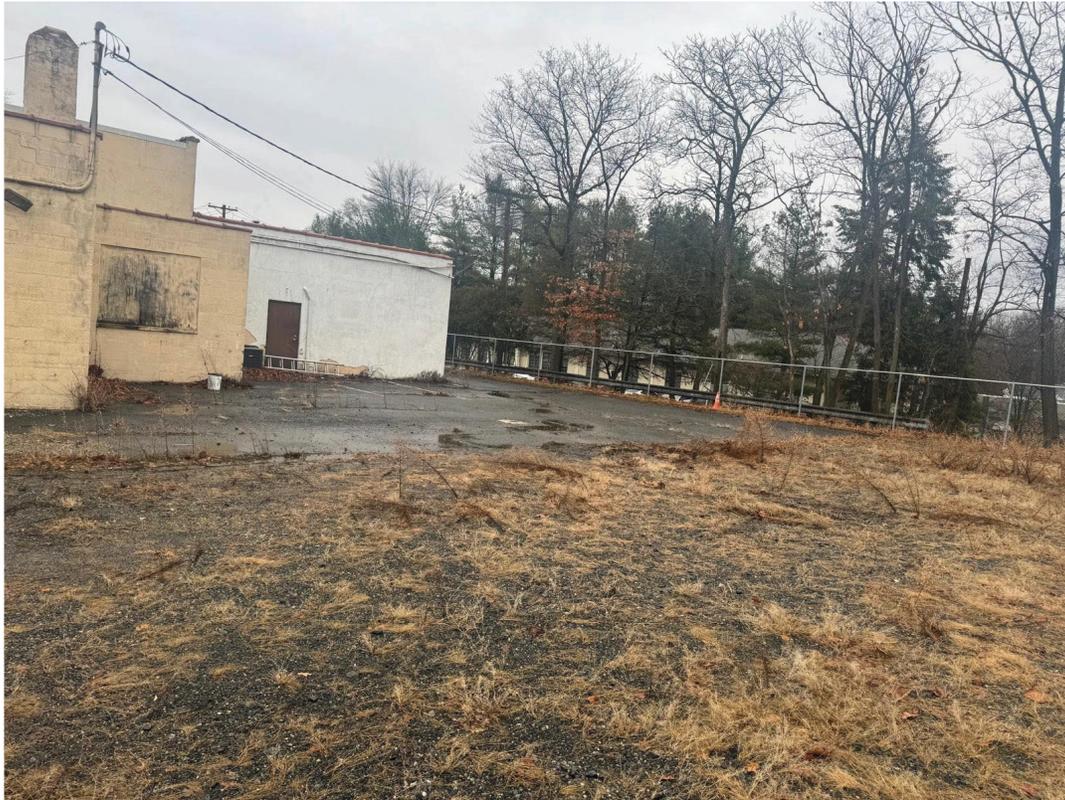
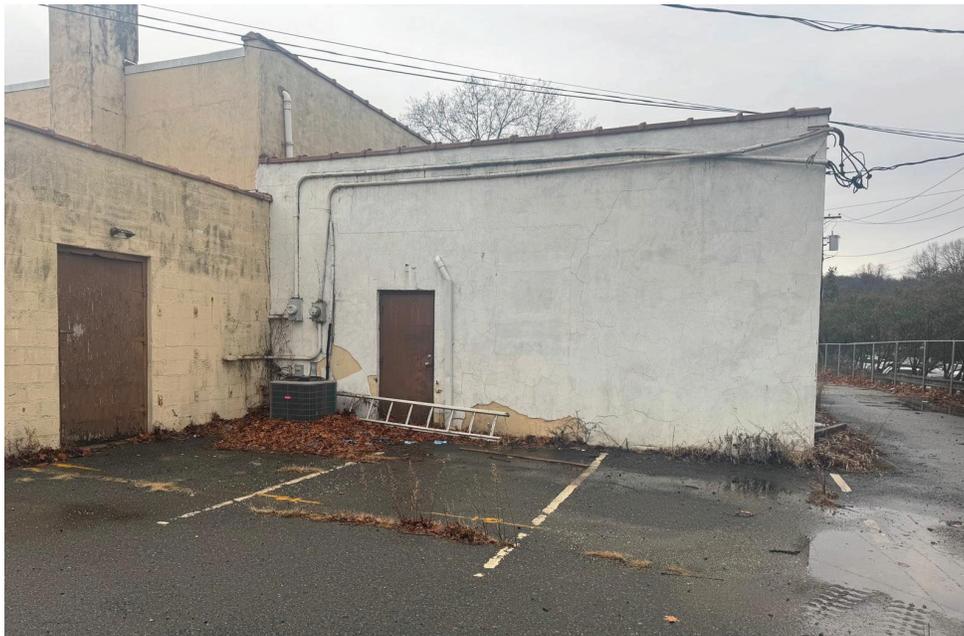
View to the rear of Building A (above). The rear of the property is characterized by broken asphalt, gravel, and overgrowth. A closer view of the rear of Building A (below) showing the random parking spaces and a discarded ladder.

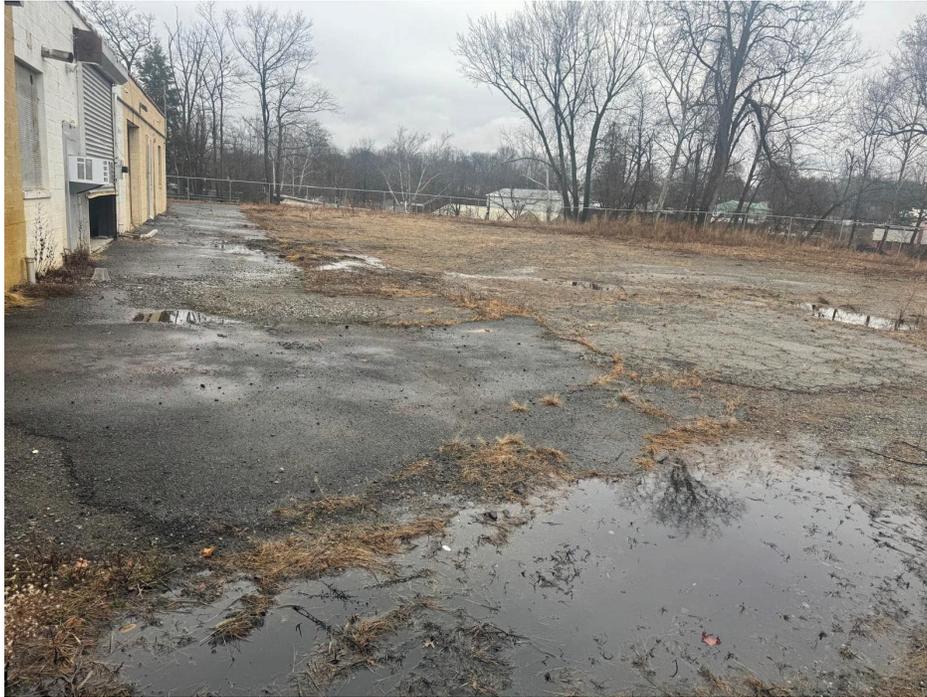
Another view of the rear of Building A and the northeasterly corner of the property, showing pool of water (just after a rain event) and significantly deteriorated asphalt.

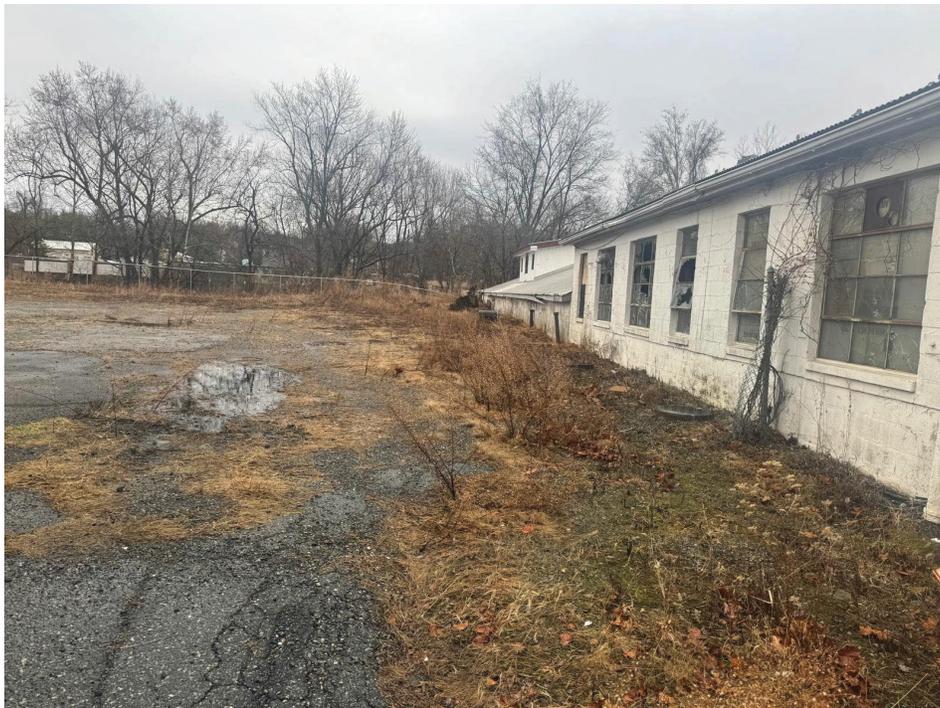
View of the northerly side of Building B and the northeasterly corner of the property. This area is characterized by poor drainage, deteriorated asphalt, and overgrowth.

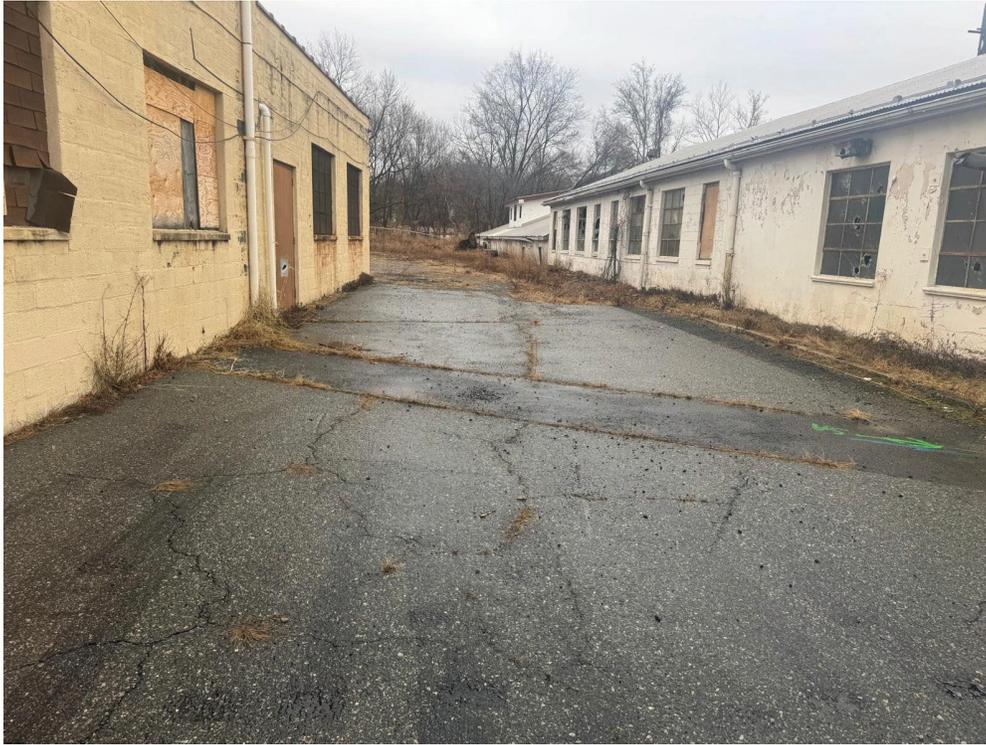
A view of the area between Building A (tan) and Building B (white). The façades of the buildings are damaged, and windows are either broken or boarded up.

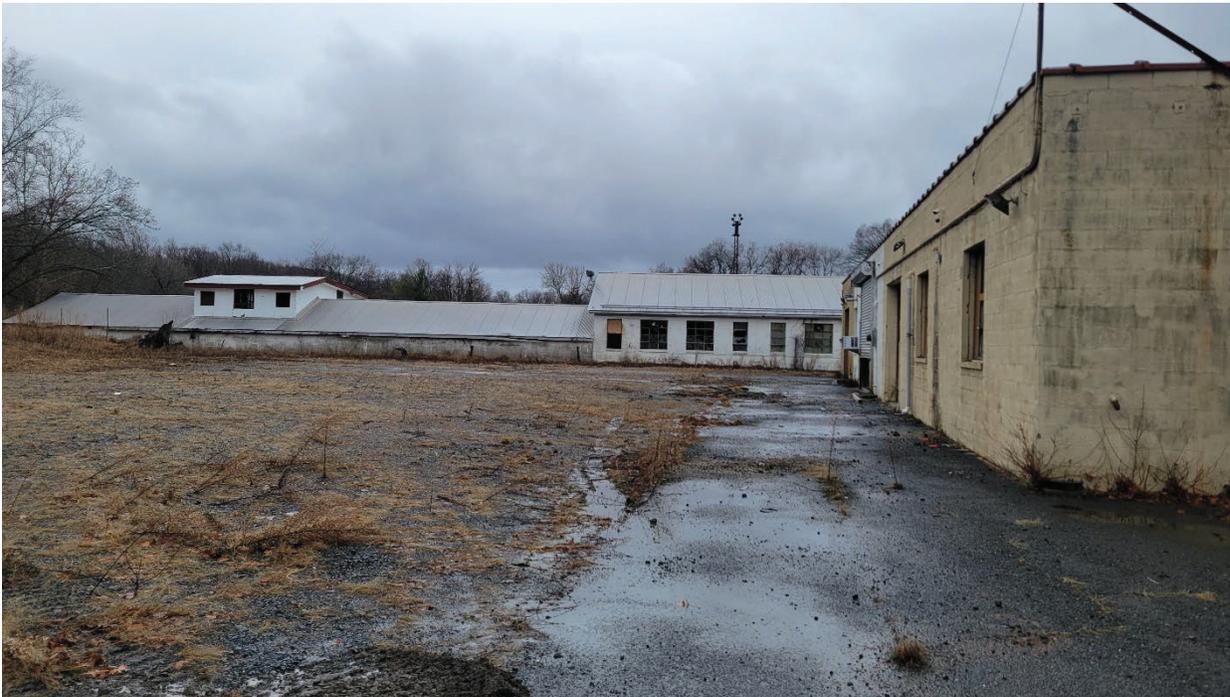
A view from the rear of Building A with Building B in the background. The ground in this area is muddy and covered in broken asphalt and gravel.

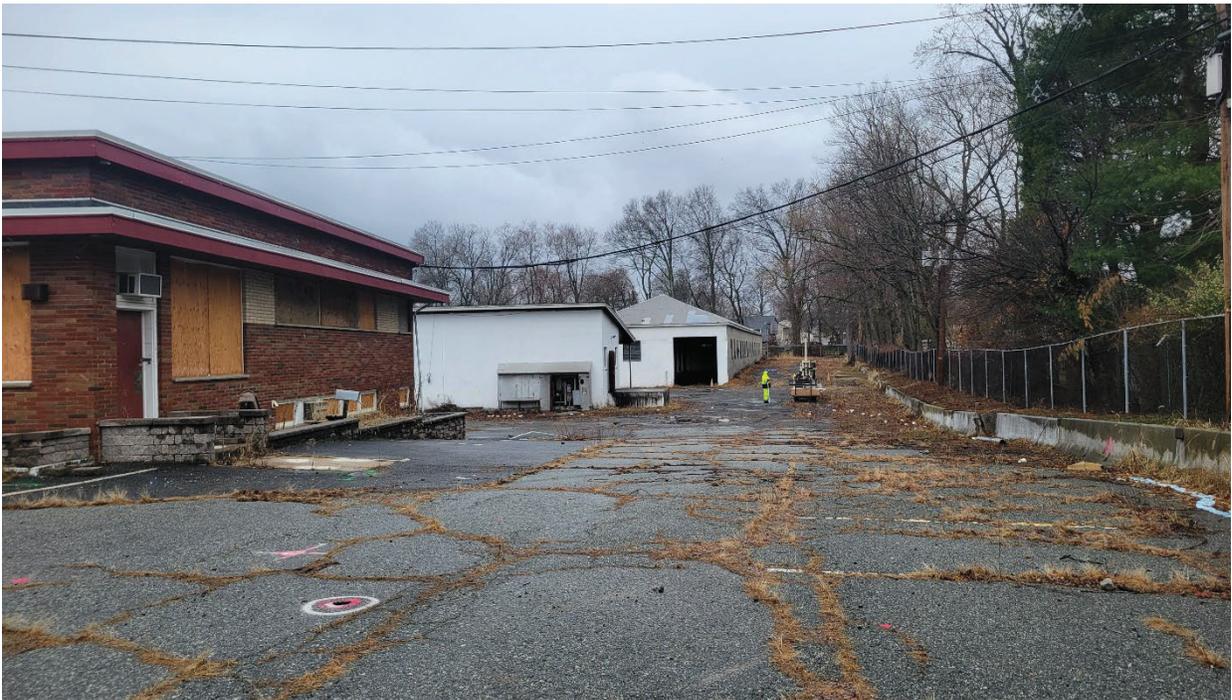
From left to right, a view of Building B, Building C, and Building E.

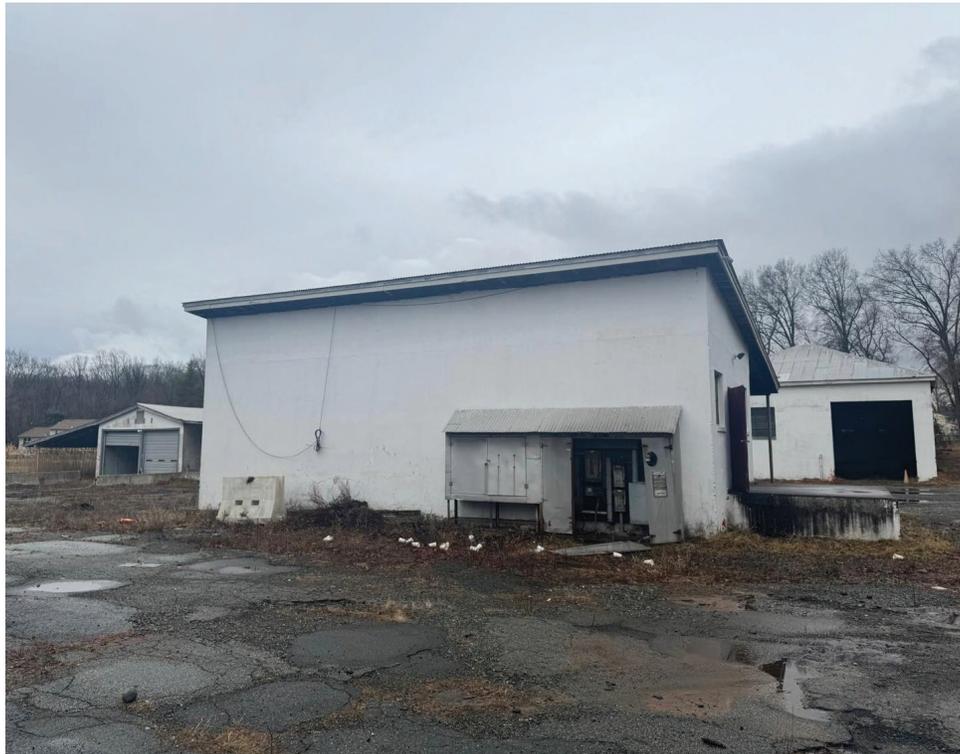
A view of the westfacing side of Building C. Water from recent rain event in the broken and cracked pavement, indicating decline and poor drainage in this area.

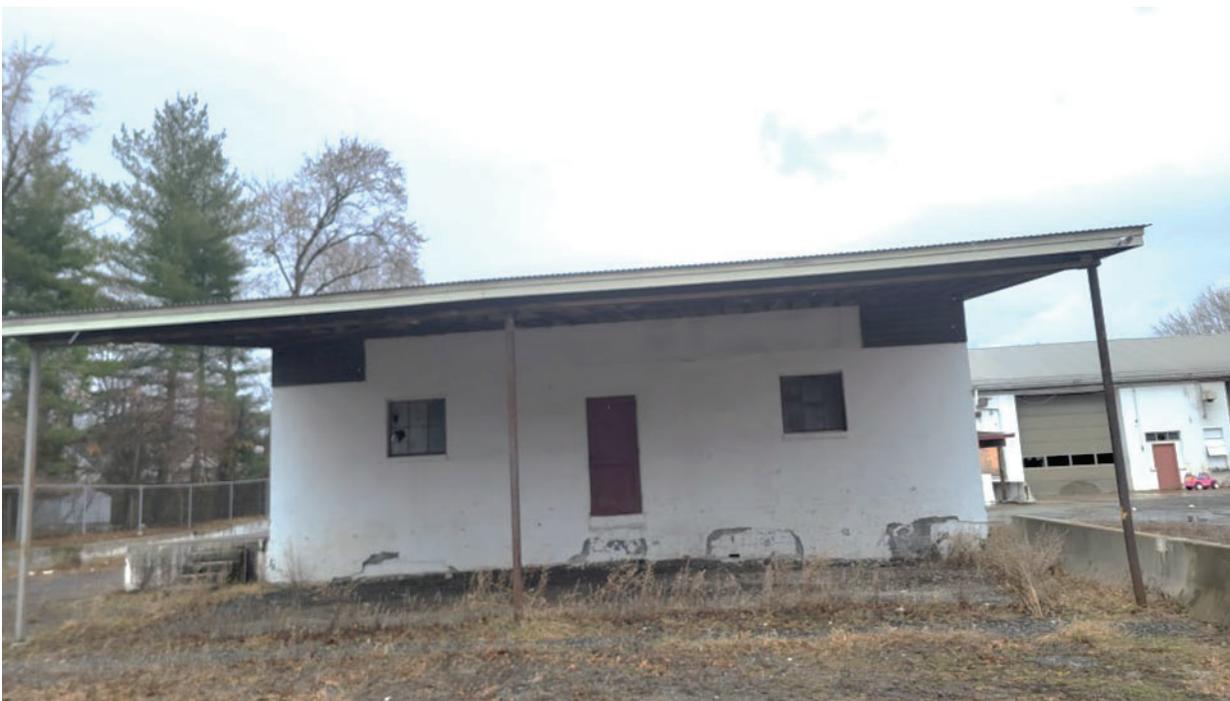
View of the south facing side of Building C. There are no stairs leading to the side doorway and the gravel/asphalt surrounding the building is completely overgrown. The windows are broken on this side but are not boarded up.

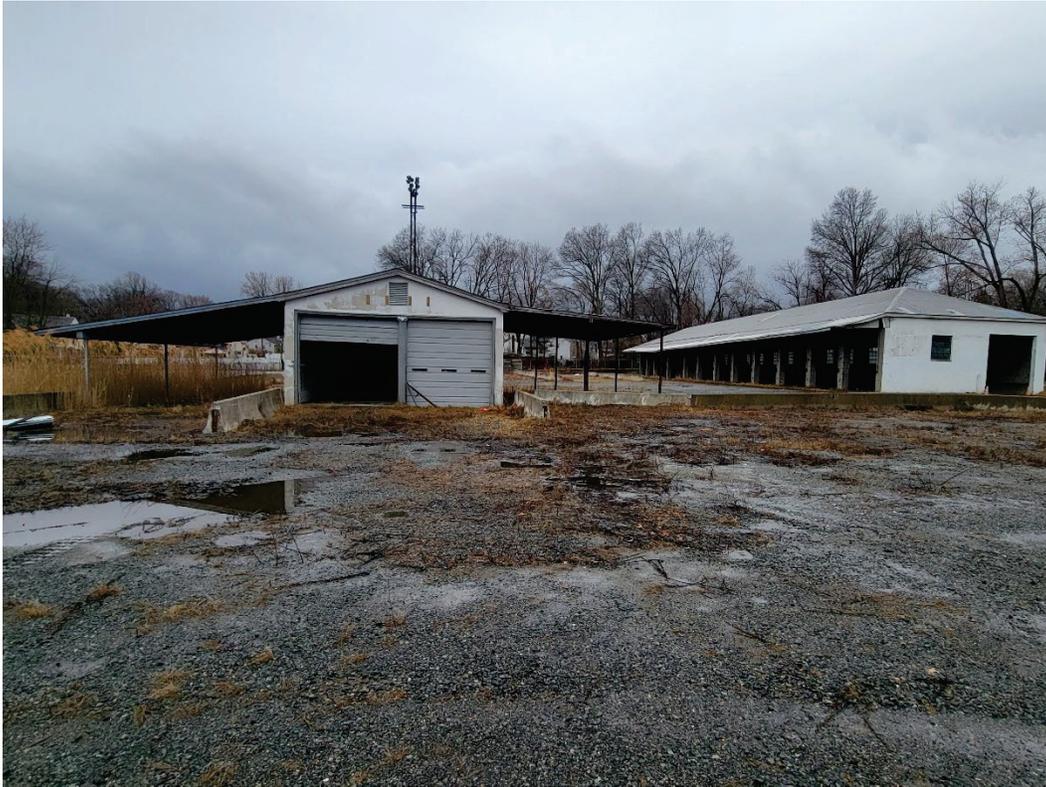
View of Building D with a pool of water in front of the building indicating the deteriorated pavement and inability to drain stormwater.

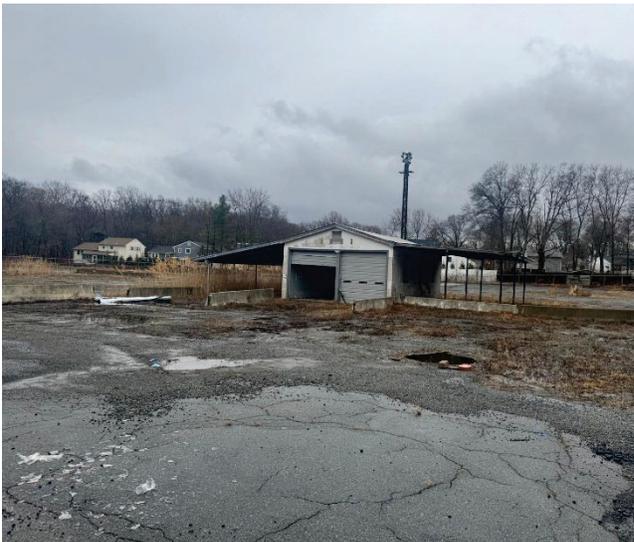
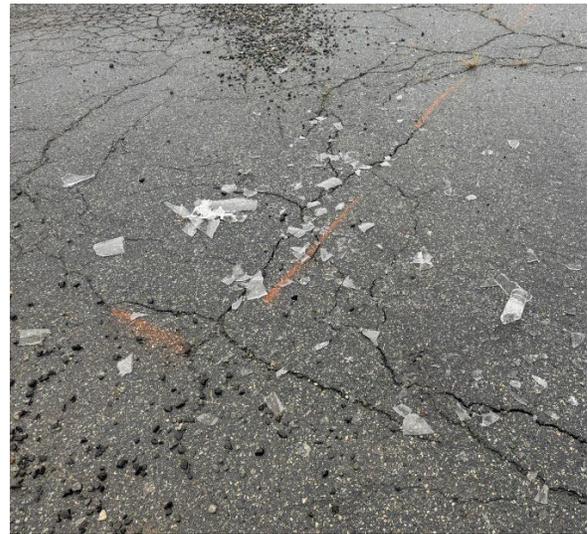
Views of the area surrounding Building D. Broken glass was found on the pavement in front of the building (left). A closeup view of the glass (right).

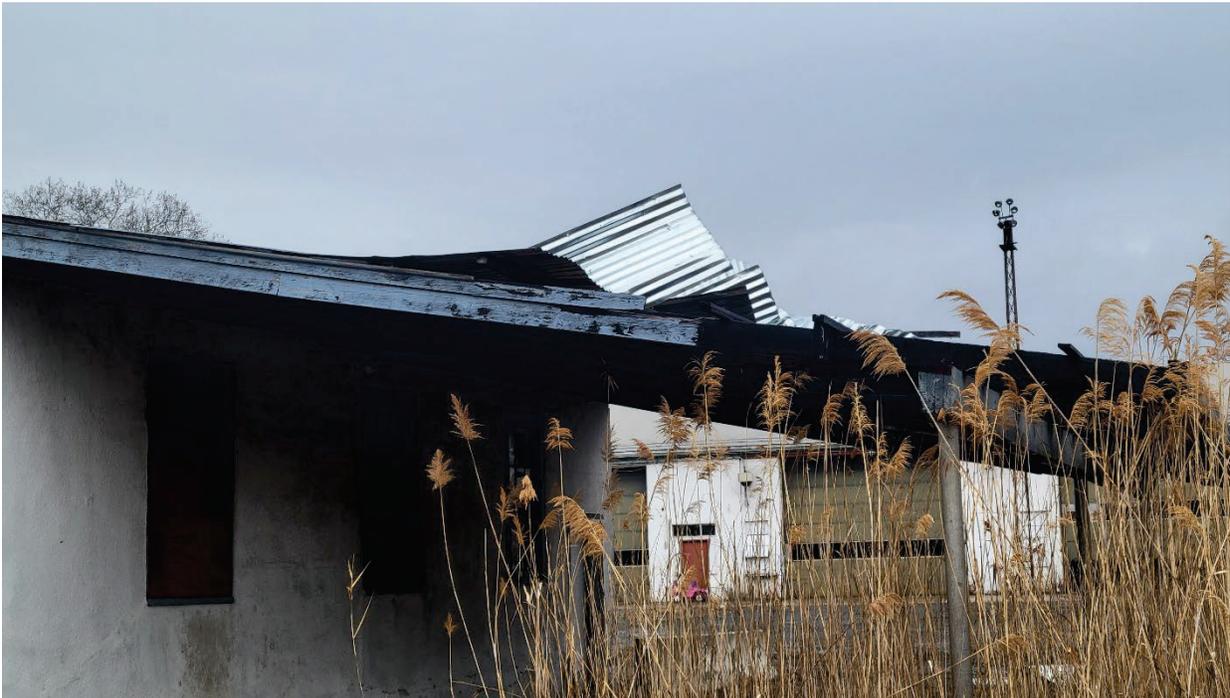
A closeup view of the roof of Building D showing the metal roof.

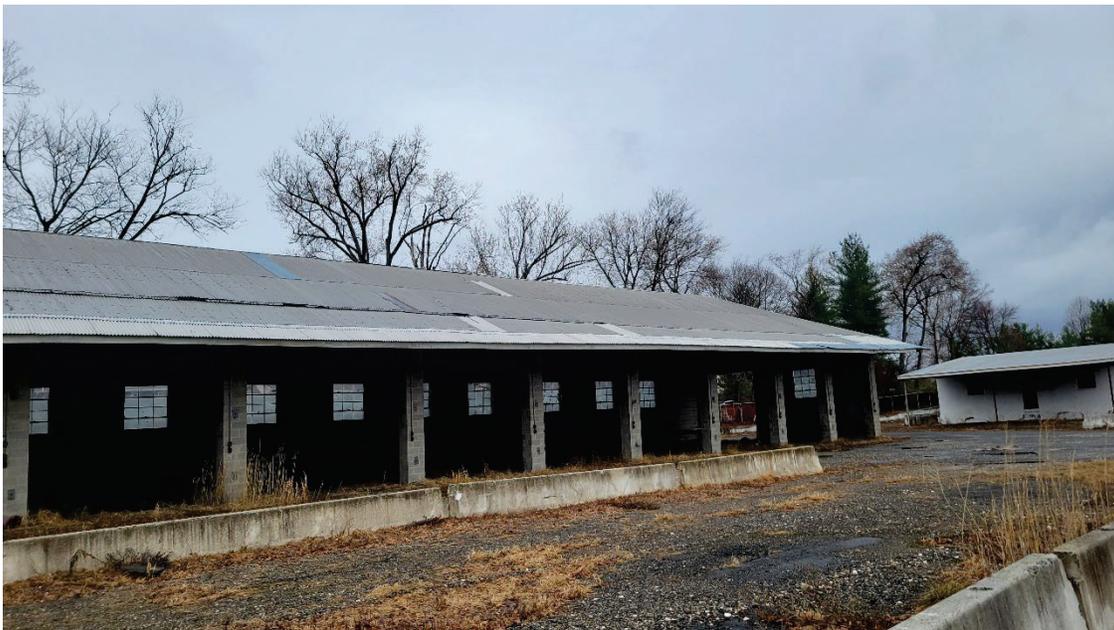
A view of Building E with Building C in the background, to the right. The southeasterly side of building E is open to the elements and is deteriorated. The area between the concrete barrier blocks is fully covered in gravel.

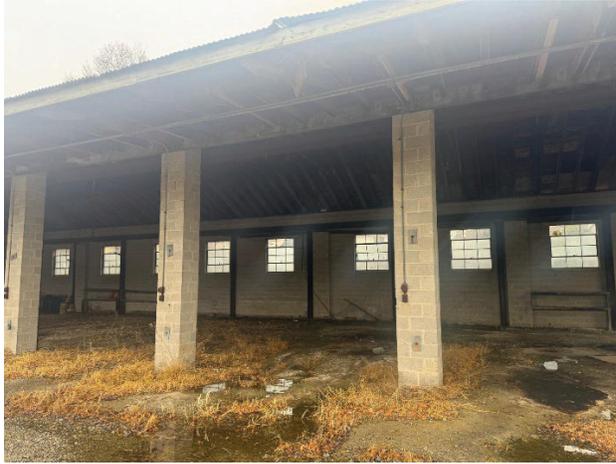
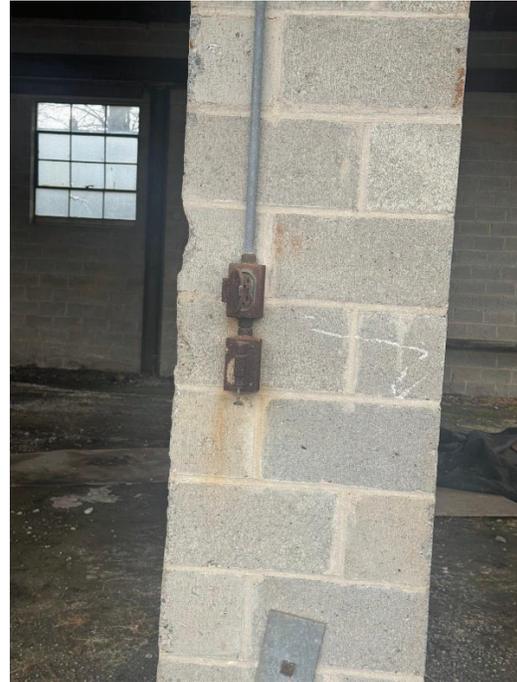
Closeup views of Building E. The concrete flooring is broken to the point where it is covered by overgrowth. The shape of the bays (left) and electrical switches on the concrete pillars (right) suggest there may have been doors along this side of the building in the past.

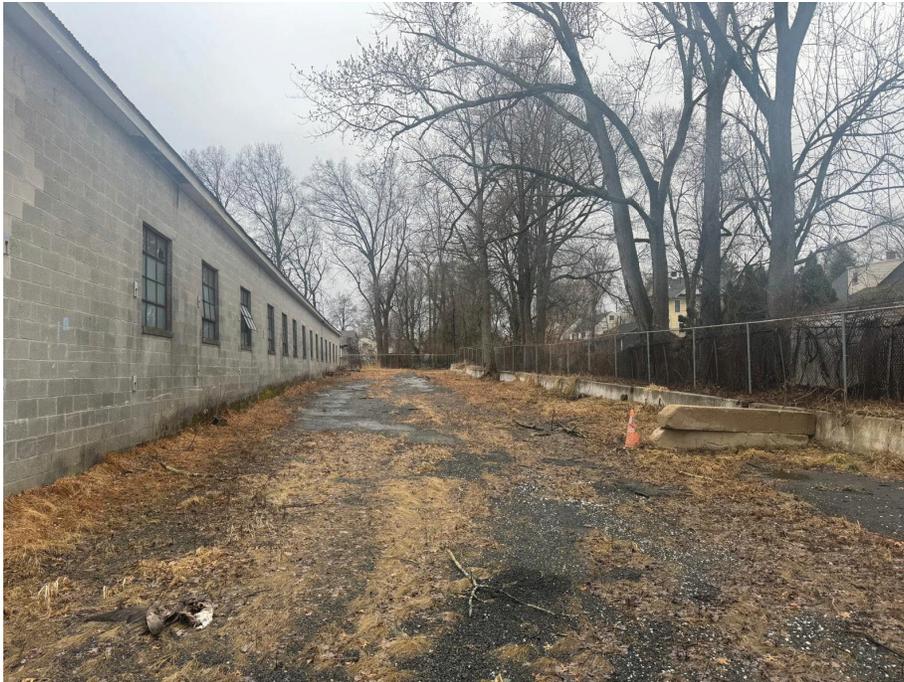
A view of the area to the rear of Building E. The pavement is deteriorated and overgrown. Some of the windows are broken but they are not boarded. Also visible are the single-family homes on the other side of the chain link fence.

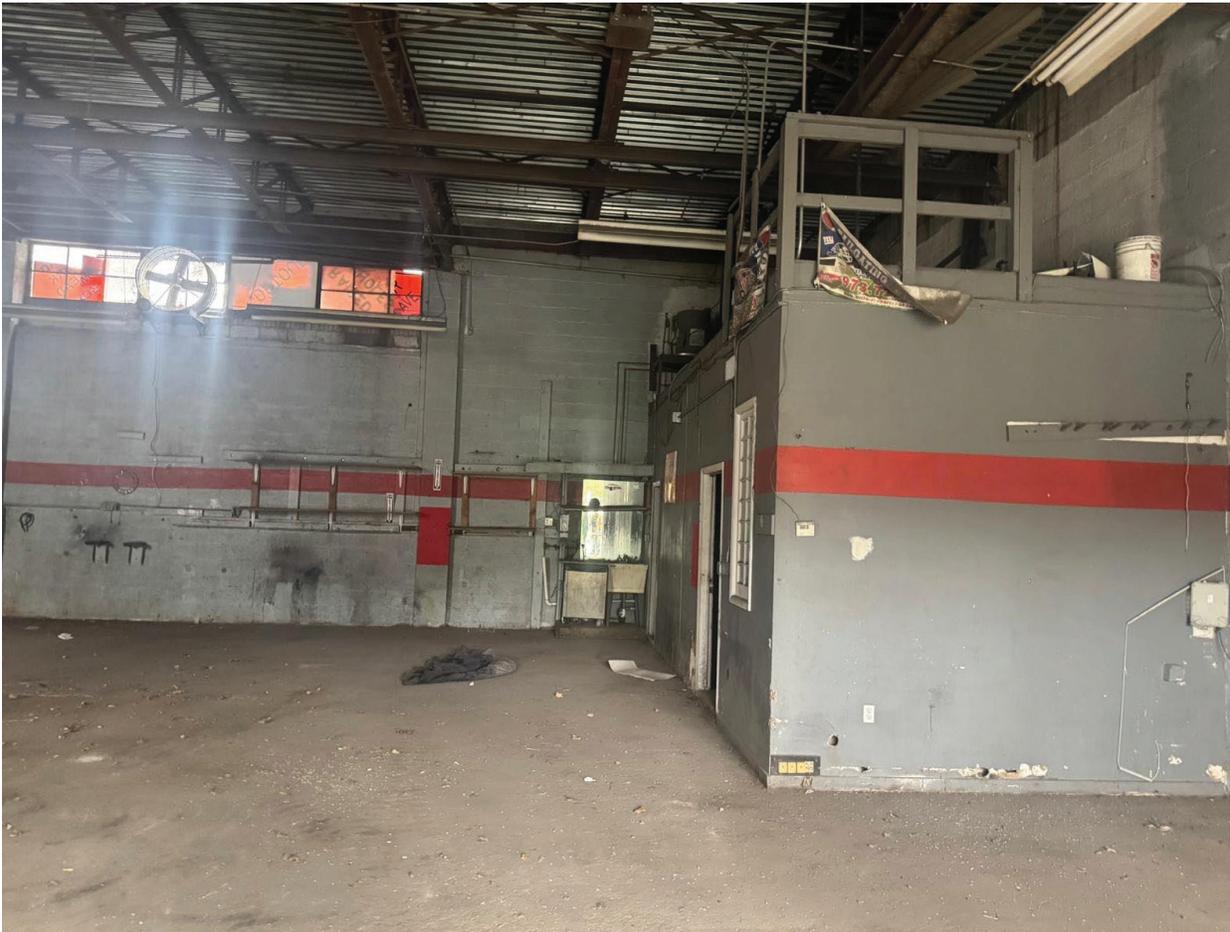
View of the second garage in Building A (above). The paint and drywall appears damaged and most of the windows are boarded with construction signs. Although the garage is empty (bottom left), large stones were found in the garage along with broken glass on the floor (bottom right) indicating probable break in attempts.

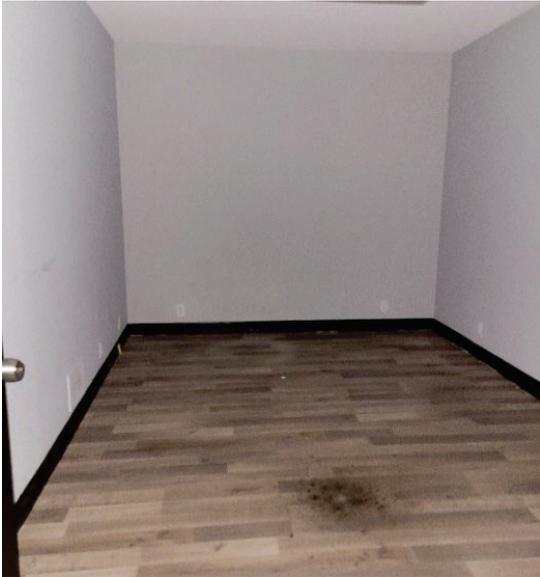
View of a room in the office space, bearing evidence of a small fire suggesting acts of vandalism.

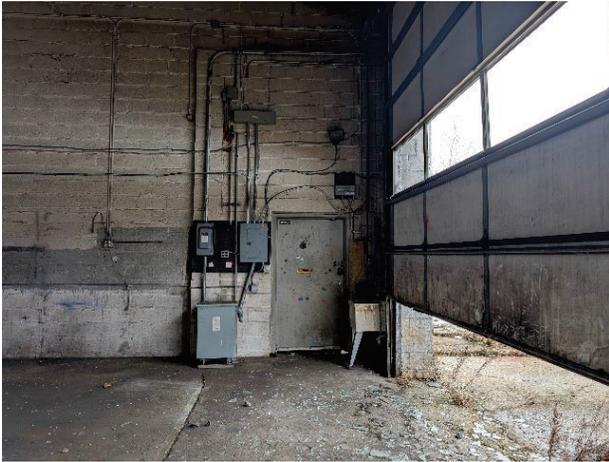
View of one of the garages with a broken door.

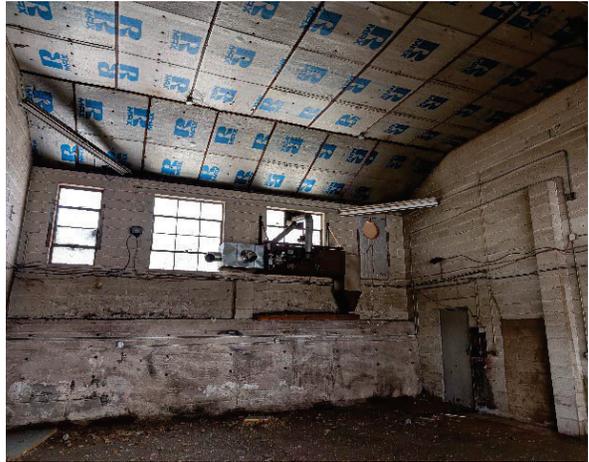
A more detailed view of the interior of the same garage with debris and plywood scraps on the floor.

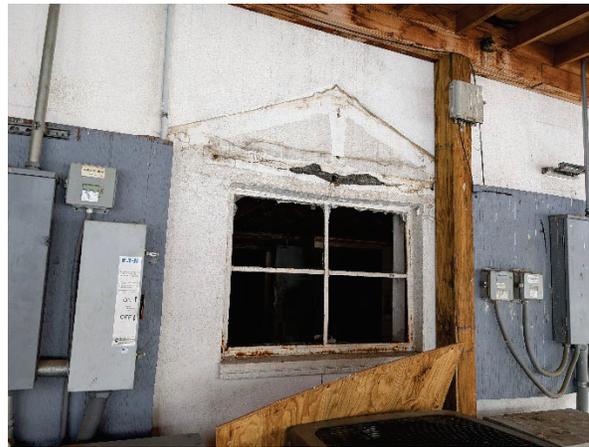
A close-up view of the shattered window near the building's side entrance.

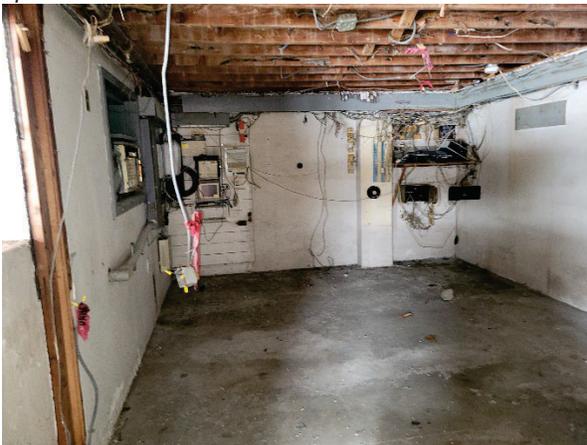
Exposed wiring and utilities that were found in the second building.

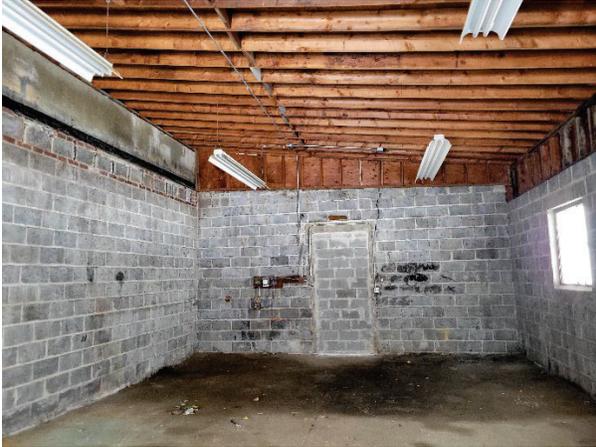
Image of the interior of Building C illustrating signs of mold and water damage on the floor and walls.

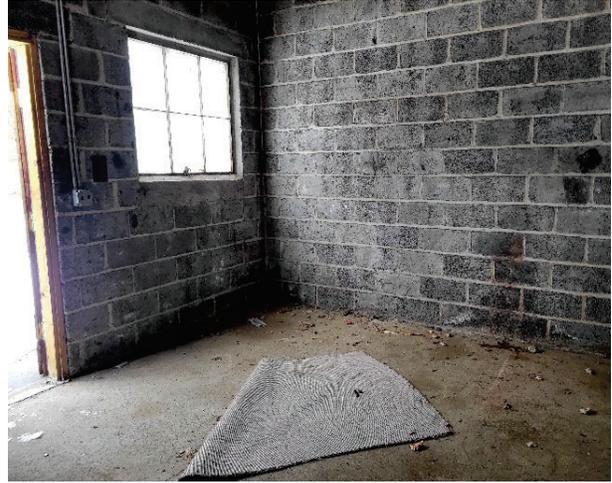
Additional image of the interior showing further signs of mold and water damage to the physical structure.

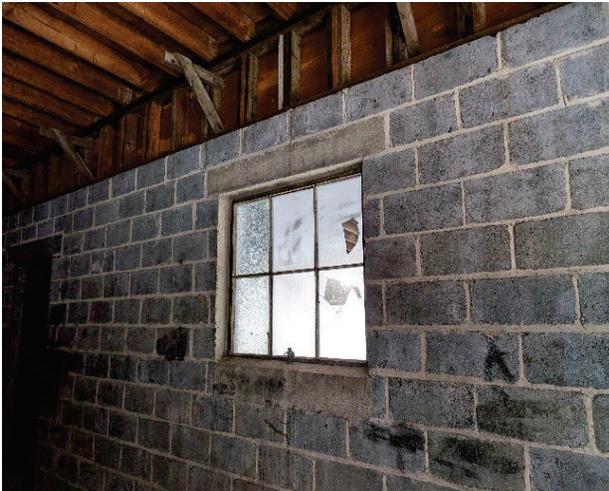
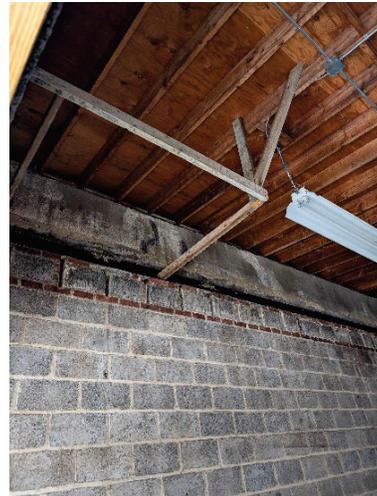
Above Left: Image showing a window that has potentially been vandalized. Above Right: Image showing the current conditions of the building's ceiling.
