**Township of  
Verona**

**420 Bloomfield  
Avenue**

**Area in Need of  
Redevelopment**

**Preliminary Investigation  
Report**

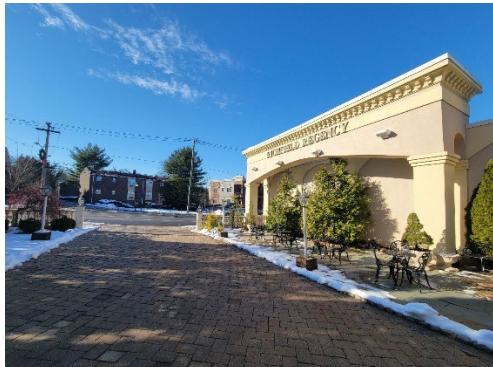
Above Left: Main entrance to Richfield Regency. Also pictured are the ingress and egress from Bloomfield Avenue which leads to a brick-paved driveway.

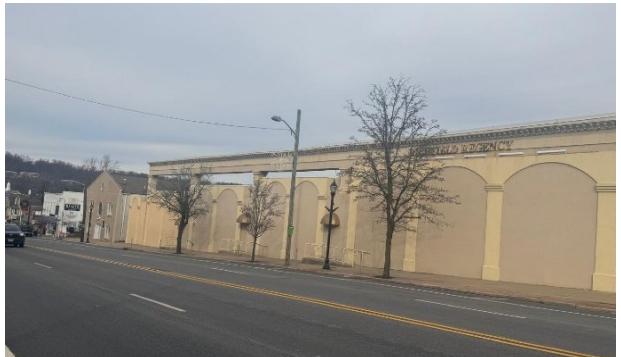
Above Right: View of the building from Bloomfield Avenue showing the blank façade.

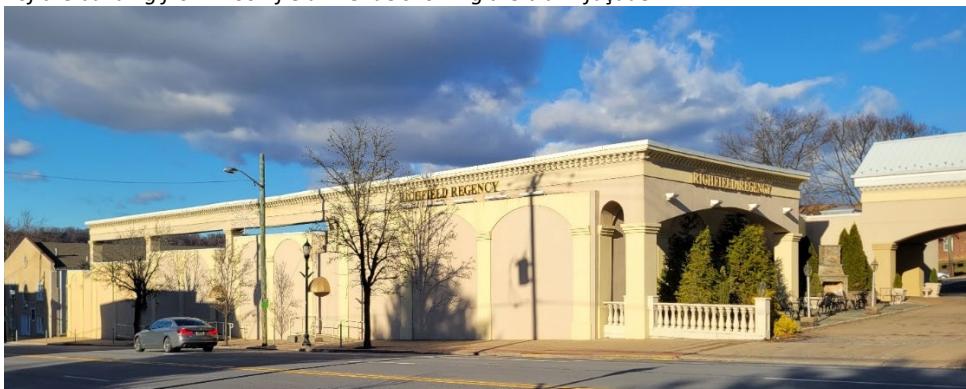
Above: Another view of the building from Bloomfield Avenue. The main entrance of the building is along the southeasterly side of the building beneath the canopy.

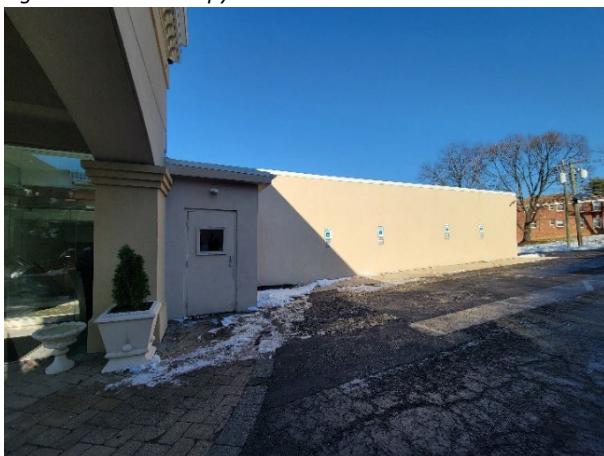
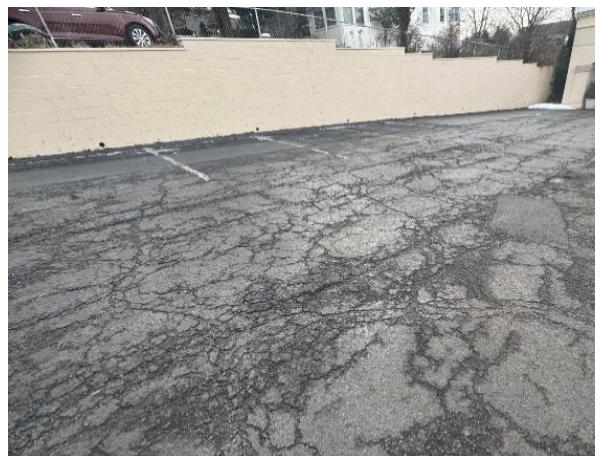
Above Left: View of southeasterly side of the building. The canopy is over the main entrance to the building. Traversing towards the rear of the building, beyond the canopy, the brick-paver drive-aisle transitions into an asphalt parking lot.

Right: Another view of the northeasterly section of the parking lot. The lot is in poor condition with cracks and potholes throughout its entirety.

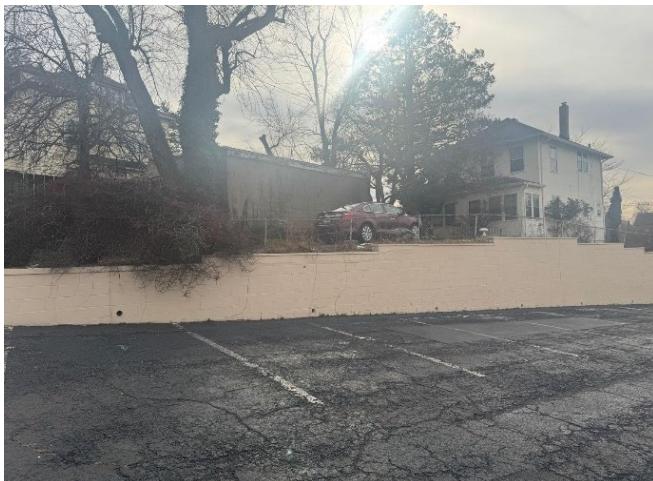
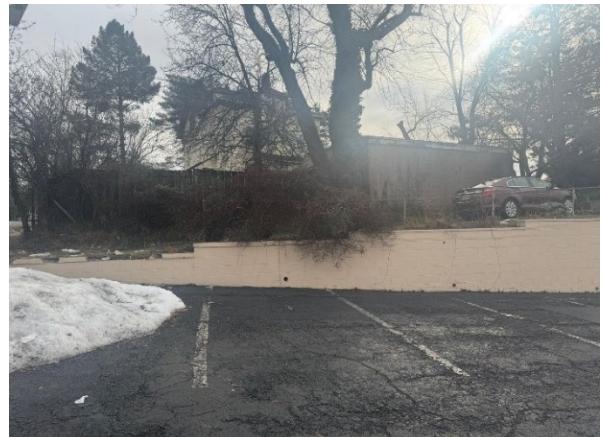
*Above: View of the retaining wall along the easterly property line. There is a lack of adequate buffer to the residential use abutting the property. The residential house is at a higher elevation than the parking lot.*

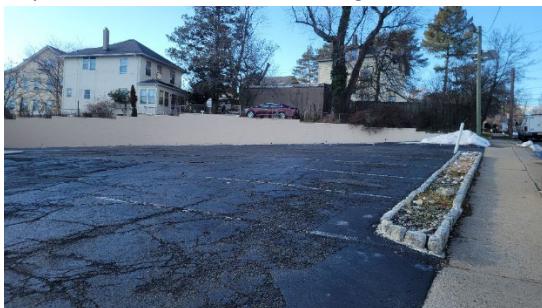
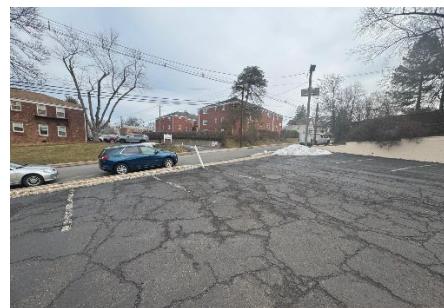
*Above Left: Rear Parking lot (northeasterly side of building). Also pictured are two points of ingress and egress onto Claremont Avenue. Parking lot has cracked asphalt and undefined parking spaces.*

*Above Right: Another view of the northeasterly side of the parking lot. The asphalt is cracked throughout the entirety of the lot, and the parking spaces lack stripping in some areas or have faded.*

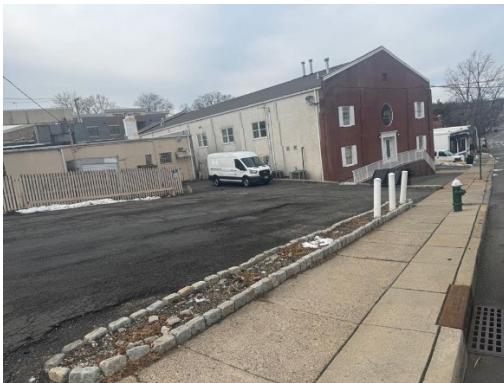
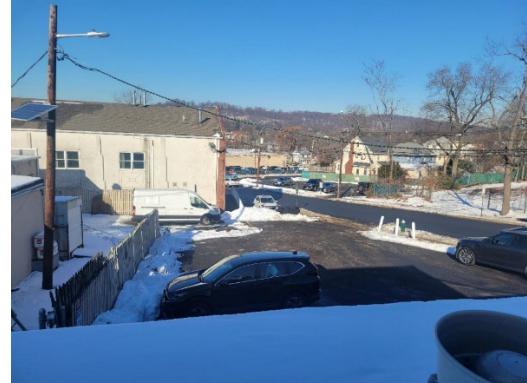
*Above Left: A view of northwesterly section of the parking lot.*

*Above Right: View of the northwesterly side of the rear parking area from the offices. Pictured are the two points of ingress and egress from Claremont Avenue. One entrance, to the right of the photo, is partially obscured by a vehicle and snowfall. The snow-covered structure is the top of the unenclosed roof over the outdoor storage area.*

As seen in the above pictures, the parking lot is ill maintained with potholes and lack of defined parking spaces.

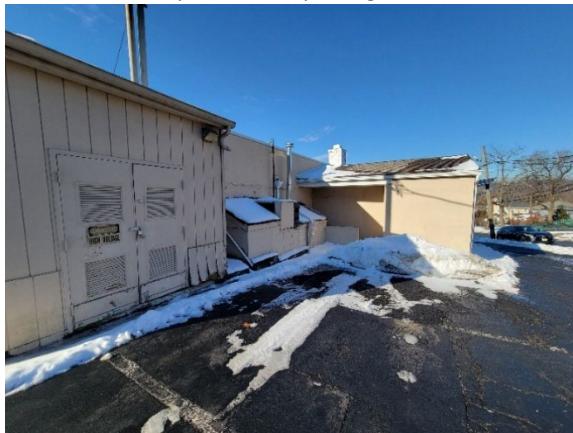
Above: View of the rear building facade. Pictured to the left is the utility shed containing high-voltage equipment and the narrow drive aisle connecting the two sides of the rear parking lot. Above right is another view of the building and the utility shed containing high-voltage equipment.

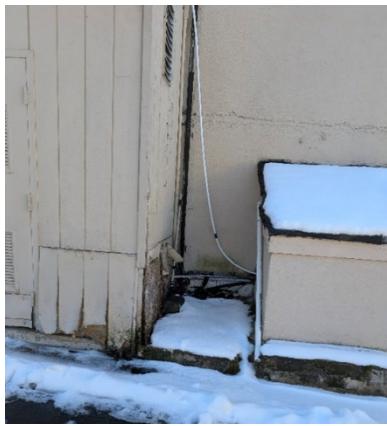
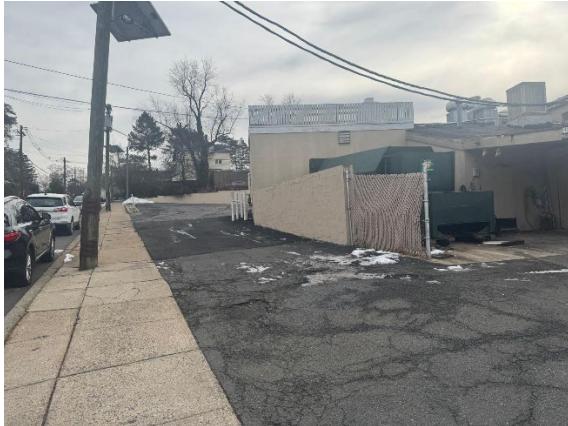
Above Left: A closeup view depicting the rotting wood and damage at the base of the utility shed storing the high voltage equipment.  
Above Right: A closeup view of the narrow drive-aisle that connects the two sections of the rear parking lot. The drive aisle exhibits significant wear and tear with large cracks and potholes. Also pictured is the fence-screening the trash compacter and outdoor storage/loading area from Claremont Avenue.

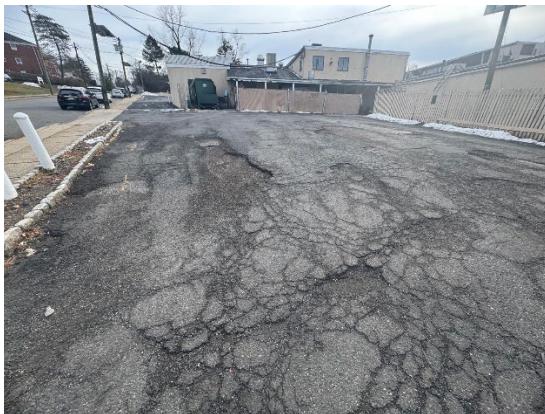
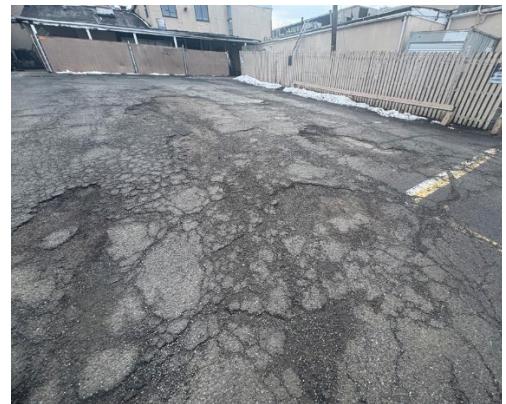
*Above Left and Right: Another view of the parking lot in the northwesterly section of the property. No clear signage for parking or loading areas is visible. The parking lot is in a state of disrepair.*

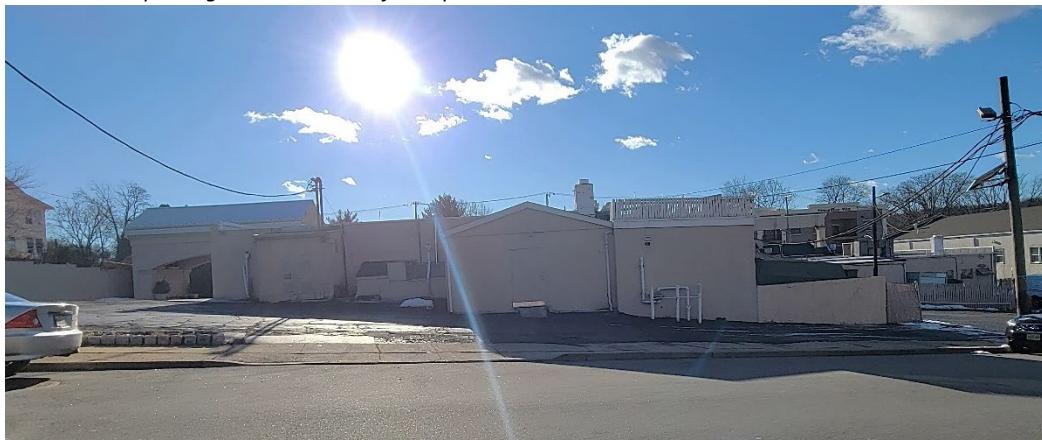
*Above: A view of the rear of the building from Claremont Avenue (northern façade). As seen above, a portion of the building projects into the rear parking lot, splitting the parking lot into two sections with a narrow drive aisle connecting the northeasterly and northwesterly sections of the parking lot.*

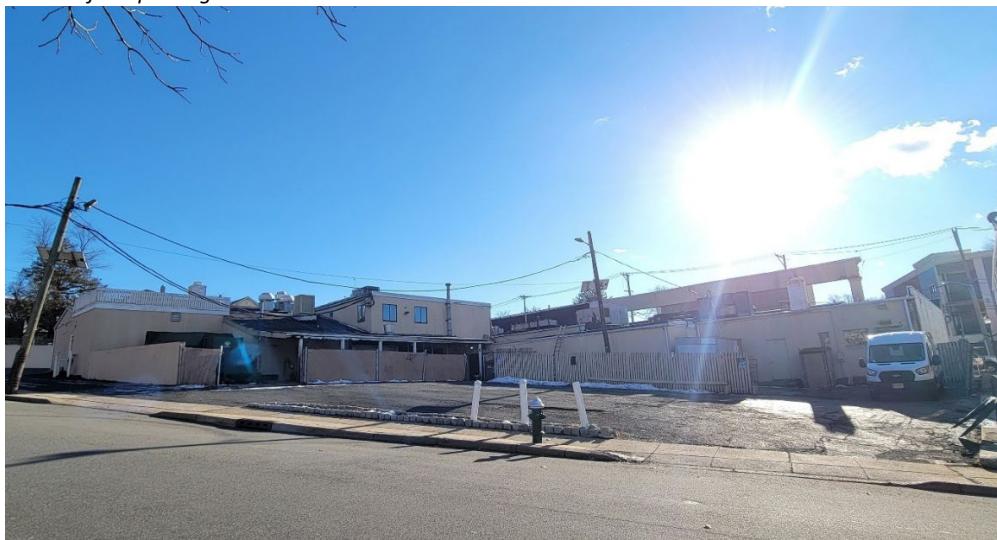
*Above: Another view of the northwesterly side of parking lot from Claremont Avenue. An outdoor trash compactor and storage/loading area against the building (left) is partially screened with a masonry wall and a chain link fence with privacy slats. A loading area and walkway (right) are screened by a fence. Also pictured are two of the four ingress and egress points along Claremont Avenue.*

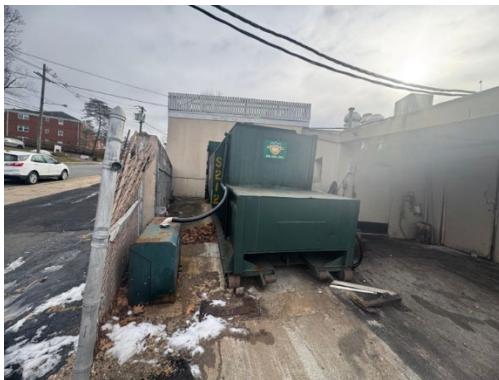
Above Left: Close up view of the trash compactor located behind the masonry wall & fence screening.

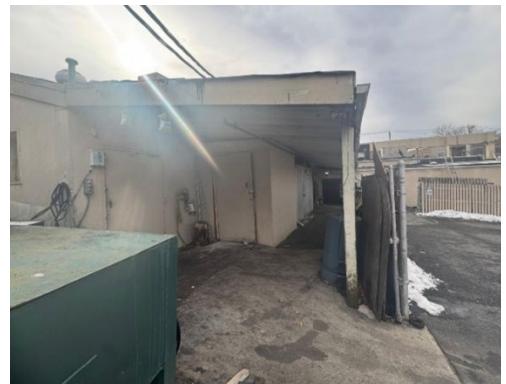
Above Right: View from the trash compactor looking in the southerly direction towards the area partially covered by an unenclosed roof. There is some screen by way of a six-foot chain-link fence with slats as seen in the photographs below.

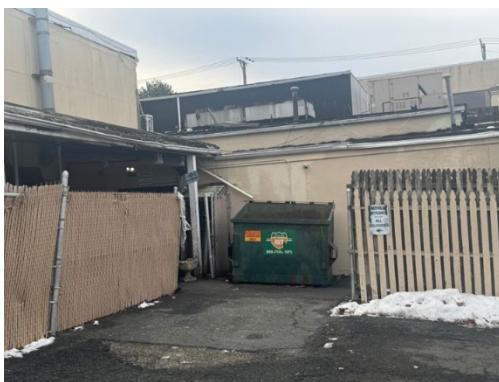
Above Left: View of the unenclosed roofed patio with fencing. Trash receptacles are in the open without screening.

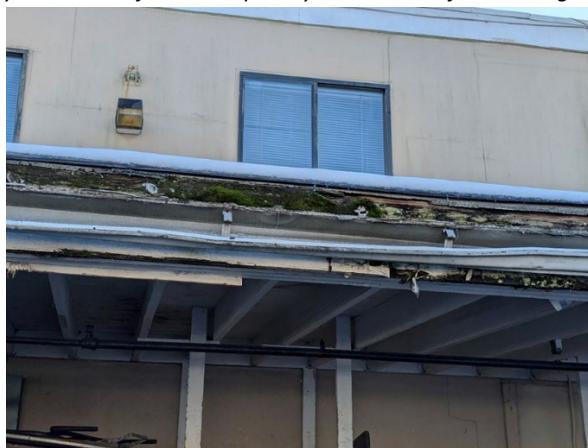
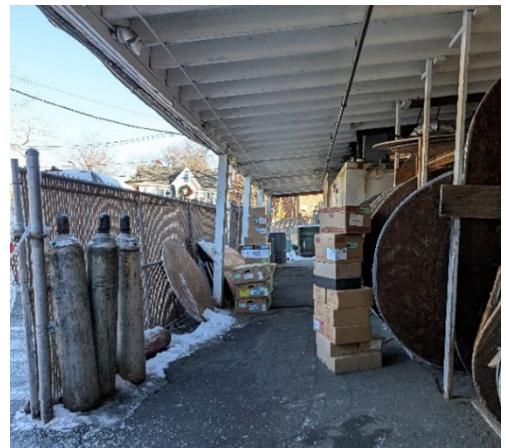
Above Left: Close-up view of the roof above the storage and loading area. There is missing siding, and the gutters are partially detached.

Above Right: View of the rear outdoor storage area under the unenclosed roof and behind the fence. Discarded items and boxes are piled up to the roof, obstructing the walkway leading to the trash compactor and exterior.

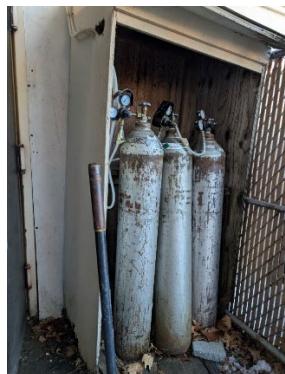
*Above Left: View of carbon dioxide cannisters stored near the service entrance to the rear of the building.*

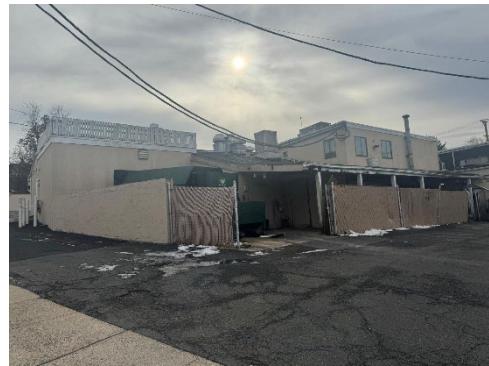
*Above Middle: Another view of the northwesterly section of parking lot showing the storage areas to the northwest of the building.*

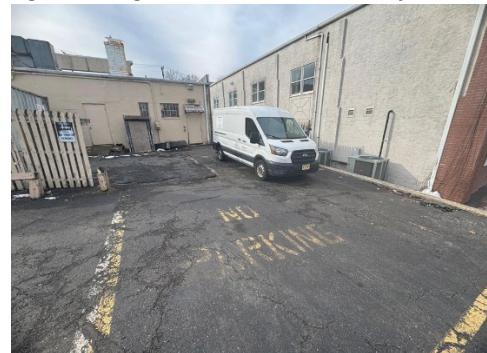
*Above Right: Another close-up view of the loading area and service entrances in northwesterly section of parking lot. The catering van is parked in the no parking area.*

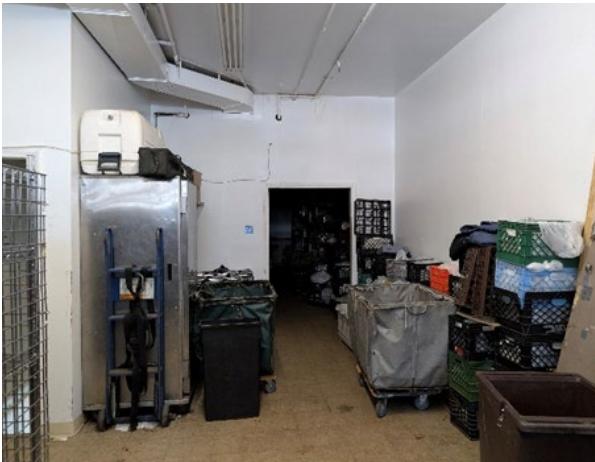
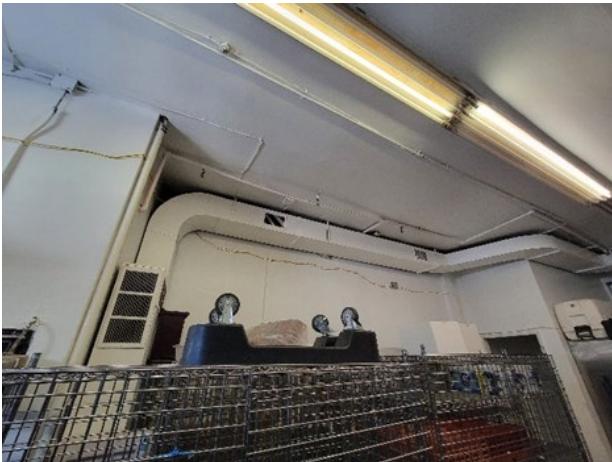
*Above: View (left and right) of an interior storage area, located on the ground floor towards the rear of the building. According to the property owner, items in this storage area are still used by staff.*

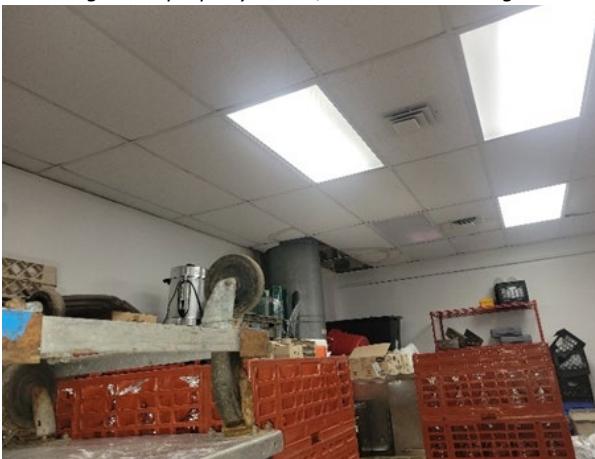
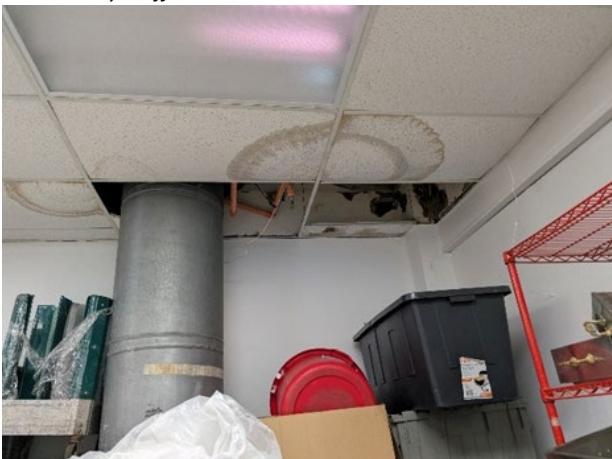
*Above Left: Another view of ground floor storage area. Above Right: A closeup view of the ceiling in the ground floor storage area with missing tiles. Water stains show water damage probably from roof leakage.*

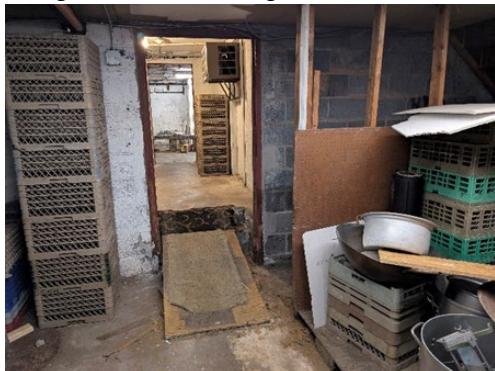
*View of the doorway connecting the ground floor storage area to the basement storage area.*

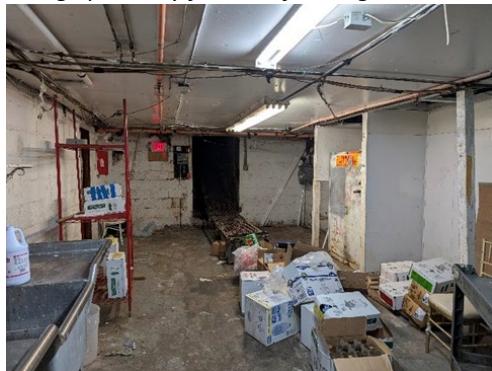
*View of the basement storage area.*

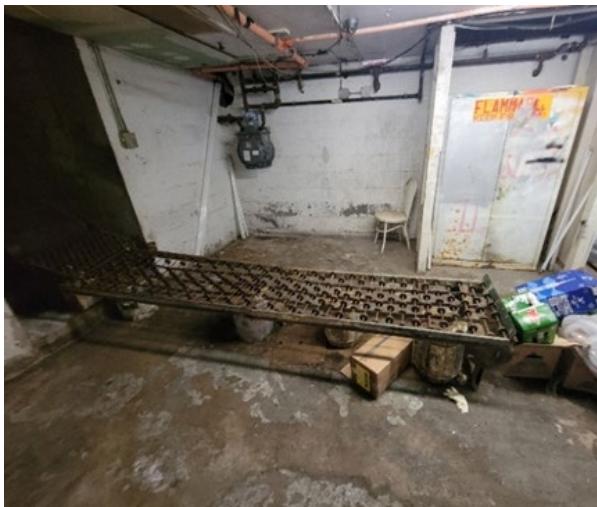
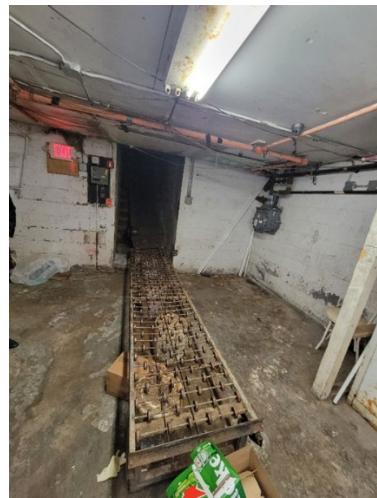
Left: View of the basement loading area. An old skate-wheel conveyor resting on buckets, is used to bring items indoors from a stairway that leads outside, to the rear of the building. There is wear and tear to the floors and to the cabinet used to store flammable items.

Right: A close-up of the loading area in the basement.

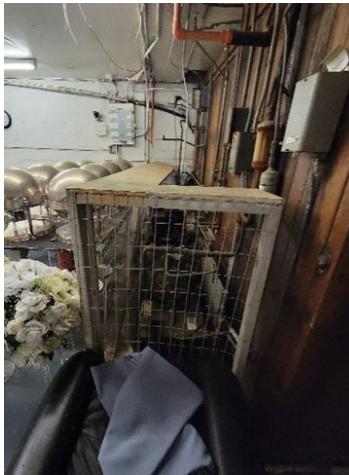
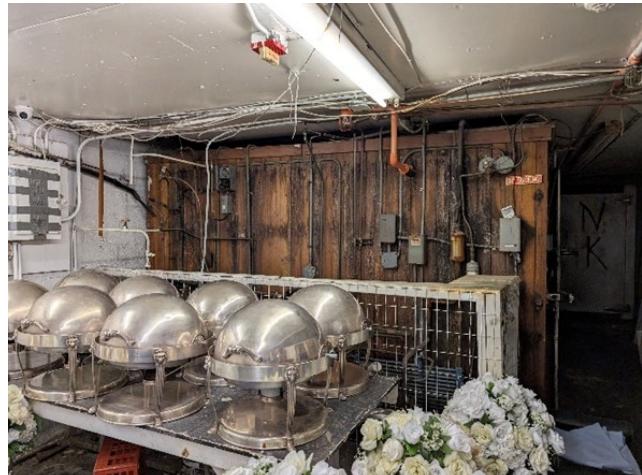
View of a built-in freezer from the 1960s (left) and close-up view of its motor (right). Property owner informed H2M that this freezer is no longer functional and is used for storage (bottom left). Also pictured (bottom right), in the hallway in this part of the basement where there are two more non-functional freezer/refrigerators that are currently used for beverage storage.

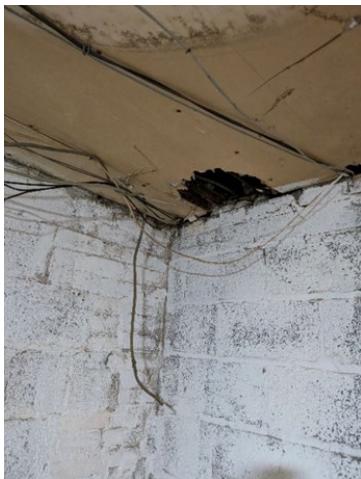
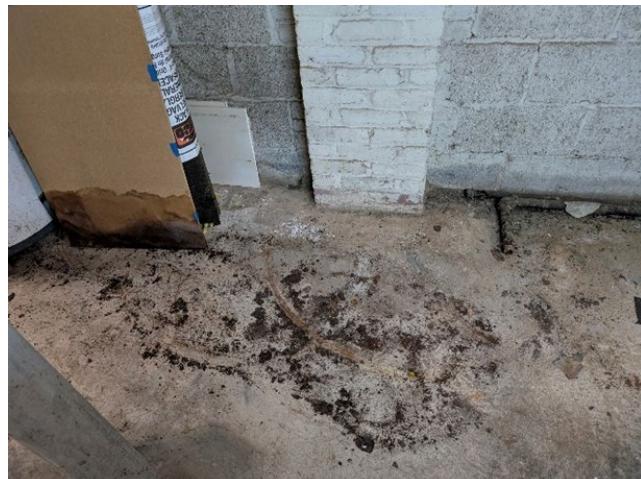
Above Left: View of rough, patchwork repair on the ceiling in the basement. Above Right: In addition to a large hole and exposed wiring, this area exhibits staining and possible mold from water infiltration. Also pictured (below left), in a separate area within the basement, water stains along at the base of the walls which are indicative of water infiltration.

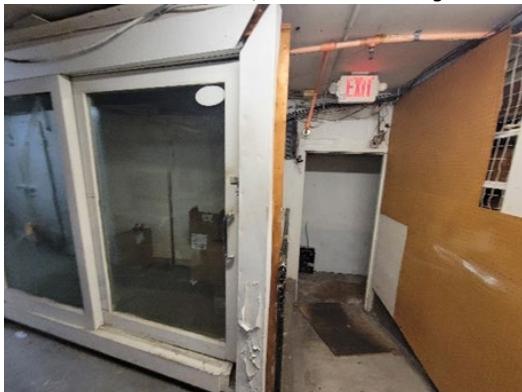
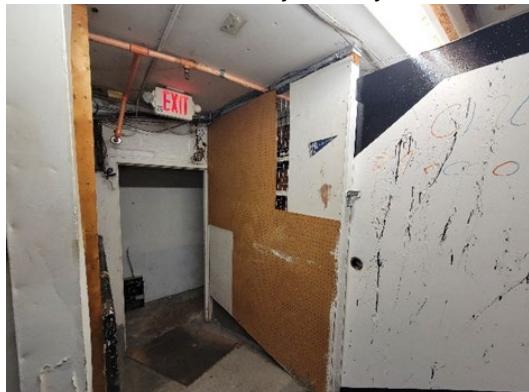
Above left: View of a non-functional freezer (left) in basement and a hallway leading to a service entrance to an upstairs ballroom. As per the property owner, this service entrance is not being used.

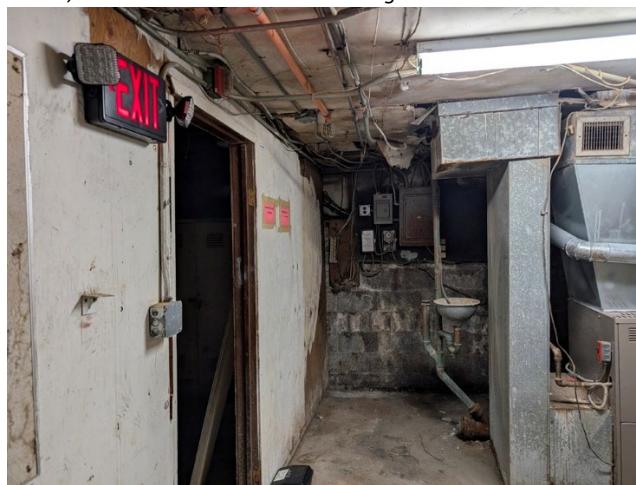
Pictured above is the entrance to a storage room in the basement. Peeling and warped ceiling tiles, water staining, exposed wiring, and aging plumbing indicate obsolescence and lack of maintenance.

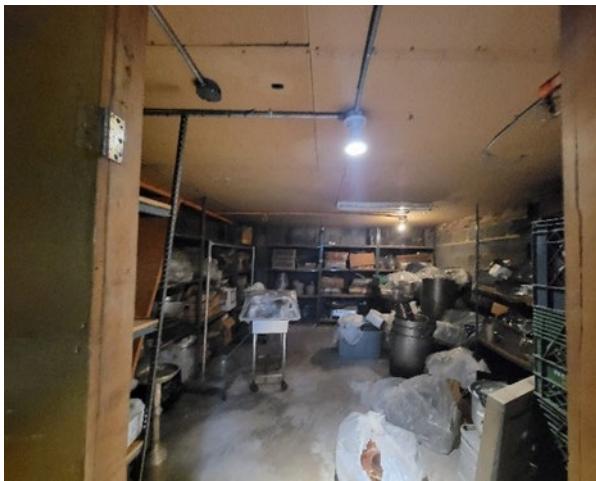
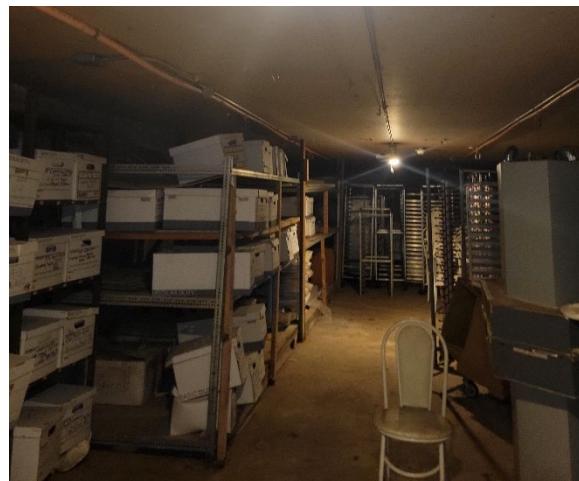
*View of separate storage rooms in the basement (above left and above right). As per the property owner, the storage rooms are for old, discarded items. Old equipment and other items are also being stored in hallways (below left and below right).*

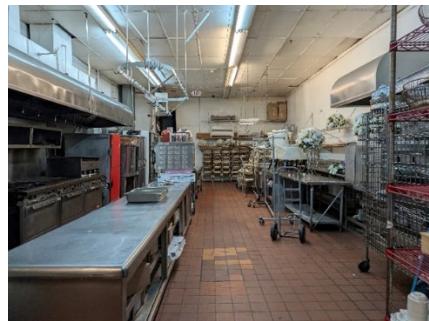
*Above Left: View of the basement floor. The gap between the foundation and concrete floor in this area is filled with stones and dirt.*

*Above Right: A view of the basement kitchen. Although the equipment and working areas are in good condition, there is evidence of a lack of maintenance and wear and tear, particularly with the floors and ceiling.*

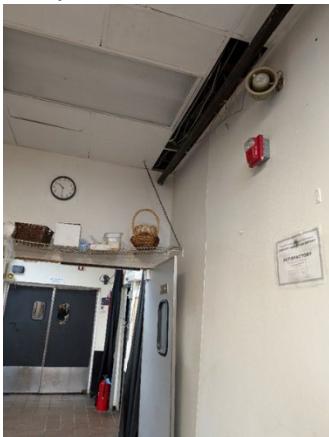
*A view of the entrance to the kitchen is pictured above. Ceiling tiles are missing and show exposed wiring.*

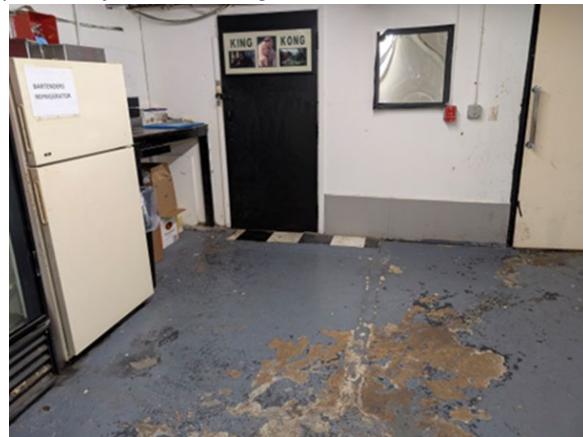
*A view of the kitchen space with bartender's refrigerator exhibiting wear and tear on the concrete flooring.*

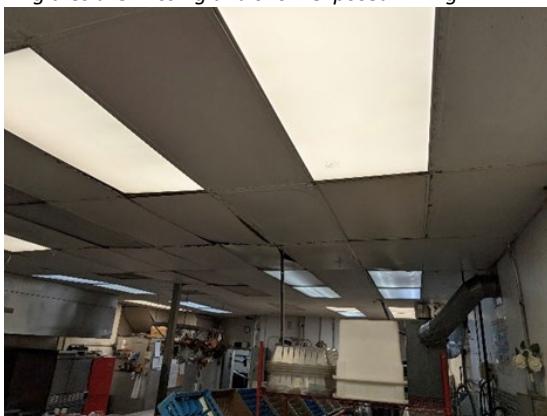
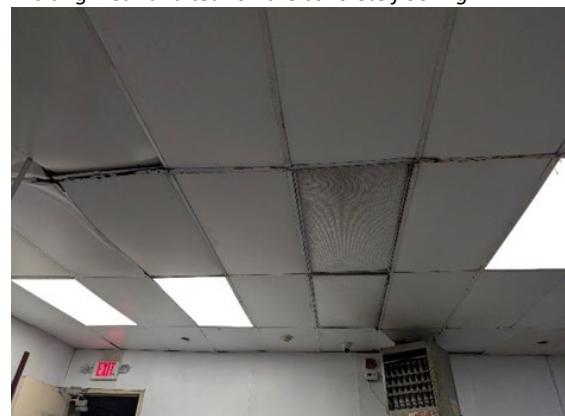
*A close-up view of the water damaged, warped ceiling tiles in the kitchen.*

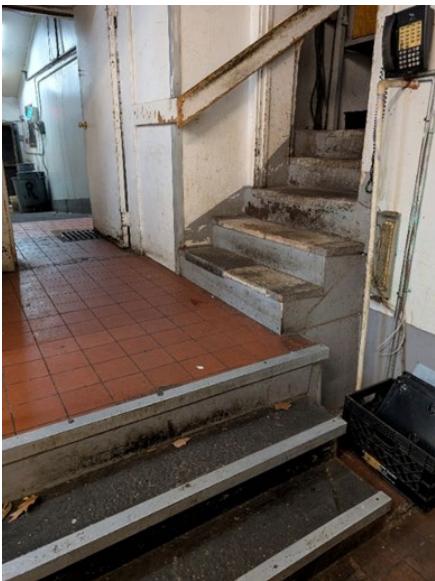
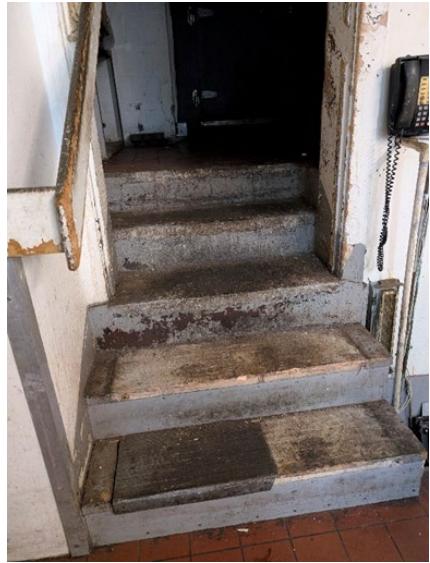
*A view of the staircase leading from the kitchen to the upper level. Stairs are missing tiles and show significant wear and tear.*

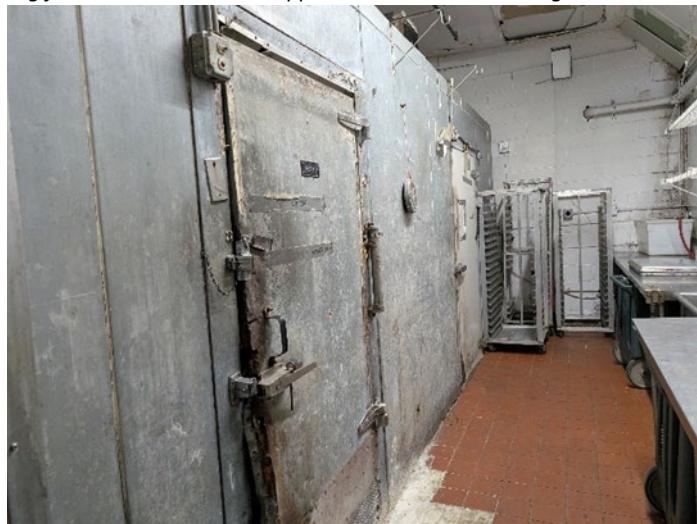
*A view of a non-functional built-in deep freezer within the kitchen. The floor around the freezer has missing tiles.*

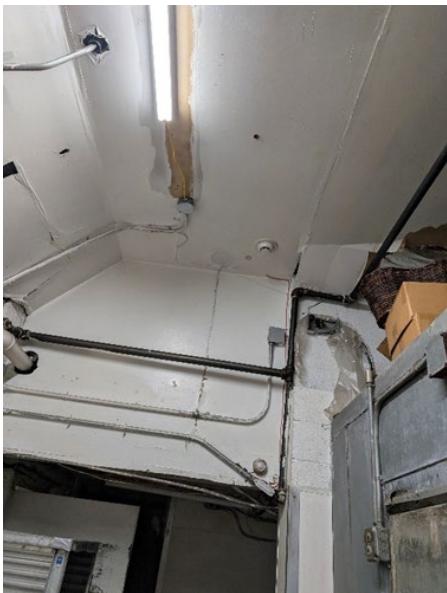
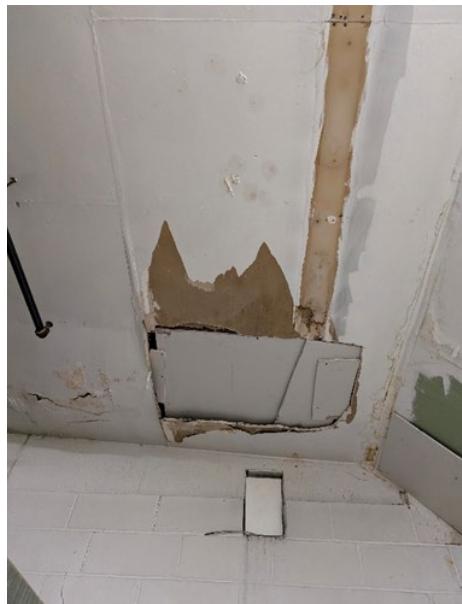
*A view of the ceiling above the non-functional freezer pictured above. A hole in the ceiling is covered by a make-shift patch.*

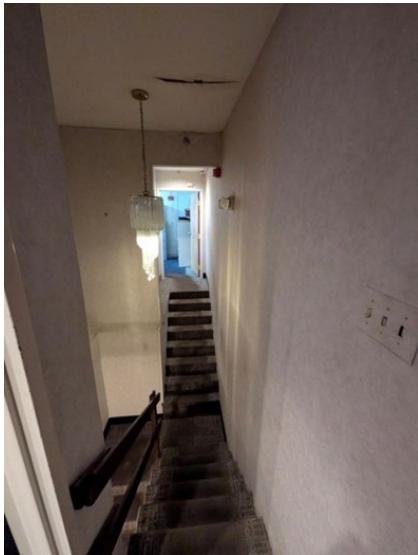
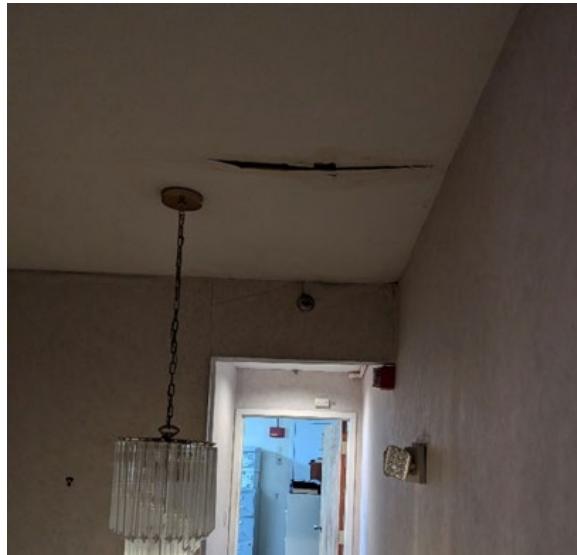
*A view of the stairway leading from the ballrooms on the ground floor to the offices at the upper level (left). A close-up view of the water damage from the leaking roof can be seen (right).*

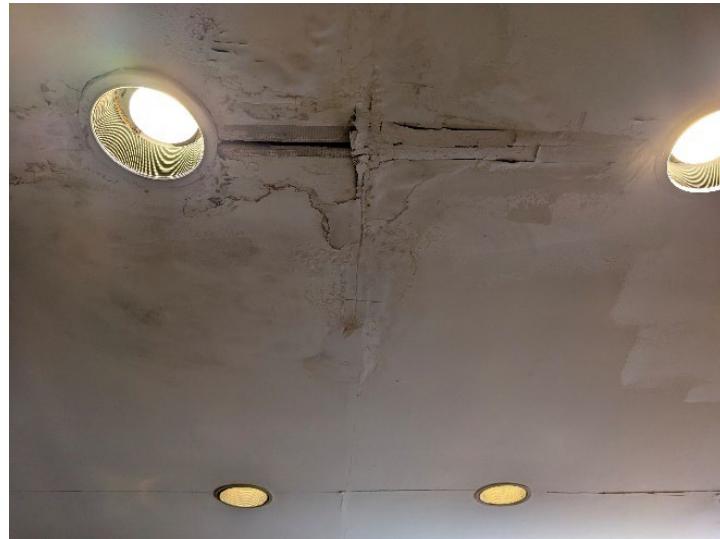
*Water damage from the leaking roof is more evident in the offices that are on the upper floor. Seen above is water damage and warped ceiling tiles in the main office.*

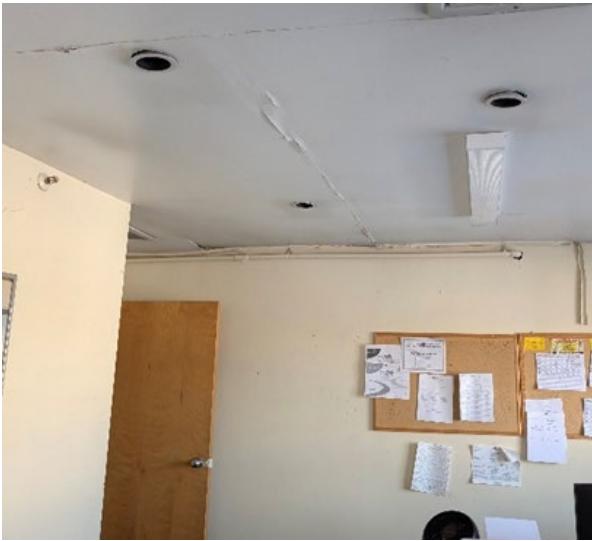
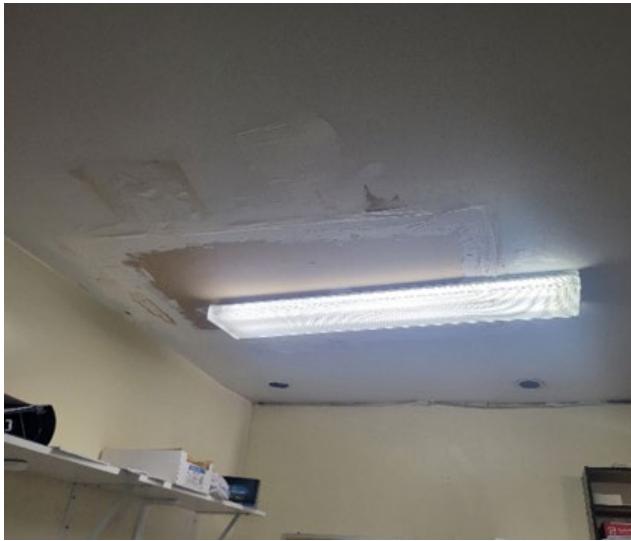
*A view of warped drop ceiling tiles in an office (left). Another office space with patched ceiling and water stains from roof leaks (right).*

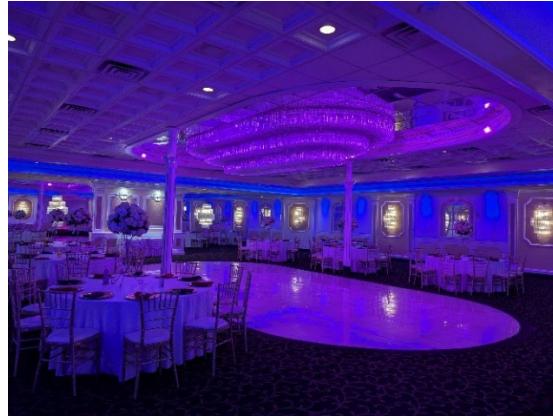
View of "Gold Room" ballroom with decorative lighting. Although room appears to be in good condition, water damage and wear and tear are apparent upon close inspection.

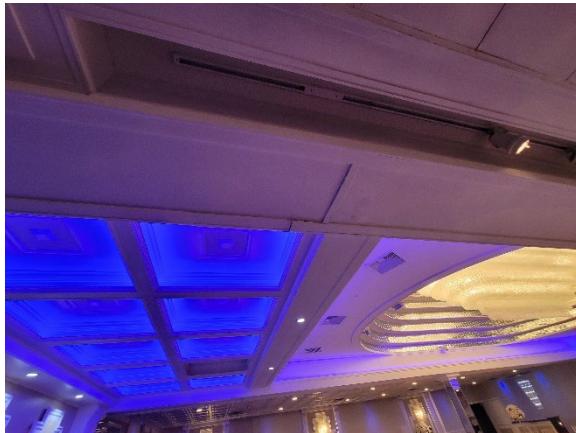
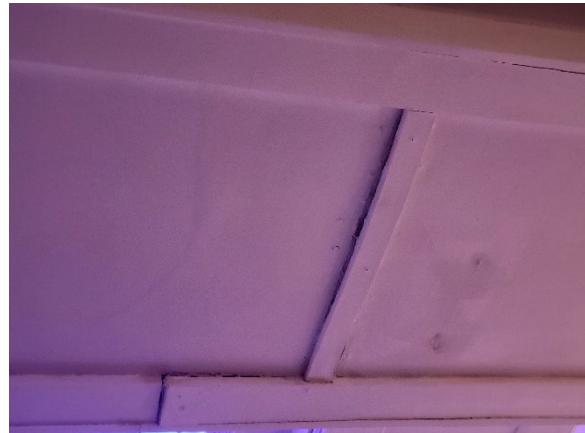
Above Left: View of the ceiling. Above Right: Closeup view of the ceiling in Gold Room where water damage from roof leakage has been patched and painted over.

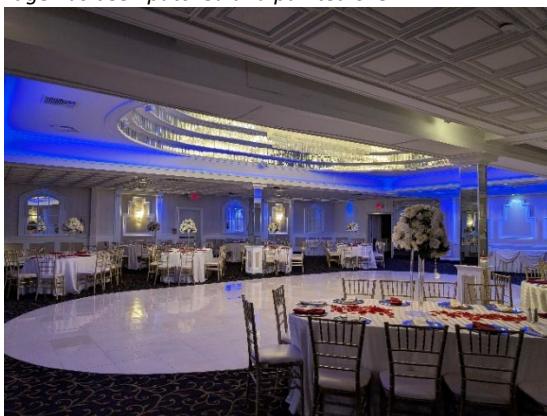
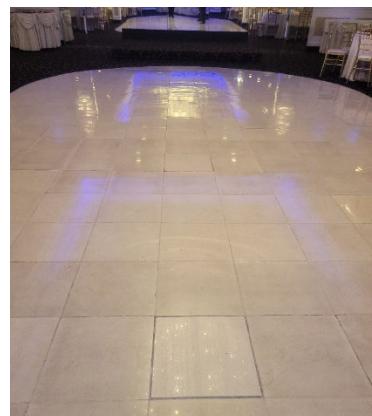
View of the "Regency Room" ballroom with decorative lighting (left). Like the Gold Room, the room appears to be well maintained but exhibits water damage and wear and tear that is apparent upon close inspection. Pictured above (right) are the room's uneven dance floor tiles.

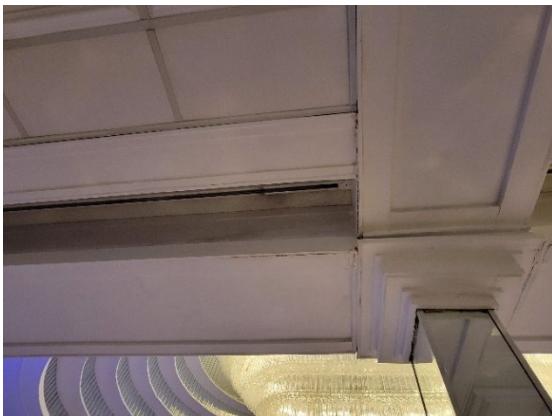
*A view of the ceiling and pillar in Regency Room showing warping and water damage from roof leaks that have been painted over to hide it.*

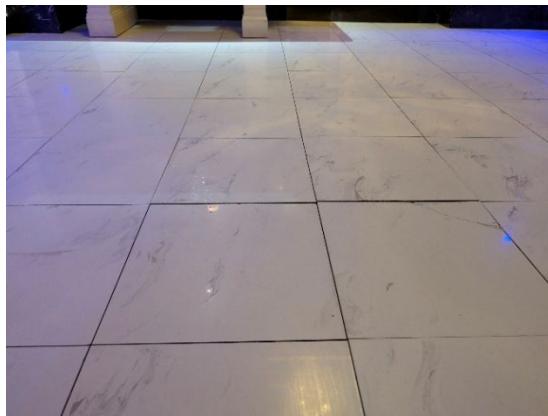
*View of the lounge on lower level (below ballrooms). As reported by the property owner, the uneven tiles are due to uplift from water infiltration and frequent repairs.*

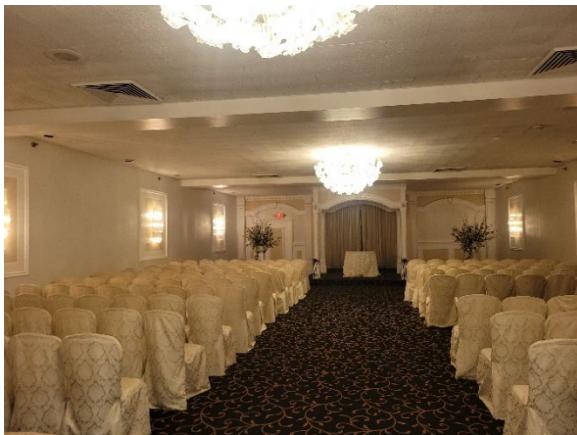
*View of chapel room with dated décor and wall to wall carpeting.*

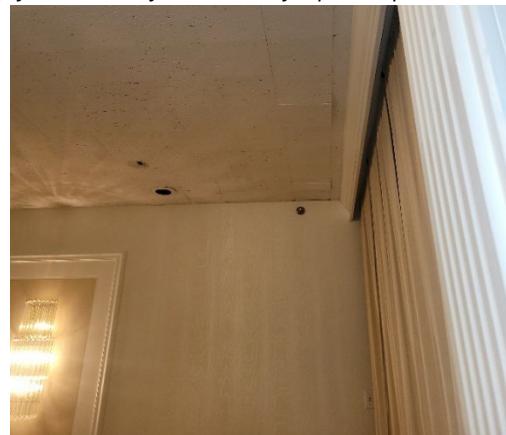
*A closeup of the warped drop ceiling tile in the chapel on ground floor of building. Although frequently patched, as per the property owner, water infiltration is also an issue in this room.*
