PUBLIC SAFETY COMPLEX COUNCIL MEETING

PUBLIC SAFETY COMPLEX - CONCEPT

POLICE DEPARTMENT, FIRE DEPARTMENT - CO. #2, RESCUE SQUAD

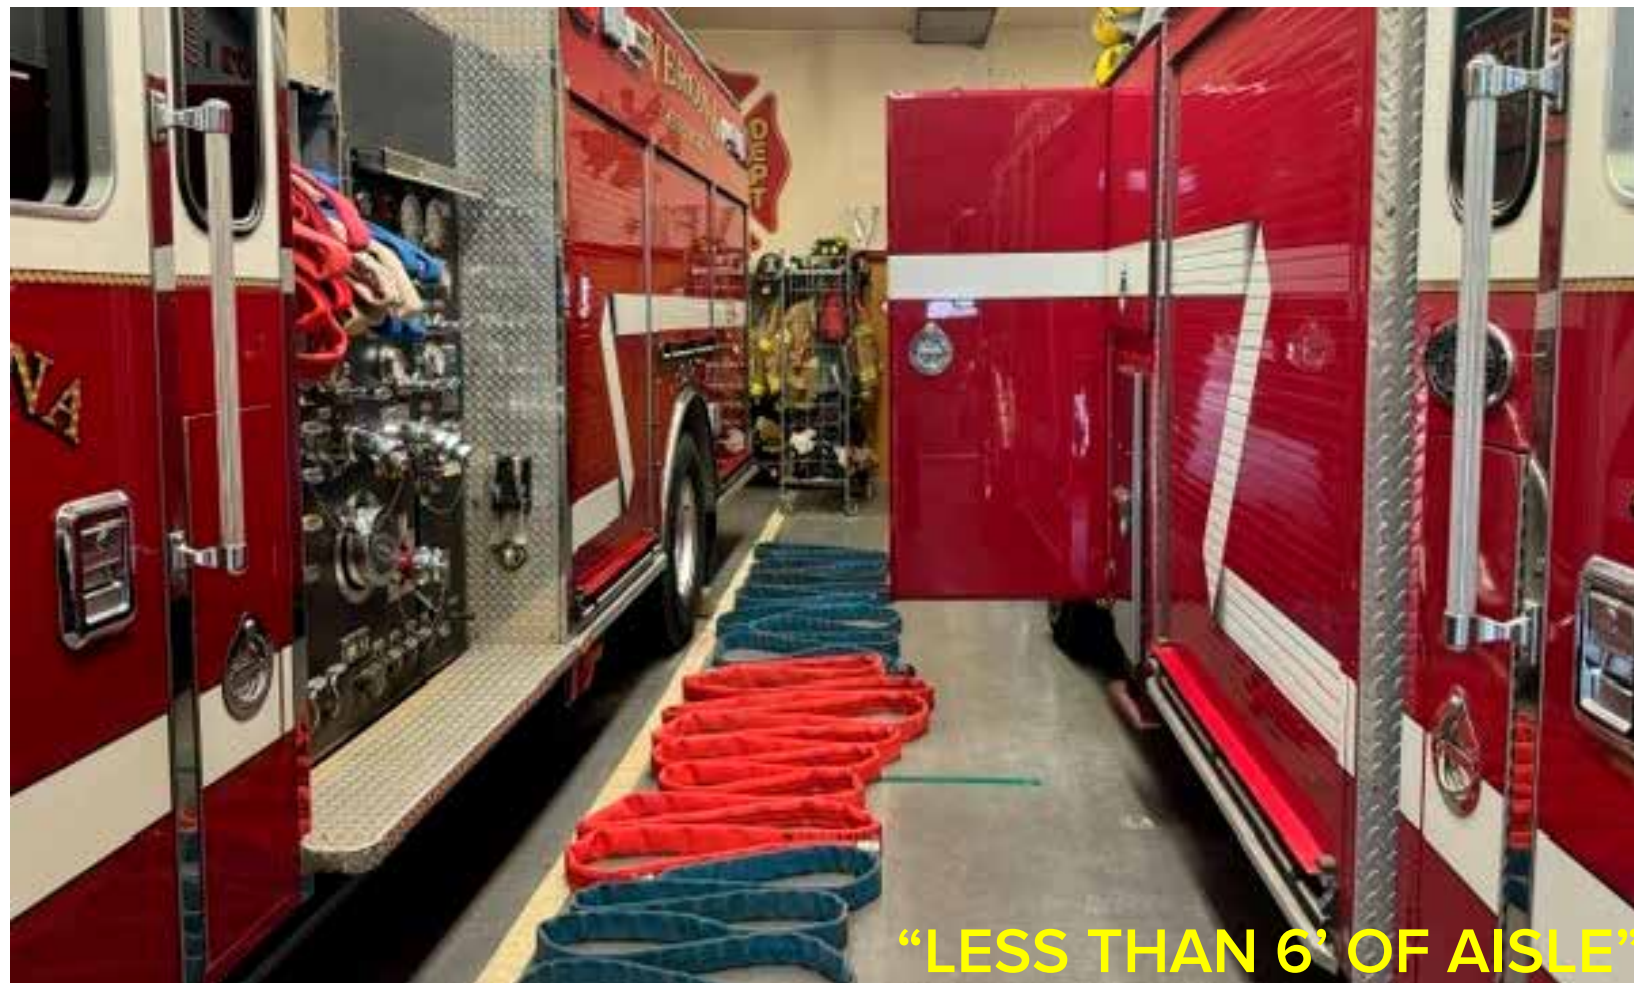
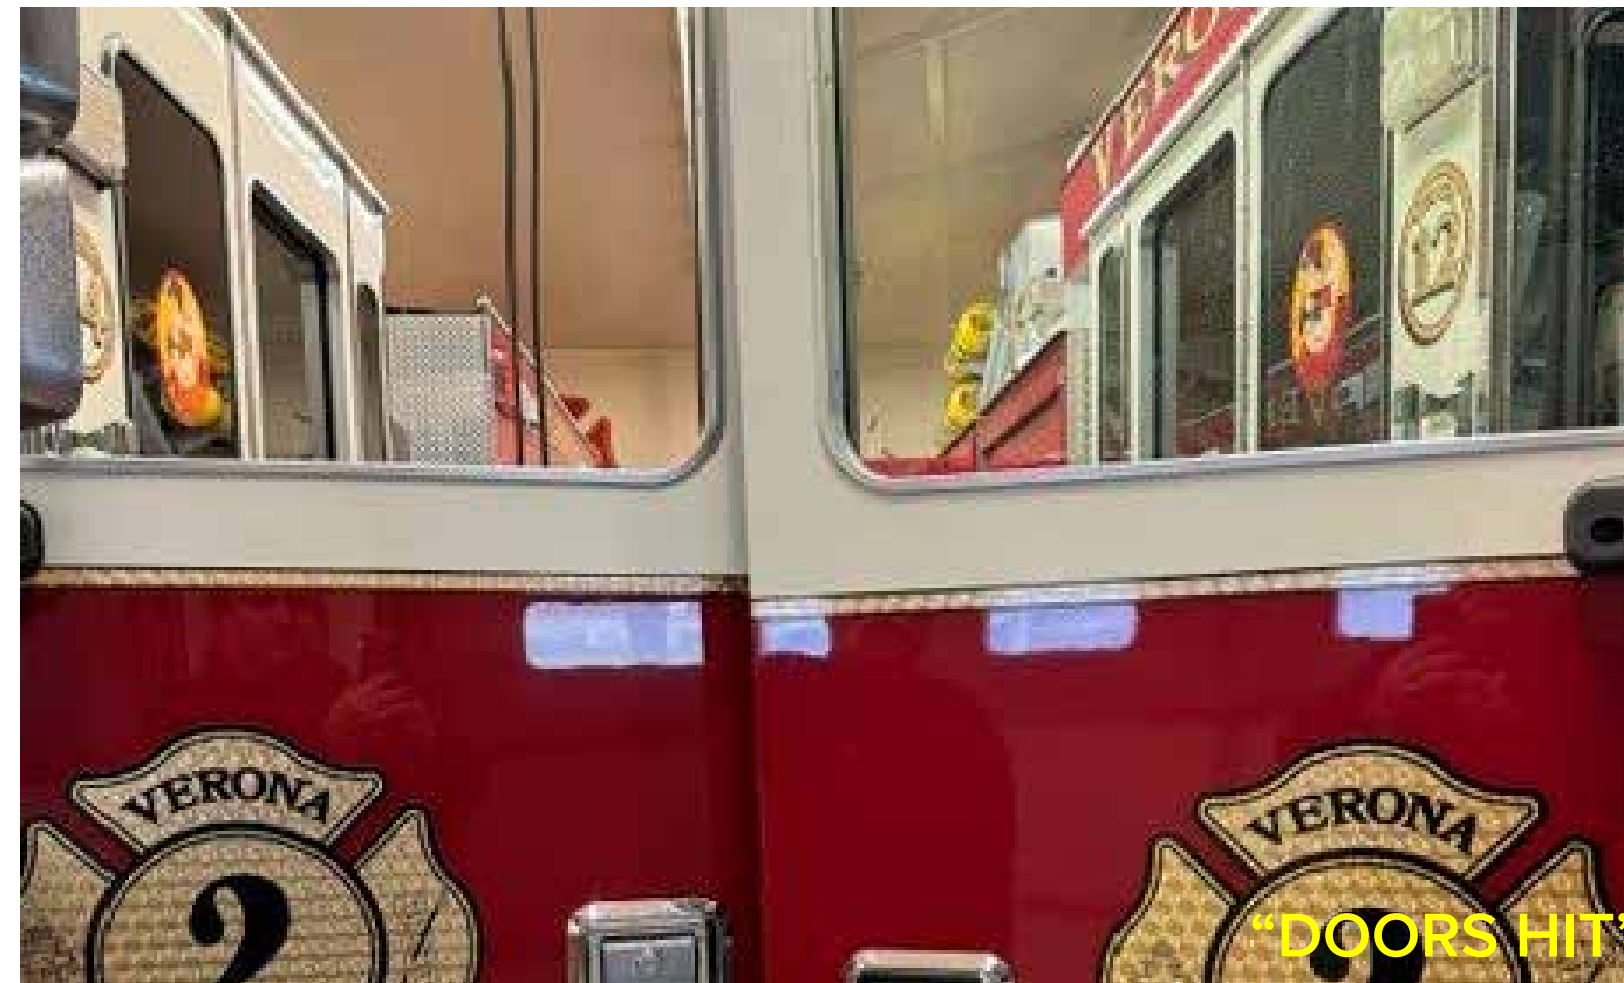
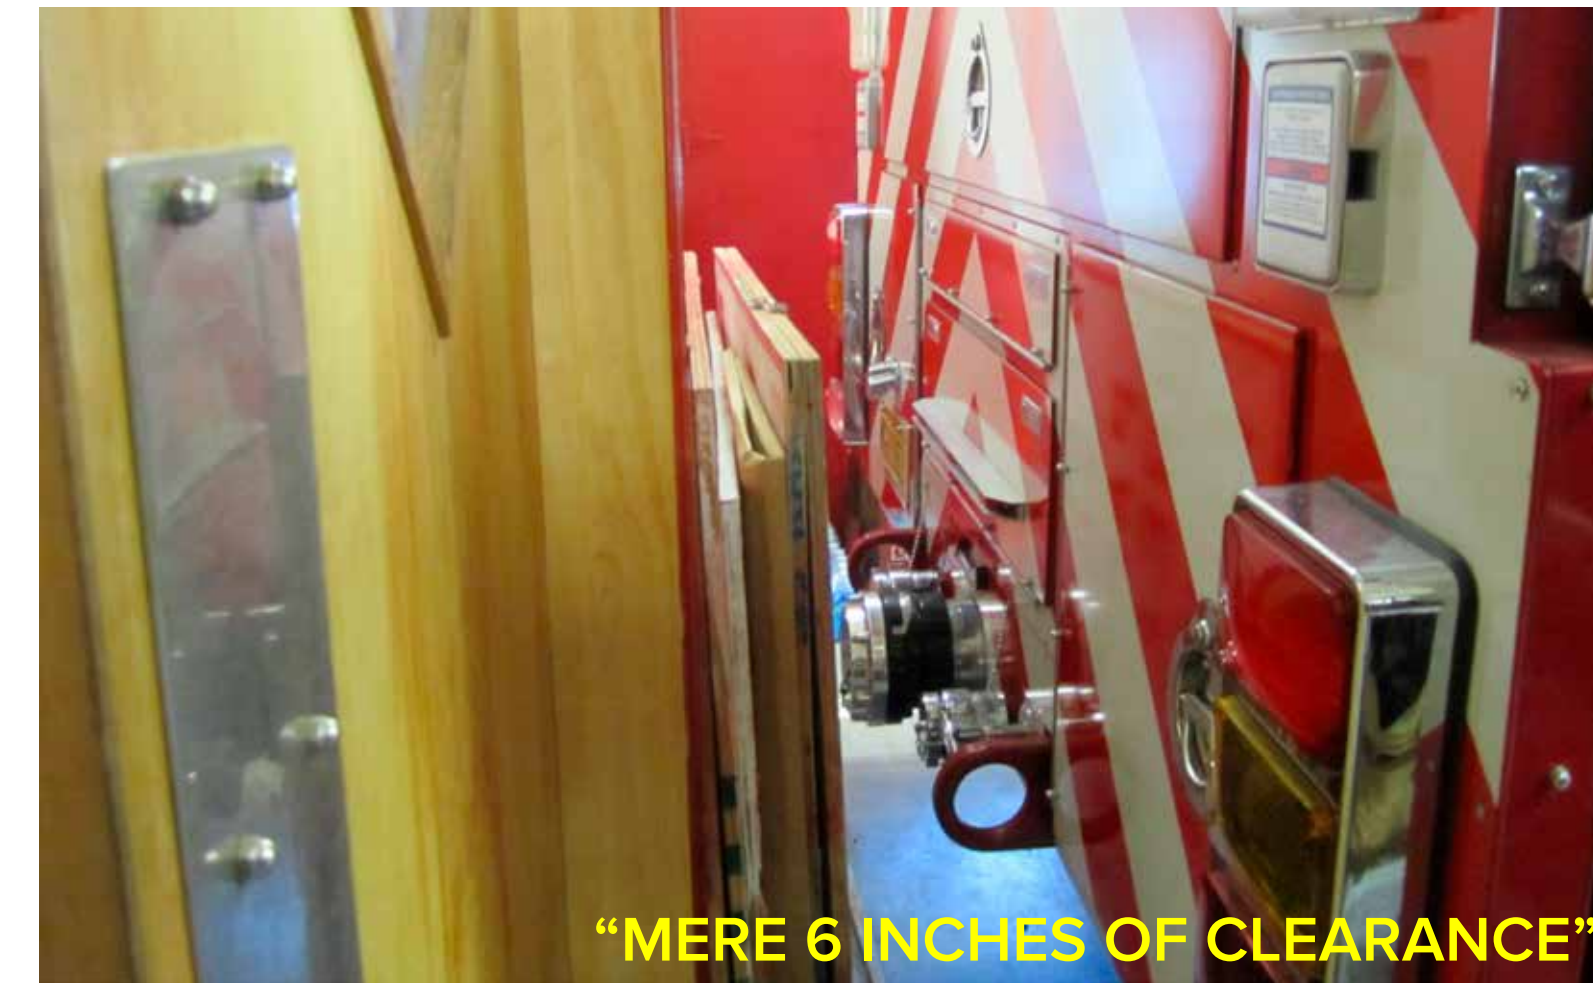
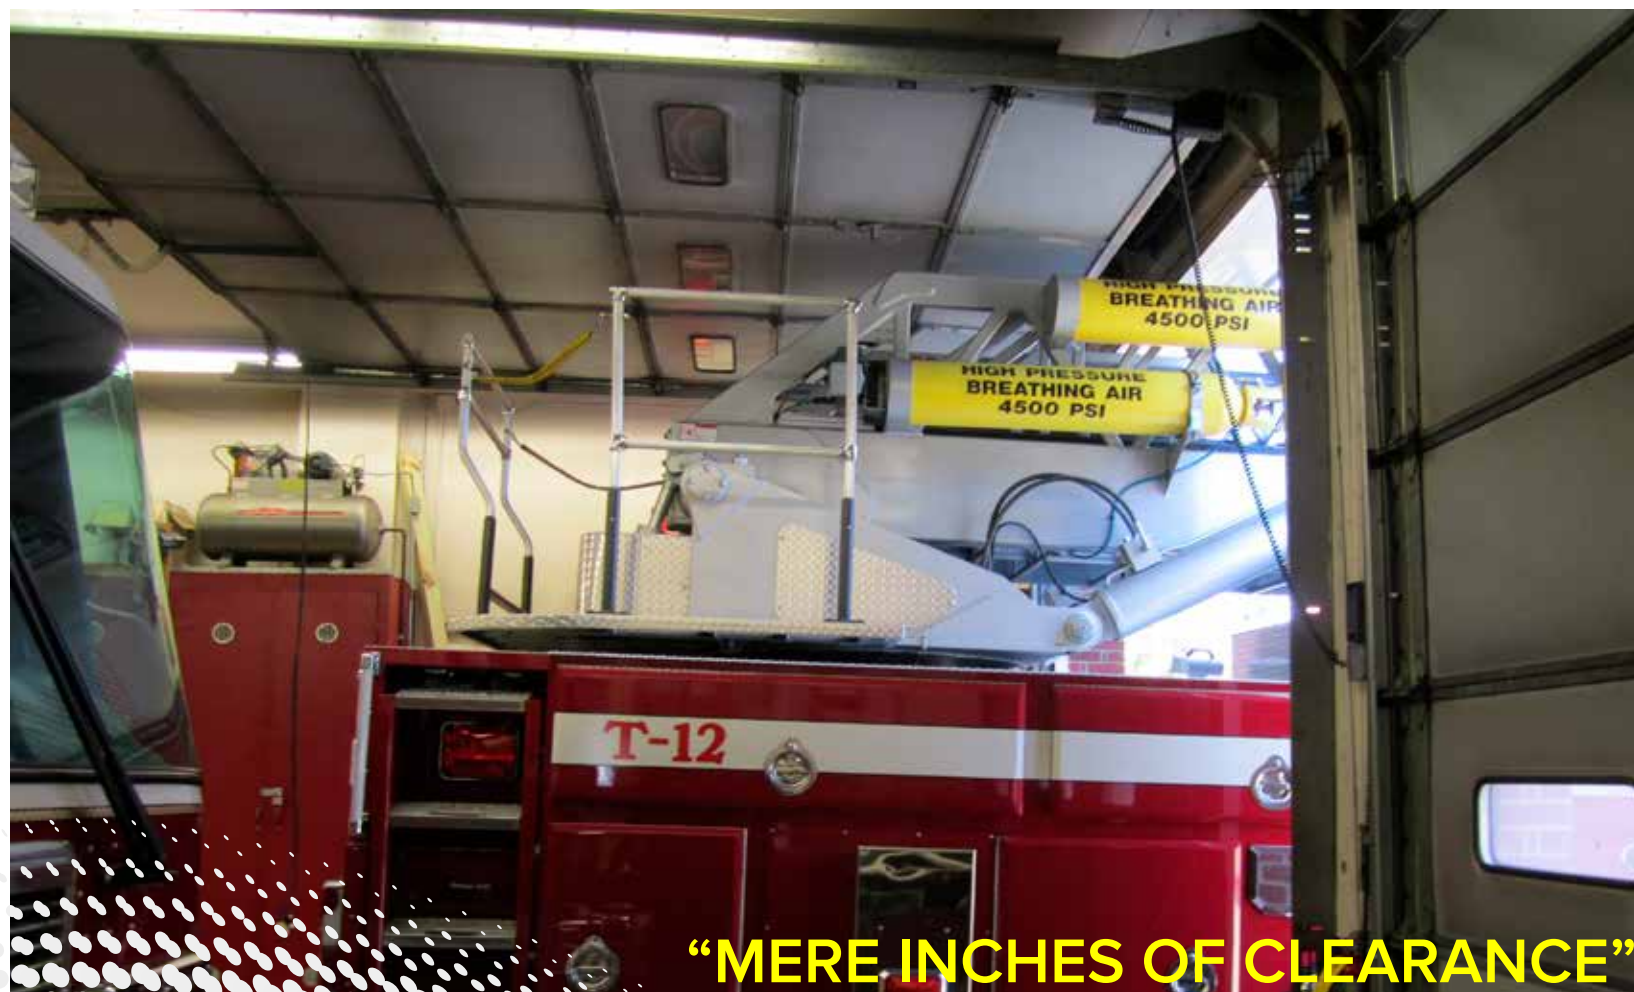
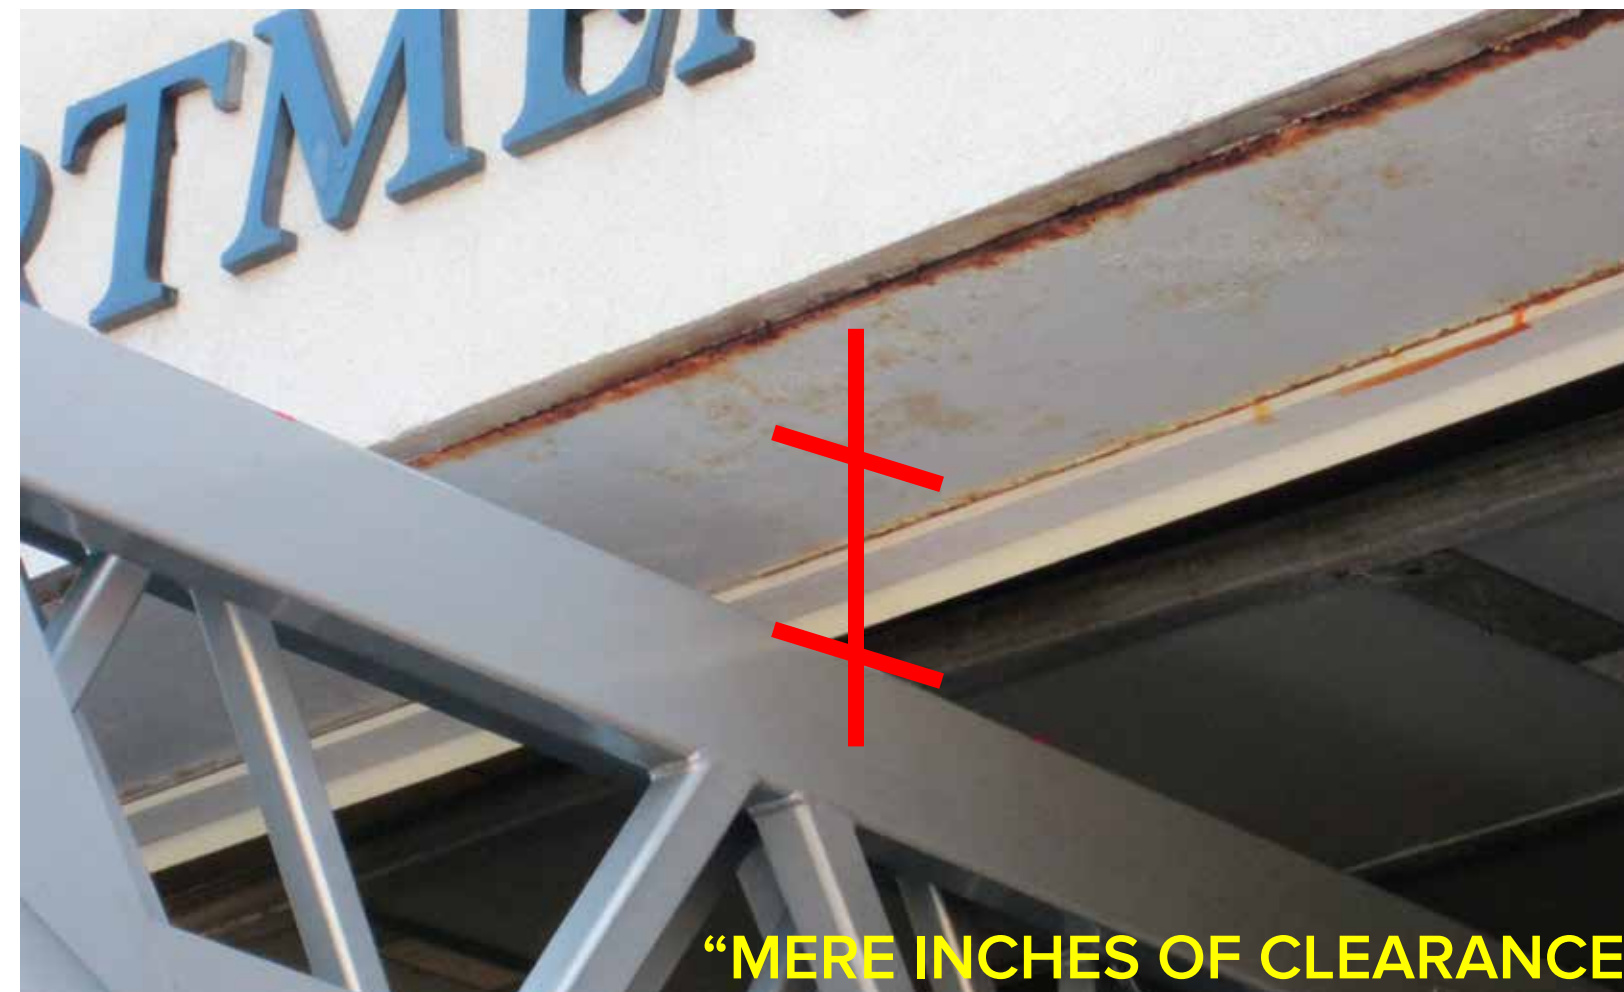
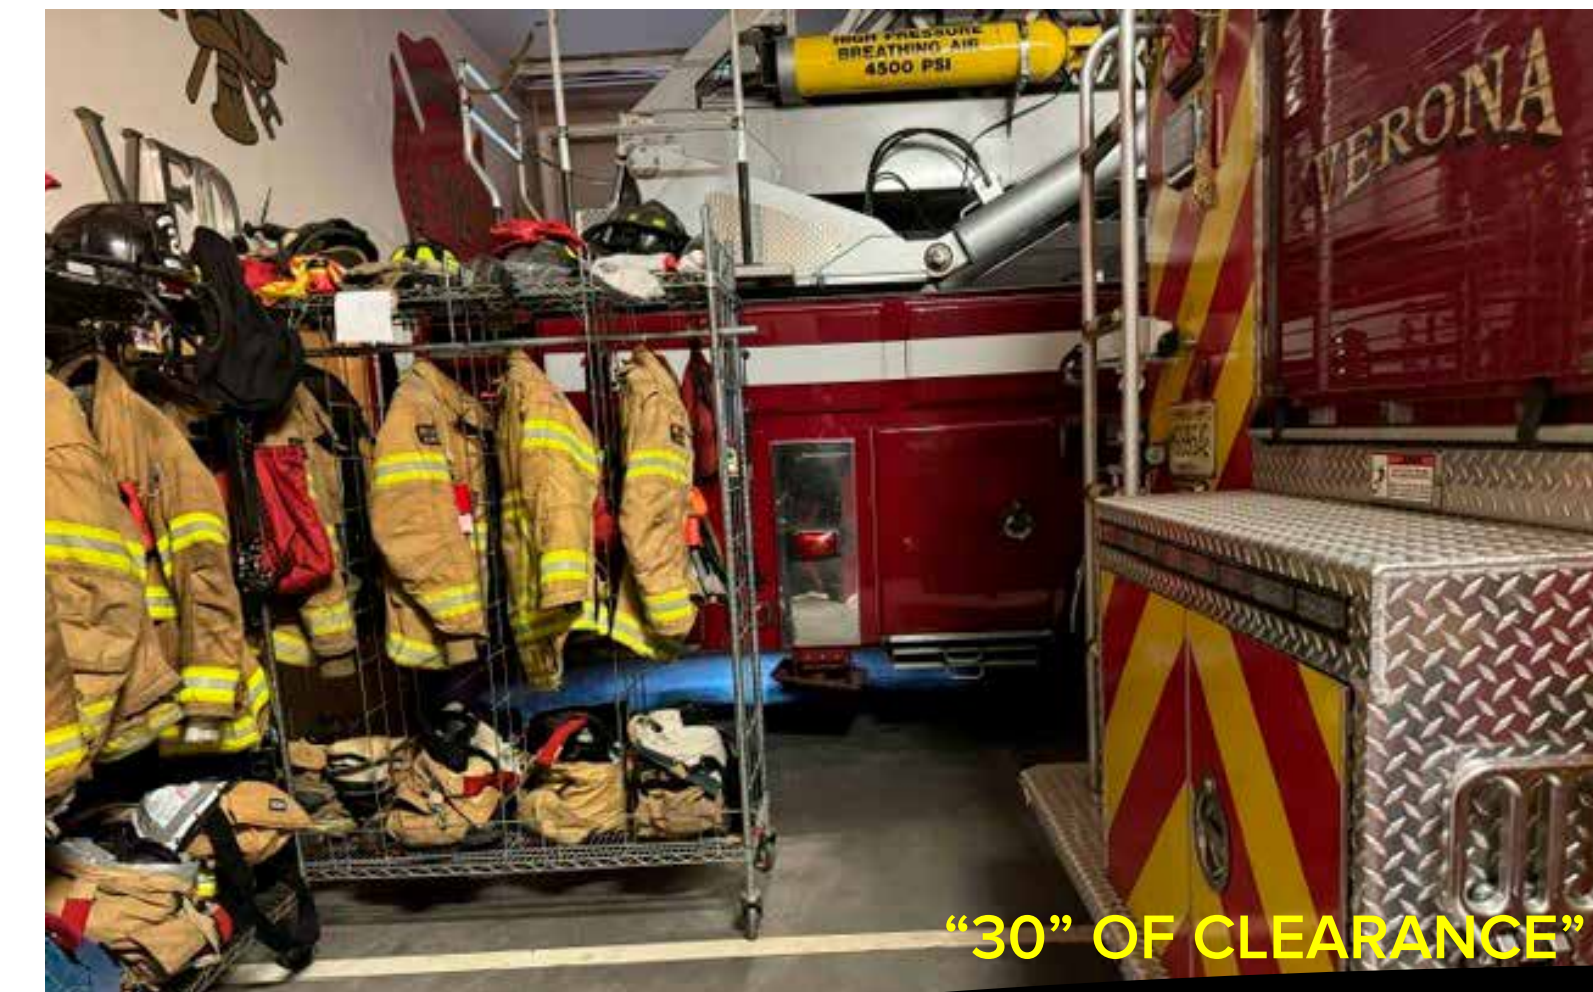
EXISTING CLEARANCES

- » Building is 74 years old and is NOT OSHA compliant with present day standards:
 - » Apparatus bay is 50' - Ladder Truck is 48' and the platform on the ladder must have 1.5' clearance from the garage doors, leaving 6" from wall of the bay.
 - » There is no room for gear racks behind the ladder truck, all the gear racks are on the driver's side wall creating a safety issue when four or five members are donning the gear necessary to respond to a fire call.
 - » Overhead doors are only 12' high resulting in minimal clearance for certain apparatus.
 - » There are inadequate parking spaces. The company may have as many as 28 members and there are only 11 parking spaces.

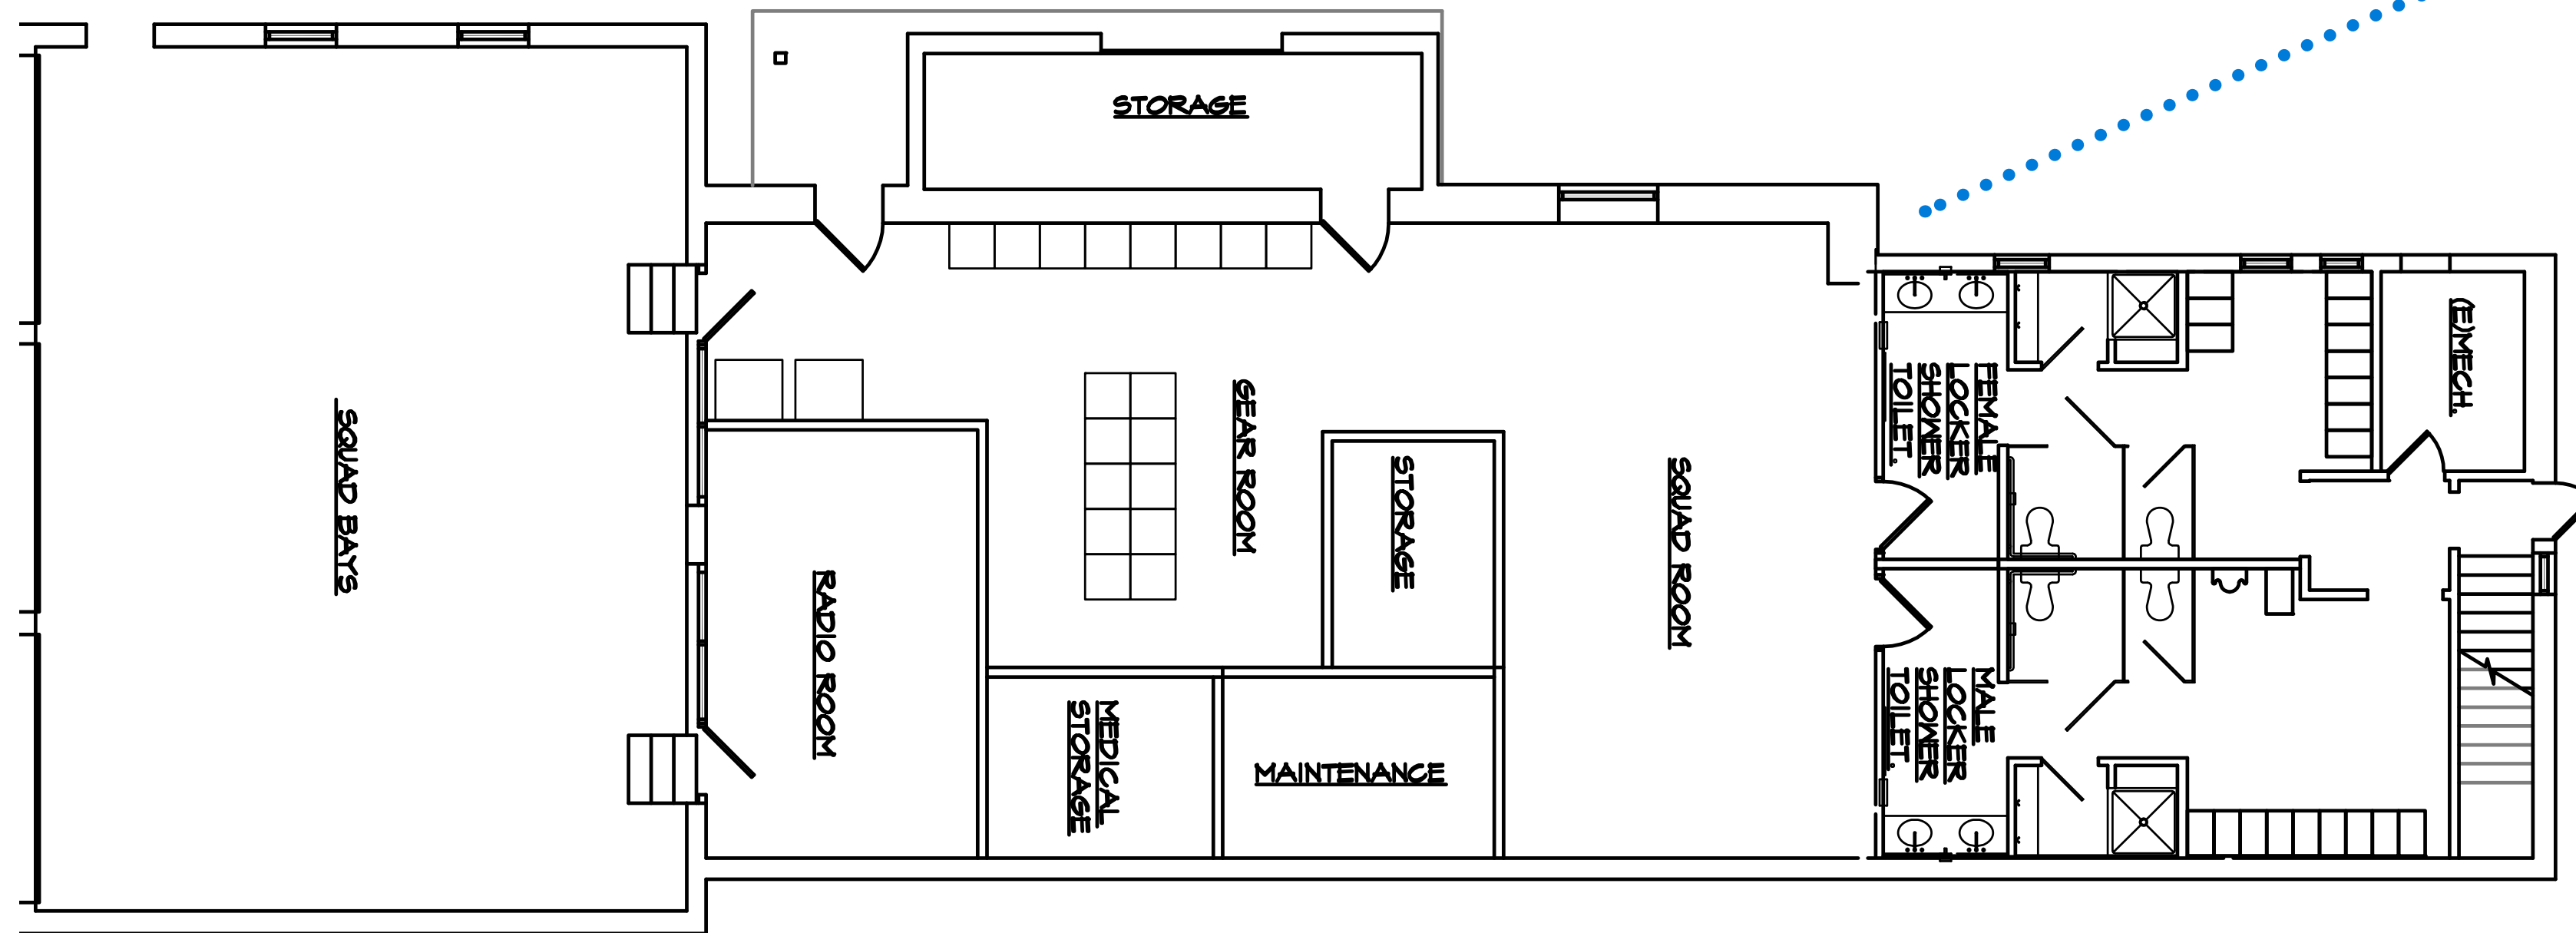
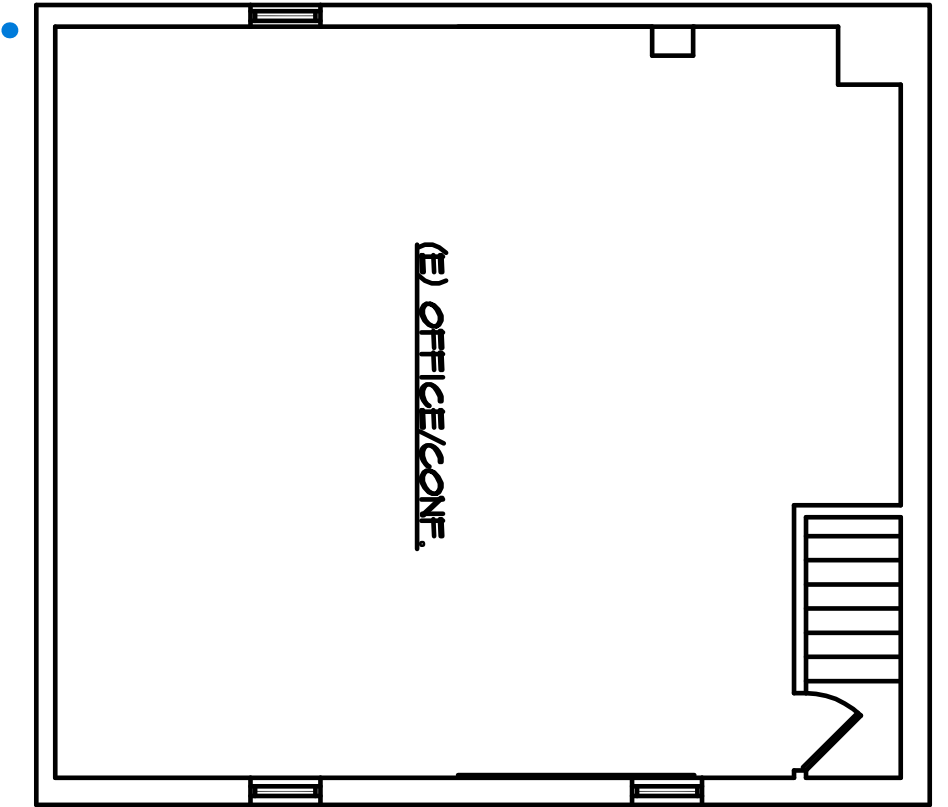
EXISTING PLAN

» Main Level - 4,632 sq.ft. - (3) Garage Bays, (1) Large Squad Room (no private areas for sensitive discussion), non-ADA compliant unisex toilet rooms, (1) Day Room, (1) Storage Room (1) Mechanical Room, (1) Kitchen, access to second floor office and conference space.

- » Existing Verona Rescue Squad occupies 4,600+/- sq.ft. in its own facility on Church Street.
- » Lacks adequate program spaces
- » Lacks adequate clearances for apparatus
- » Lacks efficiency and safety protocols
- » Is significantly deteriorated

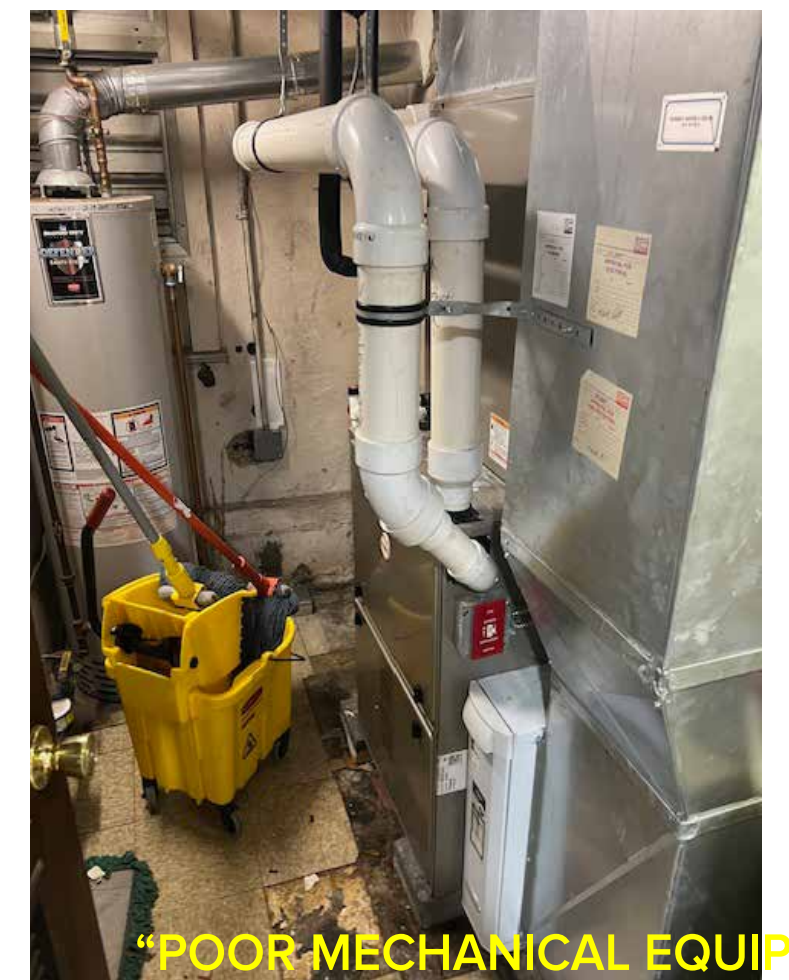
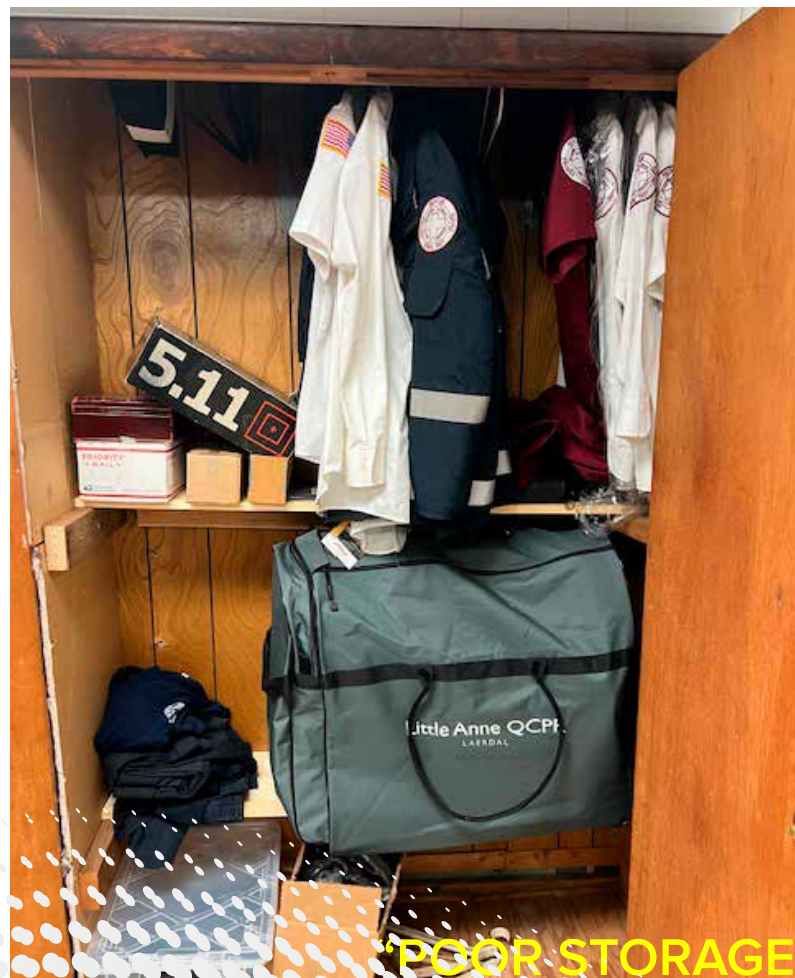
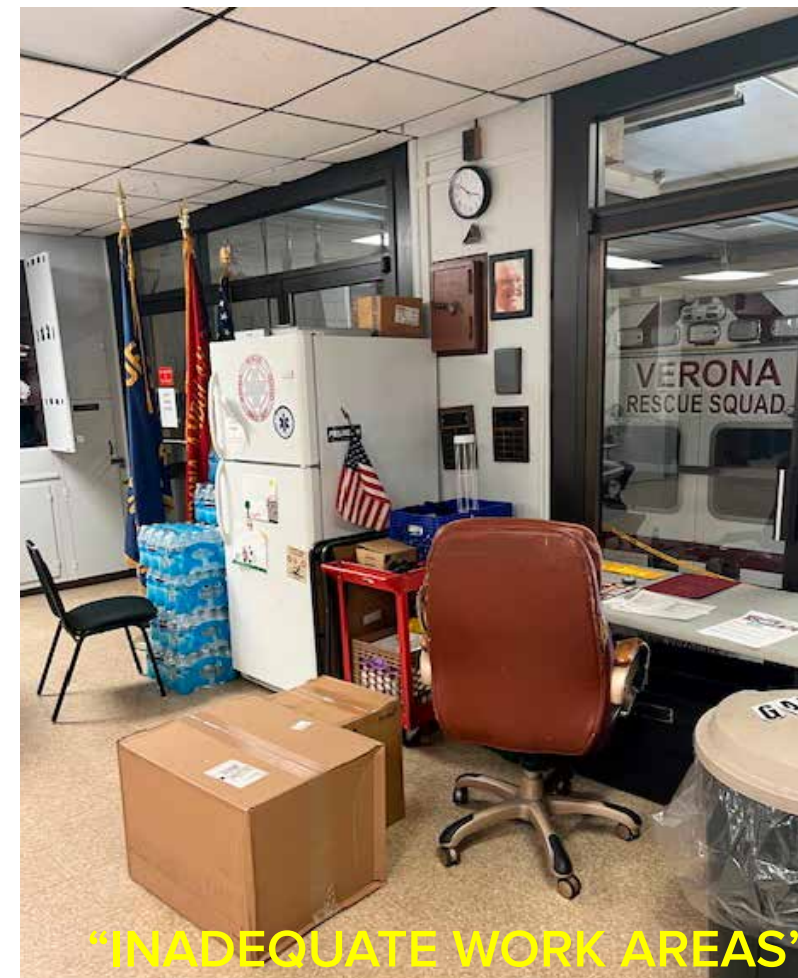
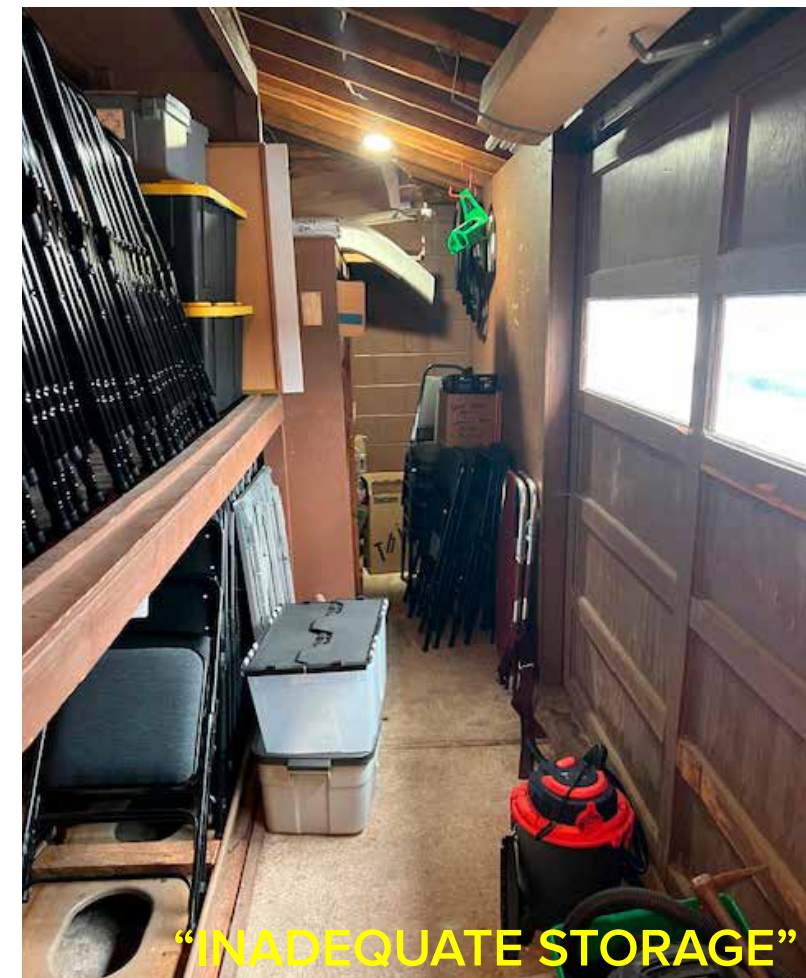
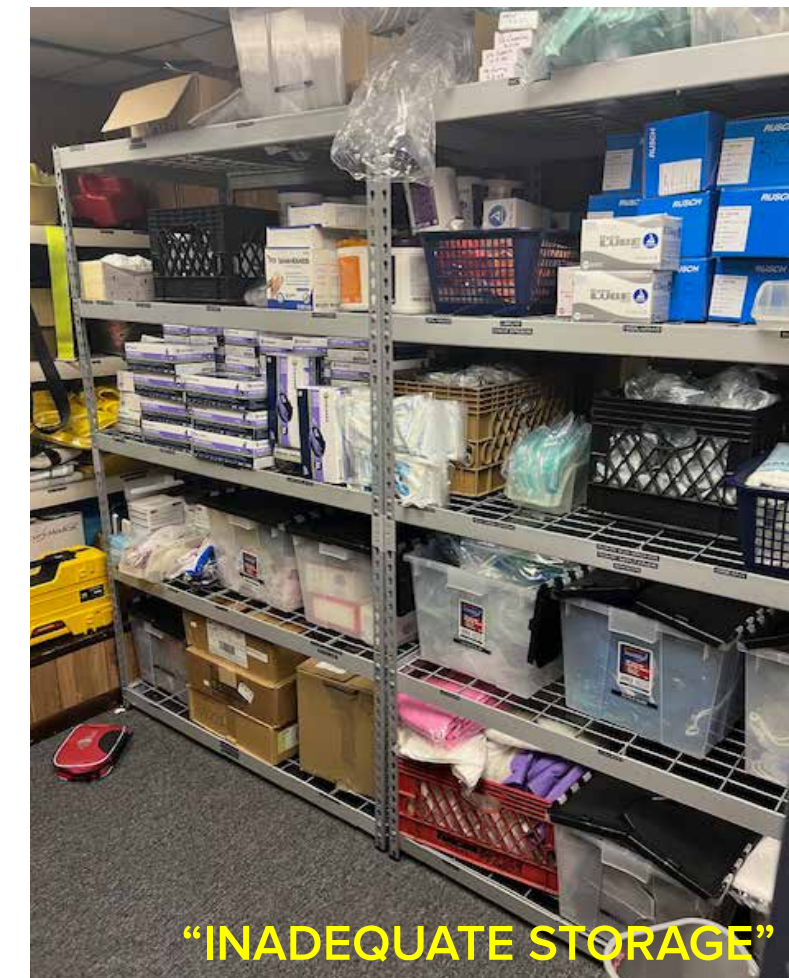
EXISTING CONDITIONS

- » Commonly, existing facilities often fail on the criteria of adequate space.
 - » Main entrance public access / ADA compliance
 - » Additional, future apparatus bays; unsafe bay clearances
 - » Adequate space for a training room
 - » Adequate kitchen space
 - » Adequate office space / watch / report rooms
 - » No decontamination space / eye wash capabilities
 - » Adequate oxygen tank storage facilities
 - » No adequate toilet facilities or shower facilities
 - » No locker rooms, bunk rooms, or private space for calls that may regard sensitive HIPAA related subjects
 - » Maintenance / Work space
 - » Inadequate parking for members
 - » Deteriorated infrastructure, power, lighting, plumbing
