PUBLIC PRESENTATION

VERONA EMERGENCY SERVICES COMPLEX

POLICE DEPARTMENT, FIRE DEPARTMENT - CO. #2, RESCUE SQUAD

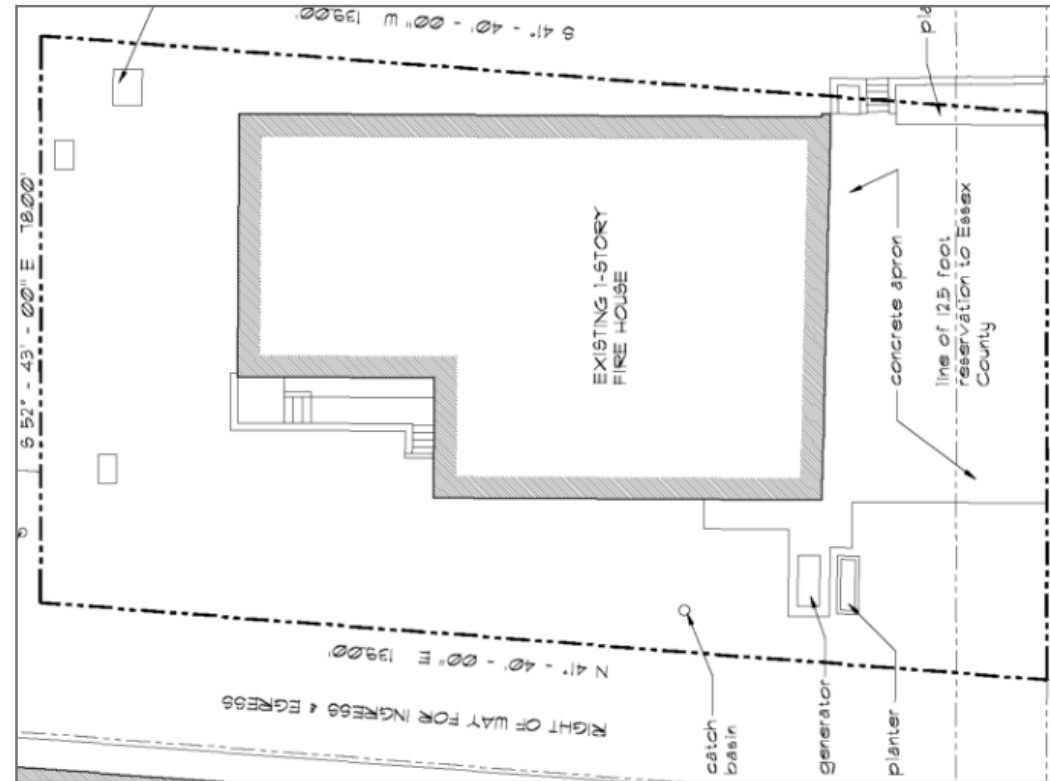
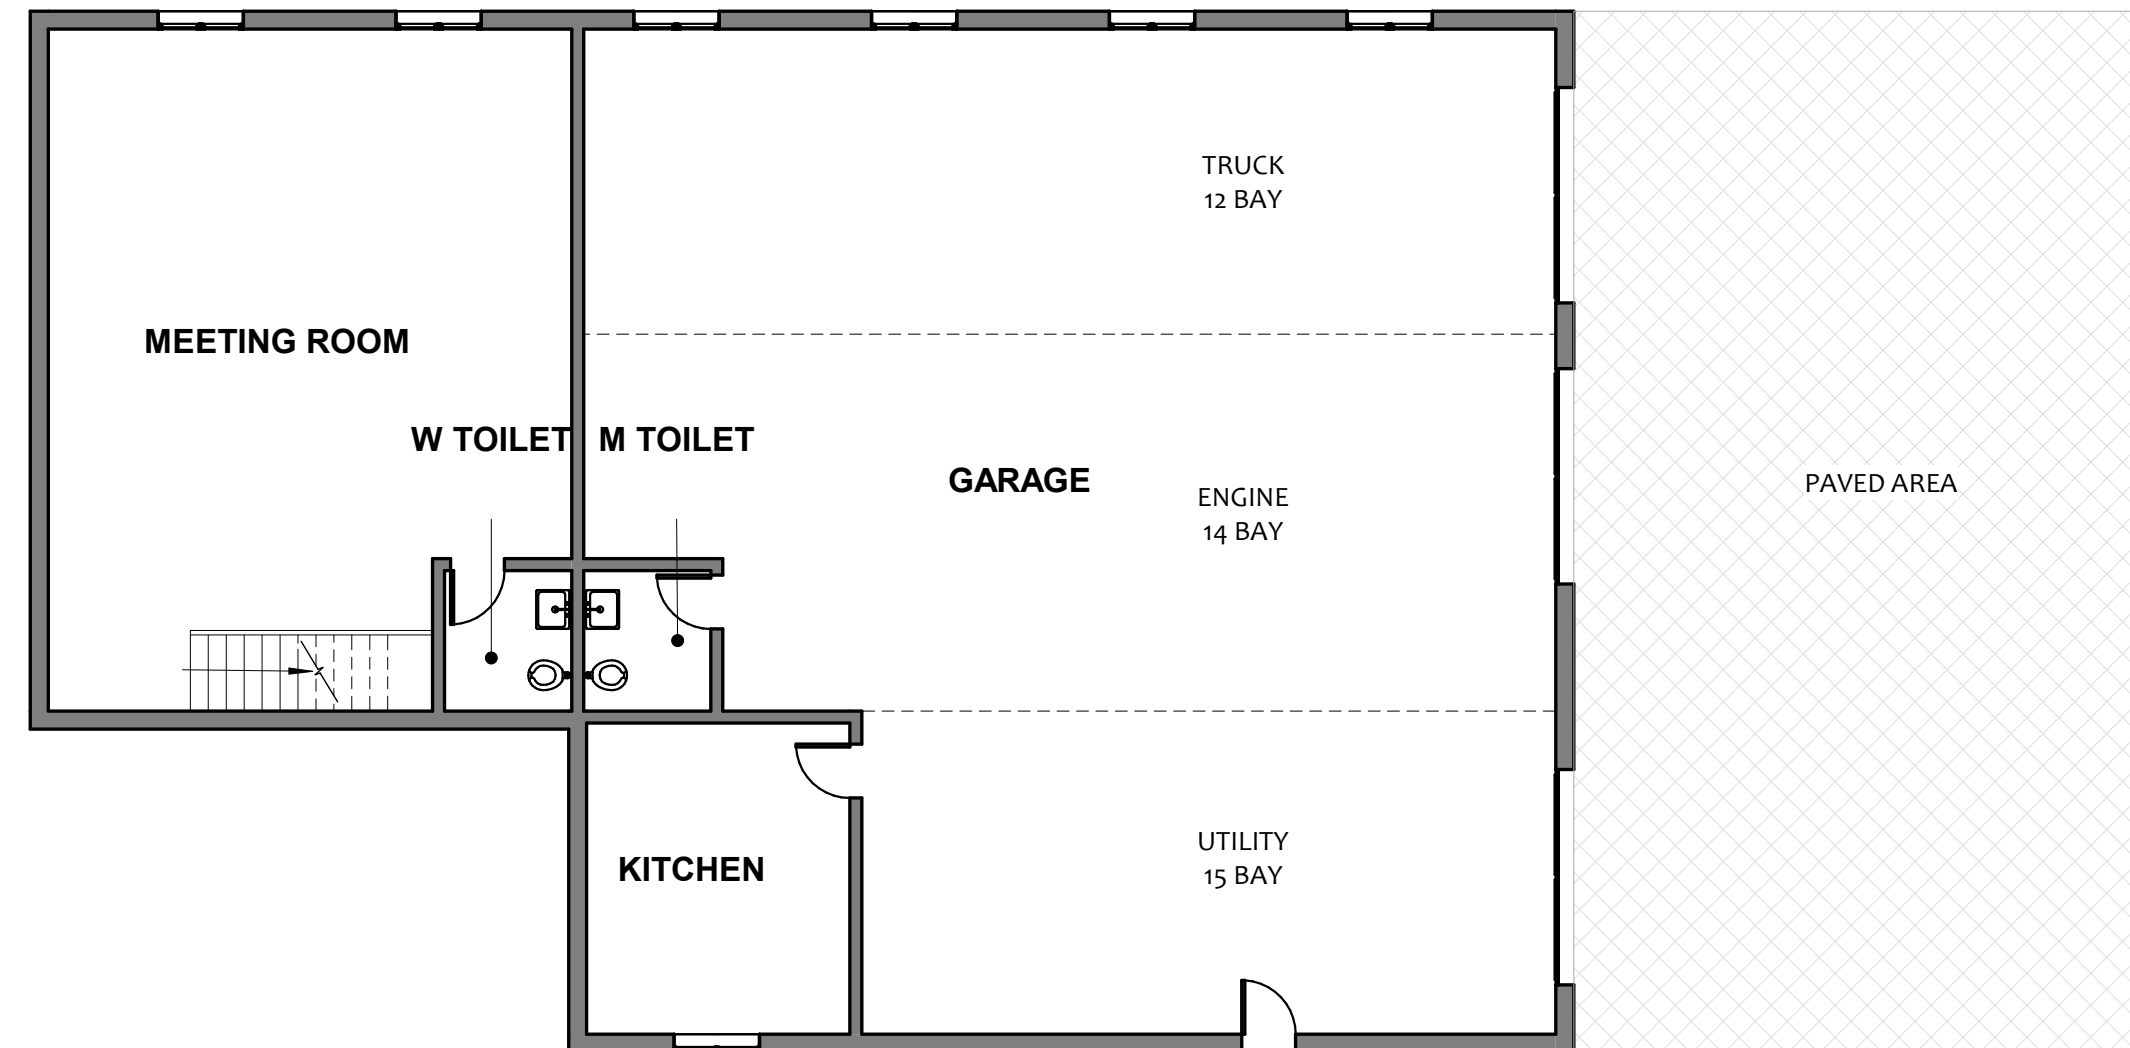
EXISTING PLAN

- » Existing Fire Company No.2 occupies 5,500+/- sq.ft. in its own facility on Bloomfield Ave.
- » Existing site is 10,842 gsf.
- » Lacks adequate program spaces
- » Lacks adequate clearances for apparatus
- » Lacks efficiency and safety protocols
- » Is significantly deteriorated

» Main Level - 5,500 sq.ft. - (3) Garage Bays, (2) Unisex Toilet Rooms, (1) Meeting Room (1) Kitchen, Access to lower level basement which is presently unusable

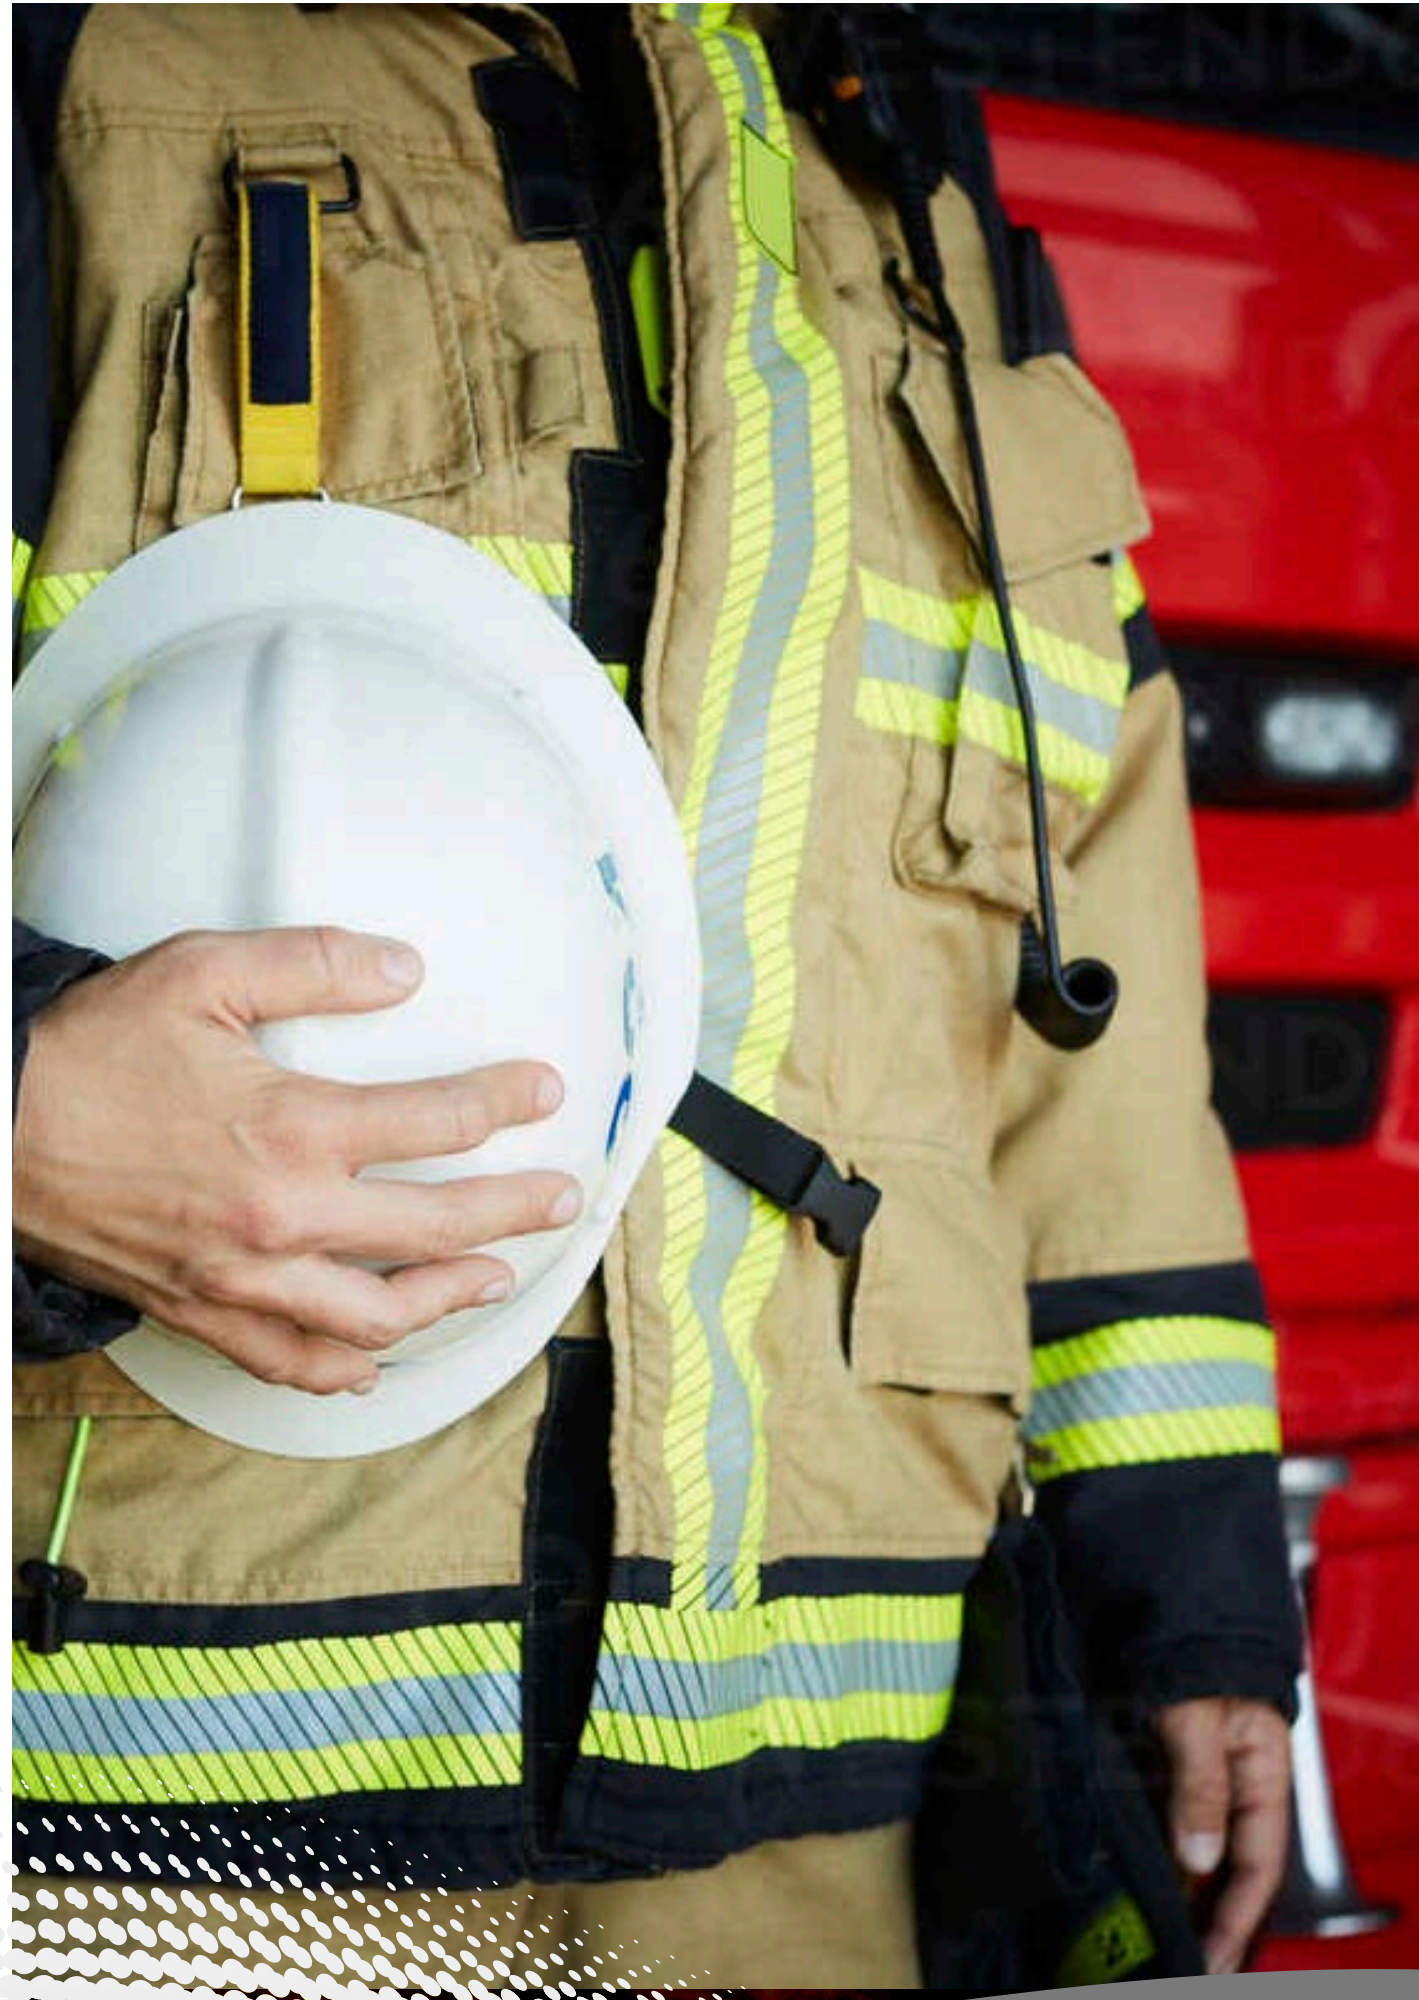
- » Building is 74 years old and is NOT OSHA compliant with present day standards:
 - » Apparatus bay is 50' - Ladder Truck is 48' and the platform on the ladder must have 1.5' clearance from the garage doors, leaving 6" from wall of the bay.
 - » There is no room for gear racks behind the ladder truck, all the gear racks are on the driver's side wall creating a safety issue when four or five members are donning the gear necessary to respond to a fire call.
 - » Overhead doors are only 12' high resulting in minimal clearance for certain apparatus.
 - » There are inadequate parking spaces. The company may have as many as 28 members and there are only 11 parking spaces.

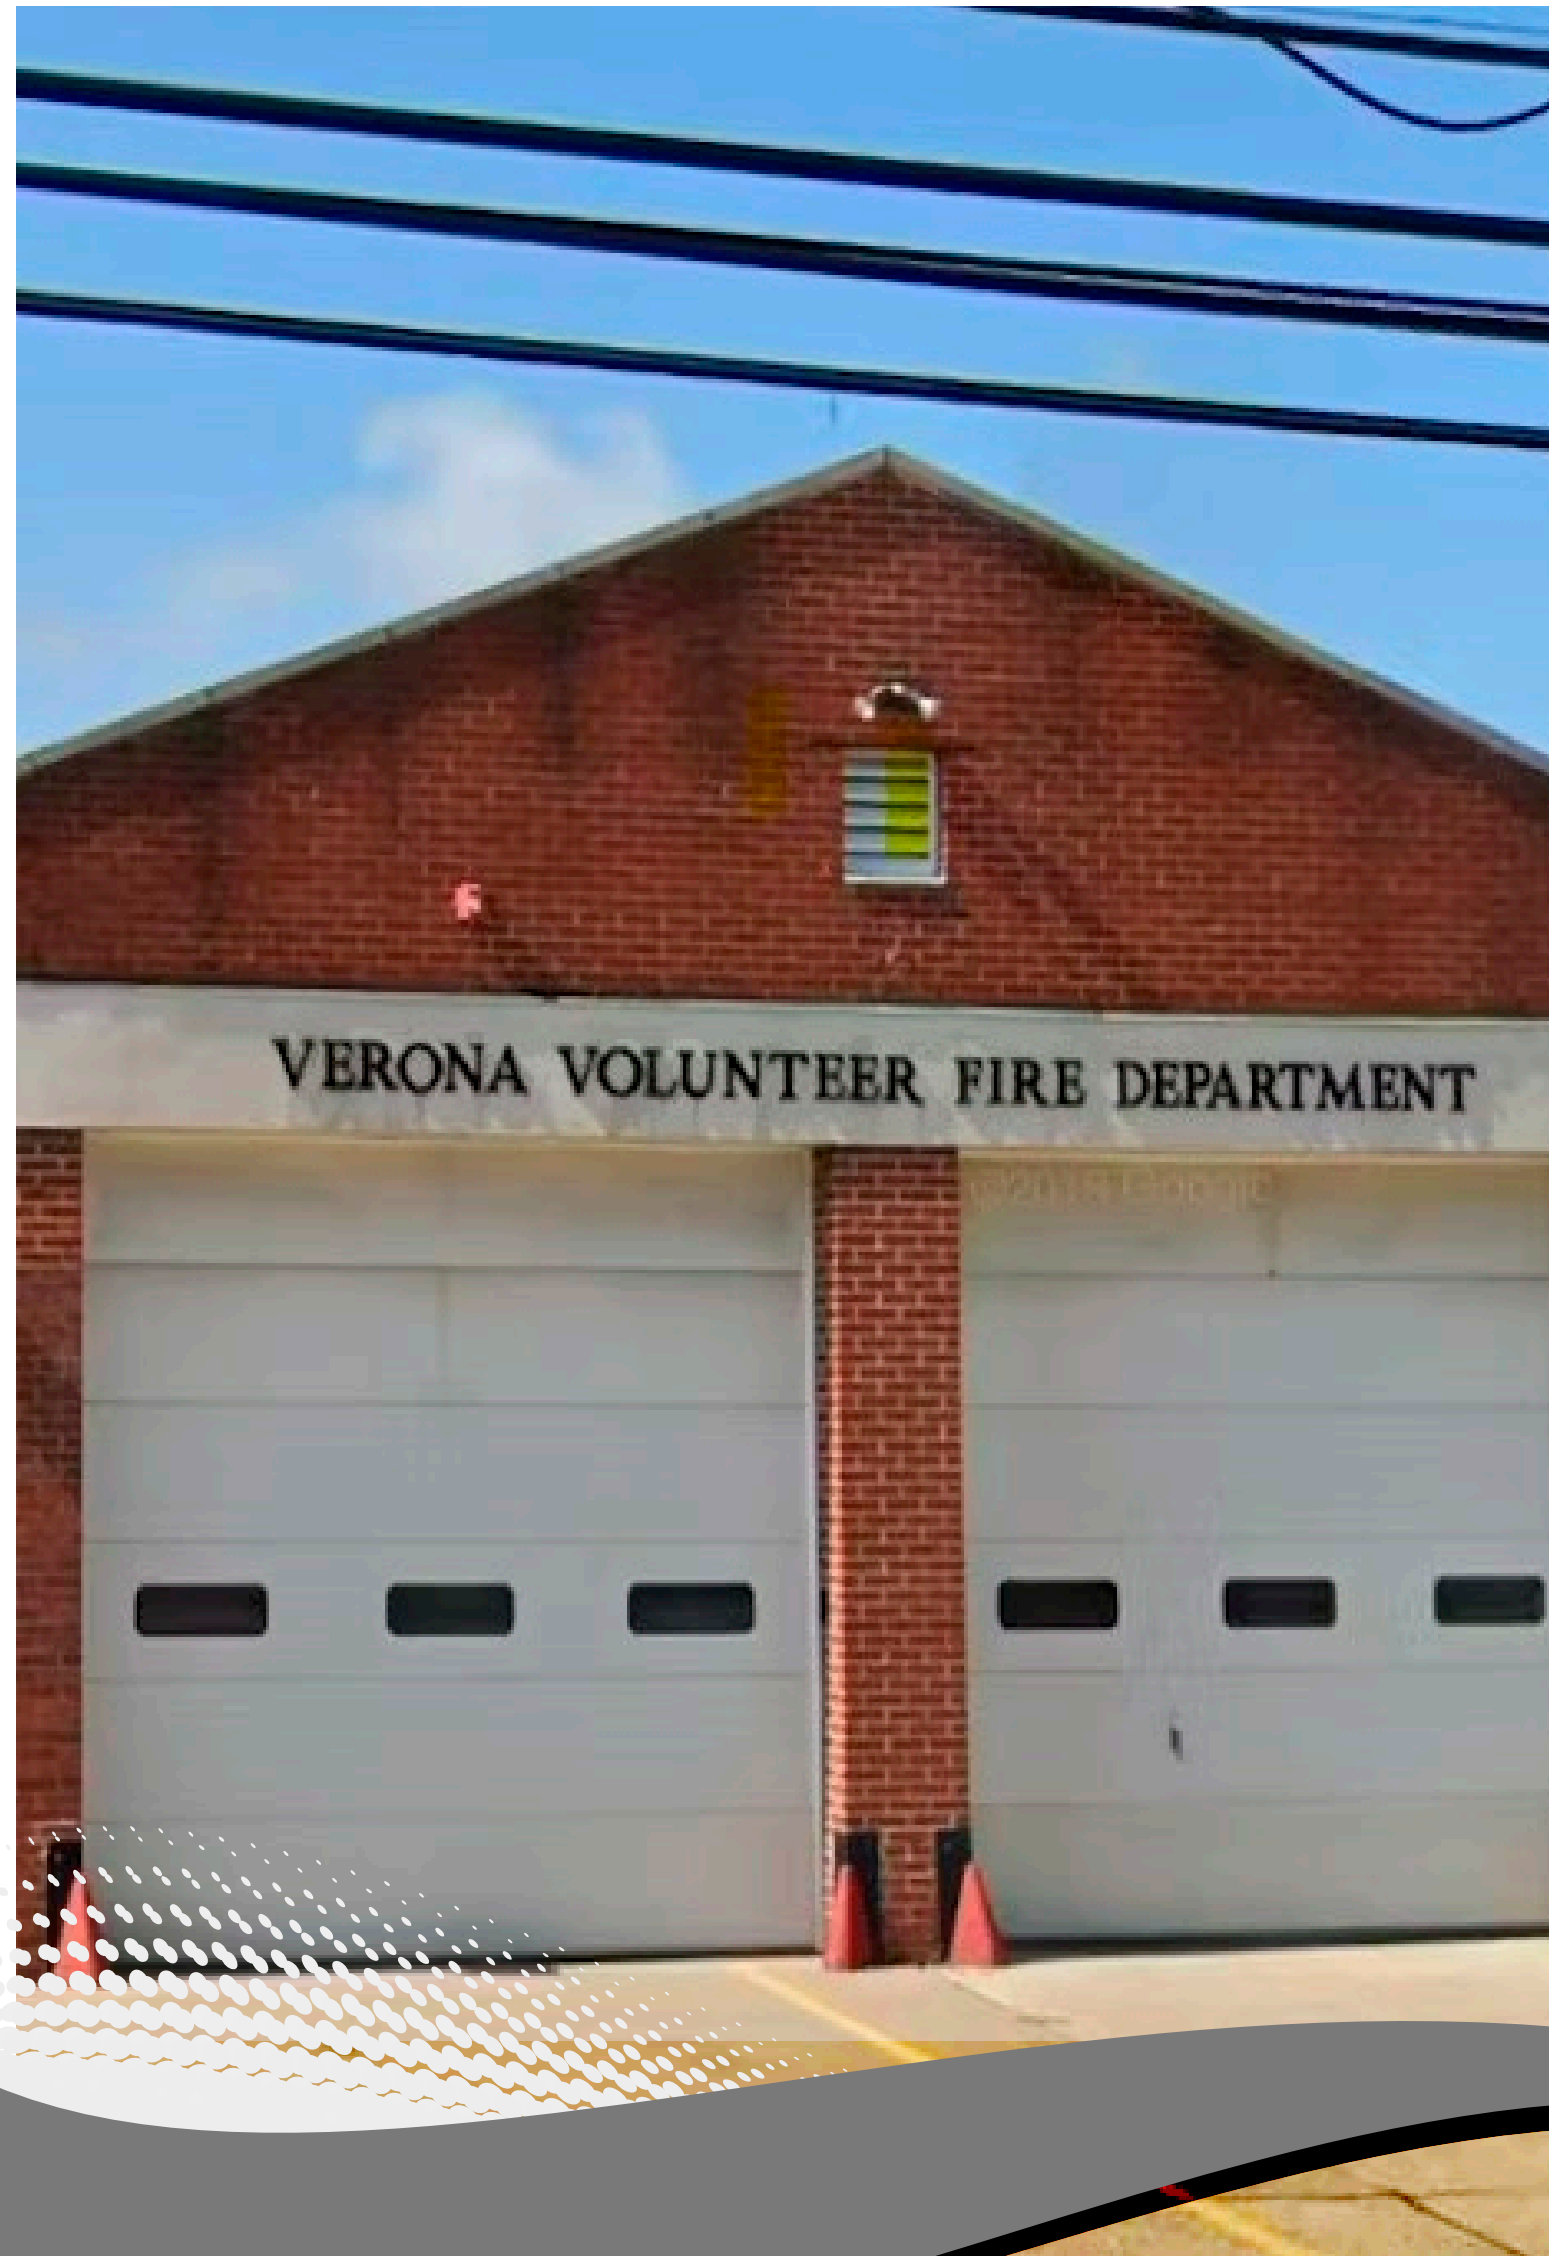
» Facility Issues:

- » Major roofing/flashings issues allowing water infiltration causing facade separation, exterior wall, window and door issues/cracking + stucco/plaster damage.
- » Major structural issues due to building settling likely from the building being constructed over organic materials leftover from fire demolition in 1949.
- » Floor tiles popping, wood floors warping, window frames at meeting room / basement are rotted/leaking. Steel lintels are rusted and bowing.
- » August 2017 - Break in main sewer line, flooded the basement. Two sump pumps in basement are inadequate to keep up during heavy rain storms resulting in more water infiltration.

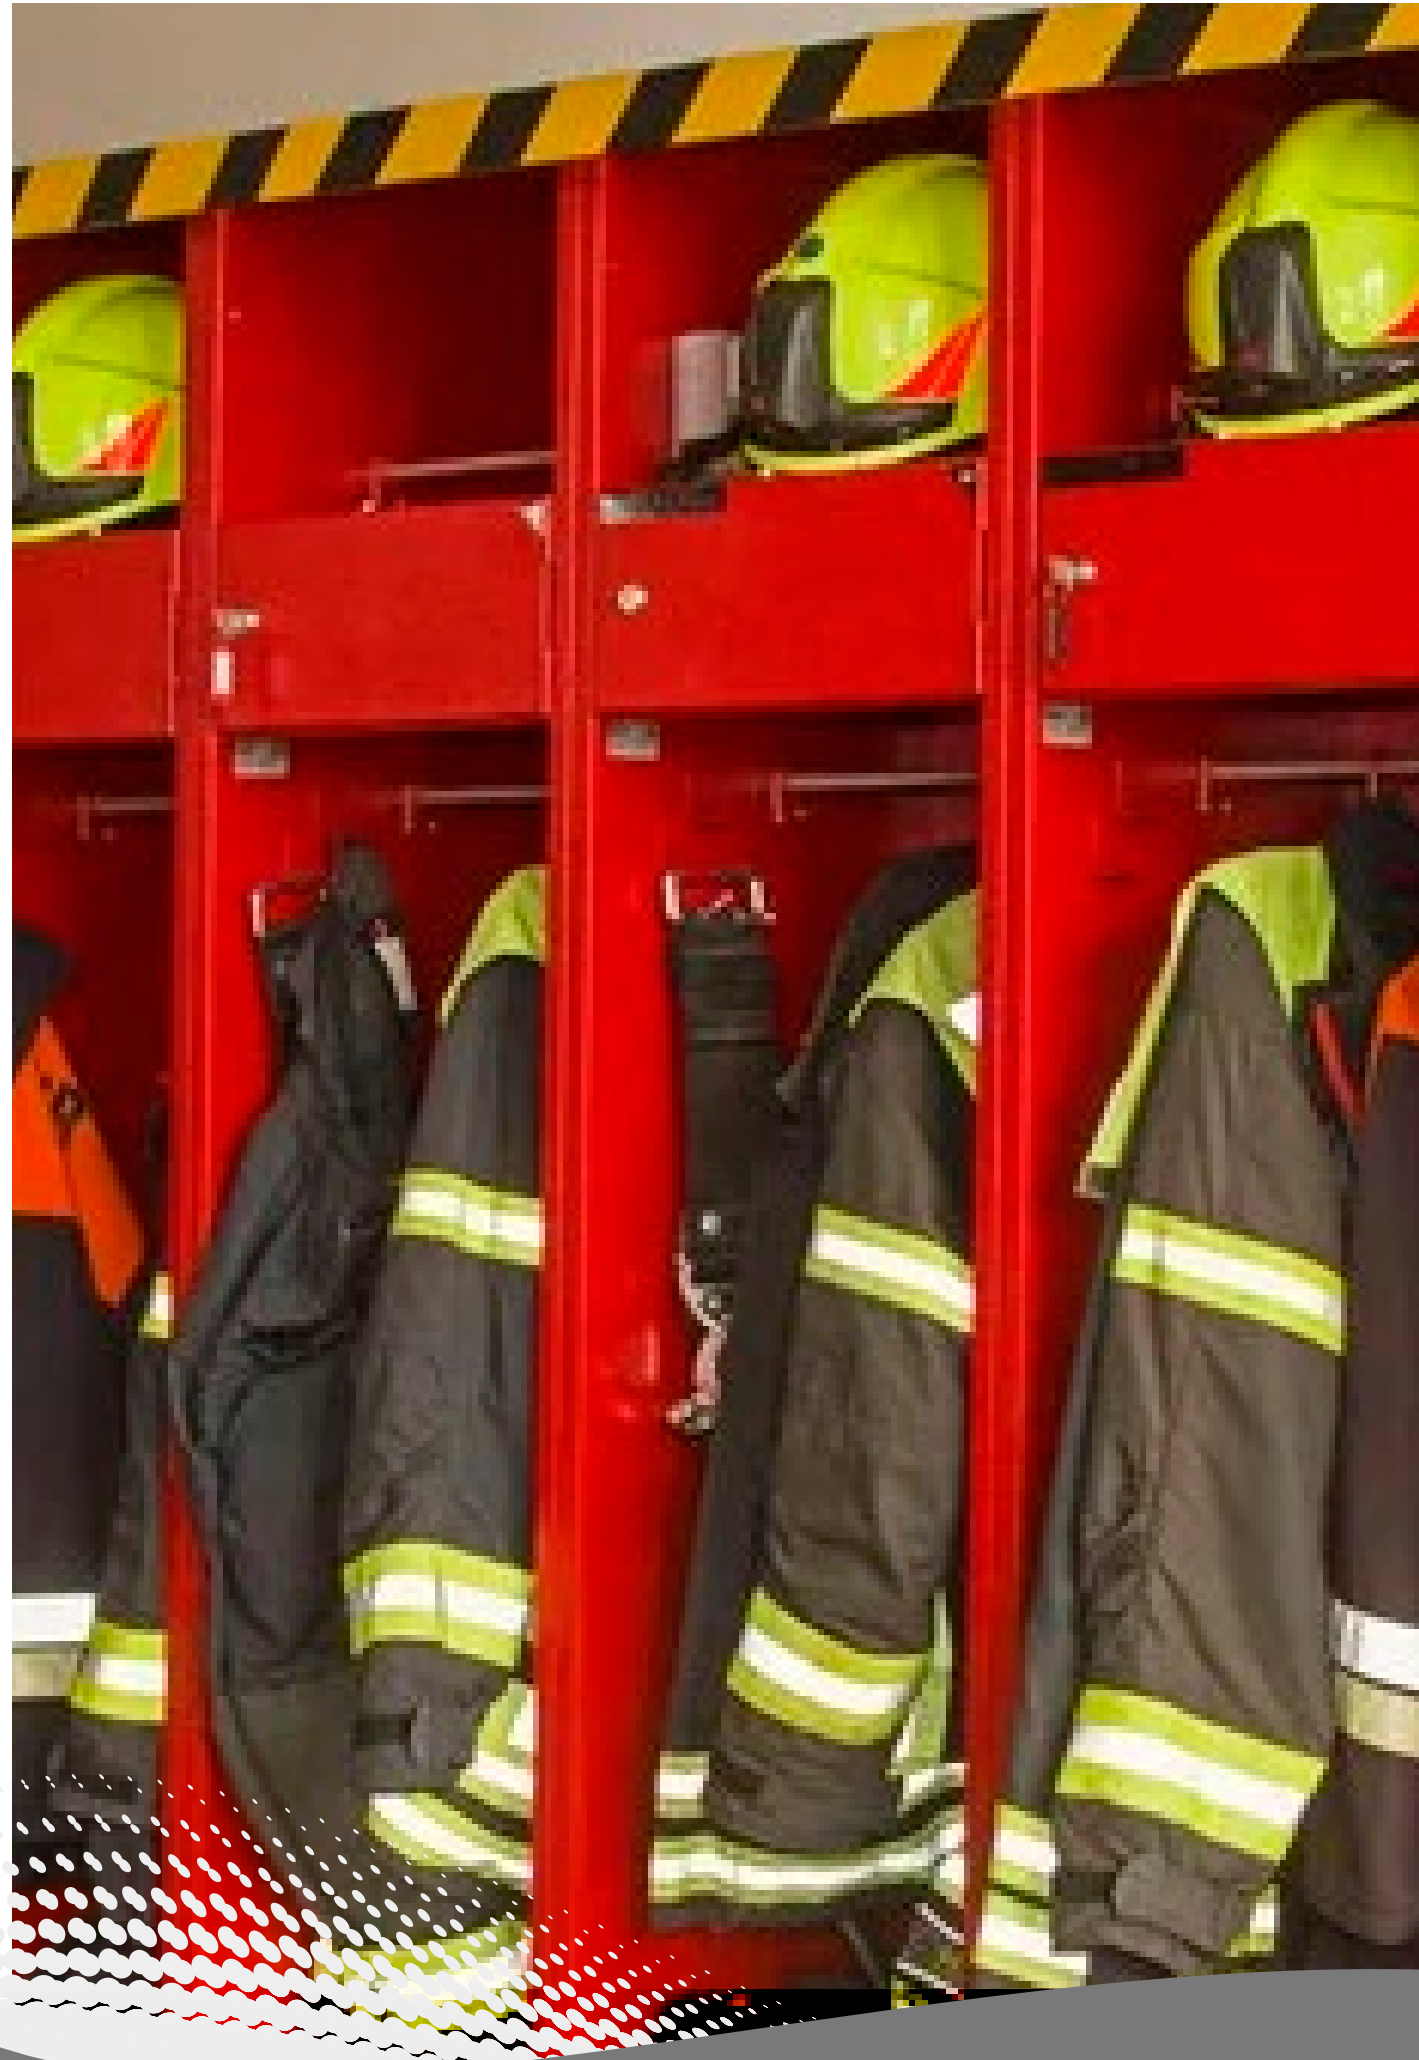
» Facility Issues:

- » The air conditioning unit on the roof is irreparable. Building and Grounds had a company come in to assess the unit, and they estimated that it would be \$15,000 to replace it.
- » Heating system was overhauled in 2020, but the boiler that was installed 70's was never replaced in spite of extensive repairs, it is in need of replacement.
- » Major plumbing leaks throughout the facility, sediment found in the system. Apparatus bay floor drains do not appear to have an oil separator.
- » The basement entry stairwell floods during heavy rain. Basement door-deteriorated and does not open, posing a safety problem. Basement cannot be used.

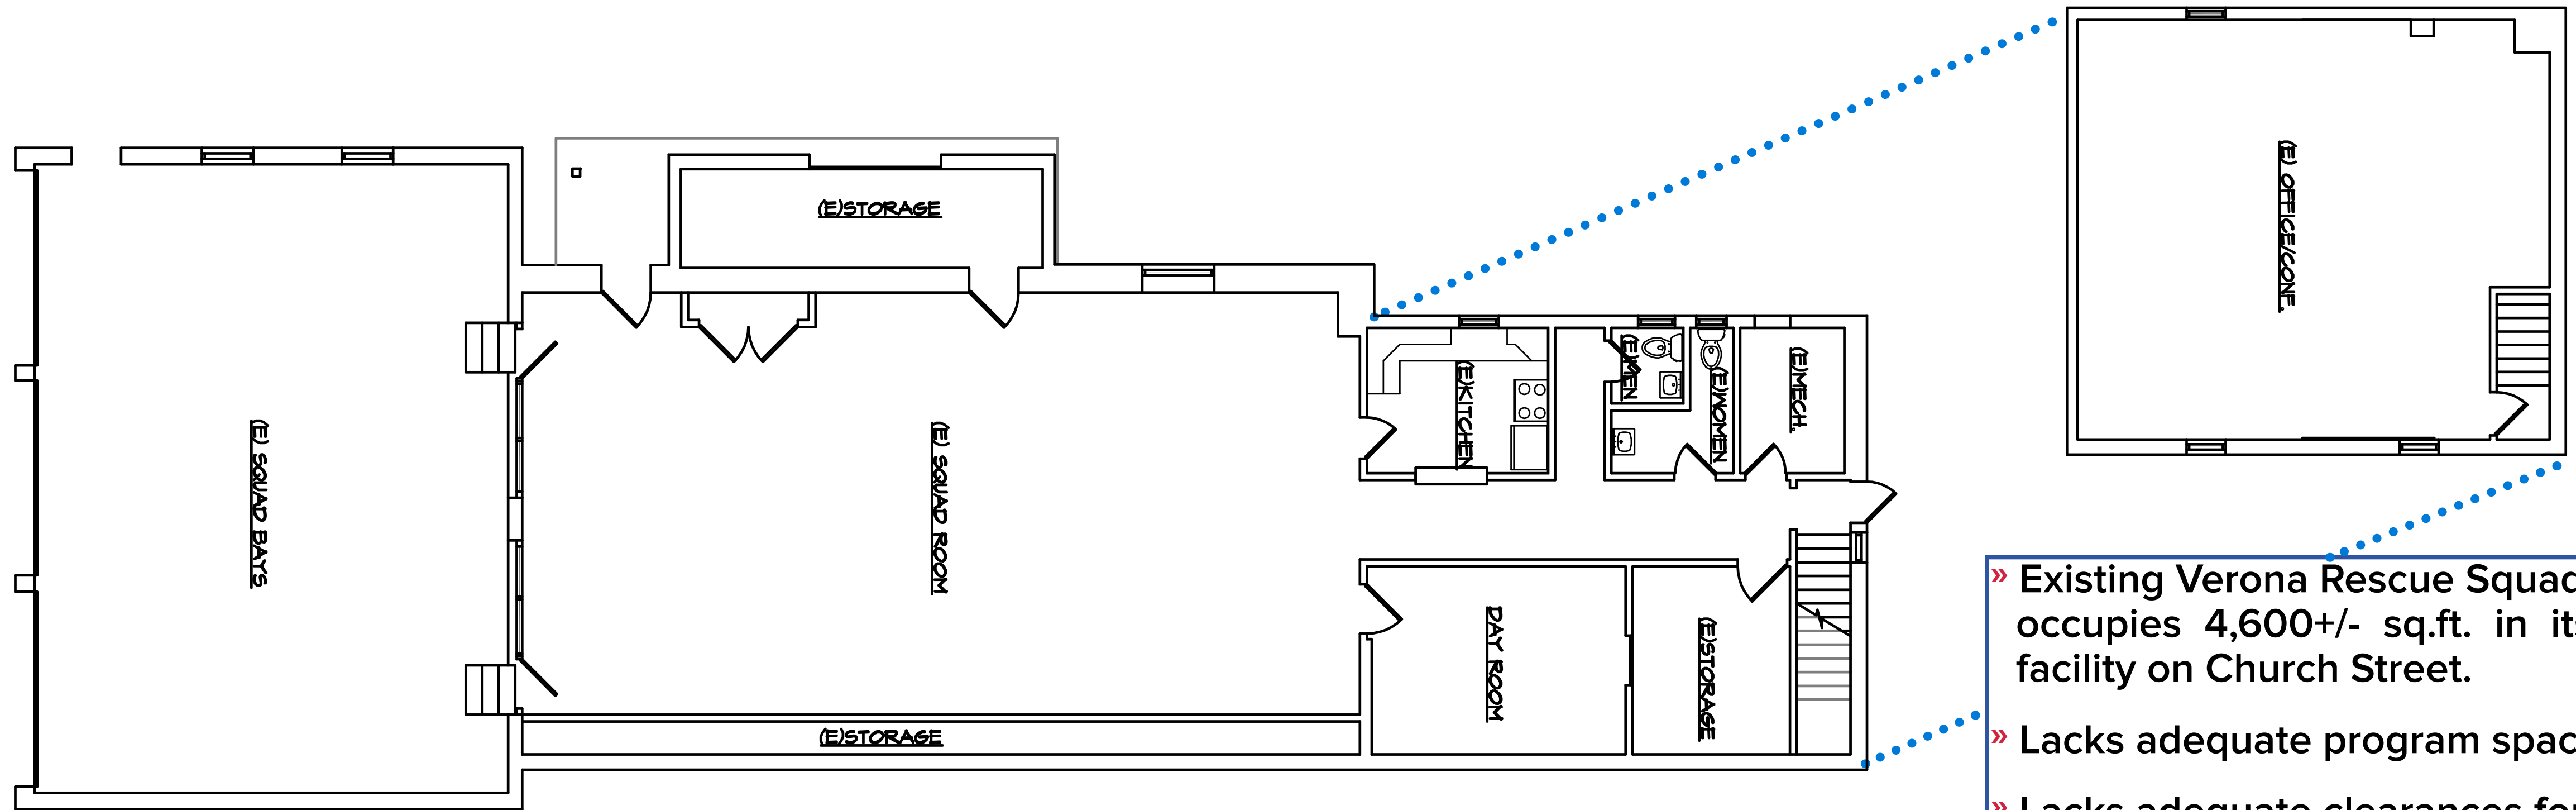
EXISTING PLAN

» Main Level - 4,632 sq.ft. - (3) Garage Bays, (1) Large Squad Room (no private areas for sensitive discussion), non-ADA compliant unisex toilet rooms, (1) Day Room, (1) Storage Room (1) Mechanical Room, (1) Kitchen, access to second floor office and conference space.

- » Existing Verona Rescue Squad occupies 4,600+/- sq.ft. in its own facility on Church Street.
- » Lacks adequate program spaces
- » Lacks adequate clearances for apparatus
- » Lacks efficiency and safety protocols
- » Is significantly deteriorated

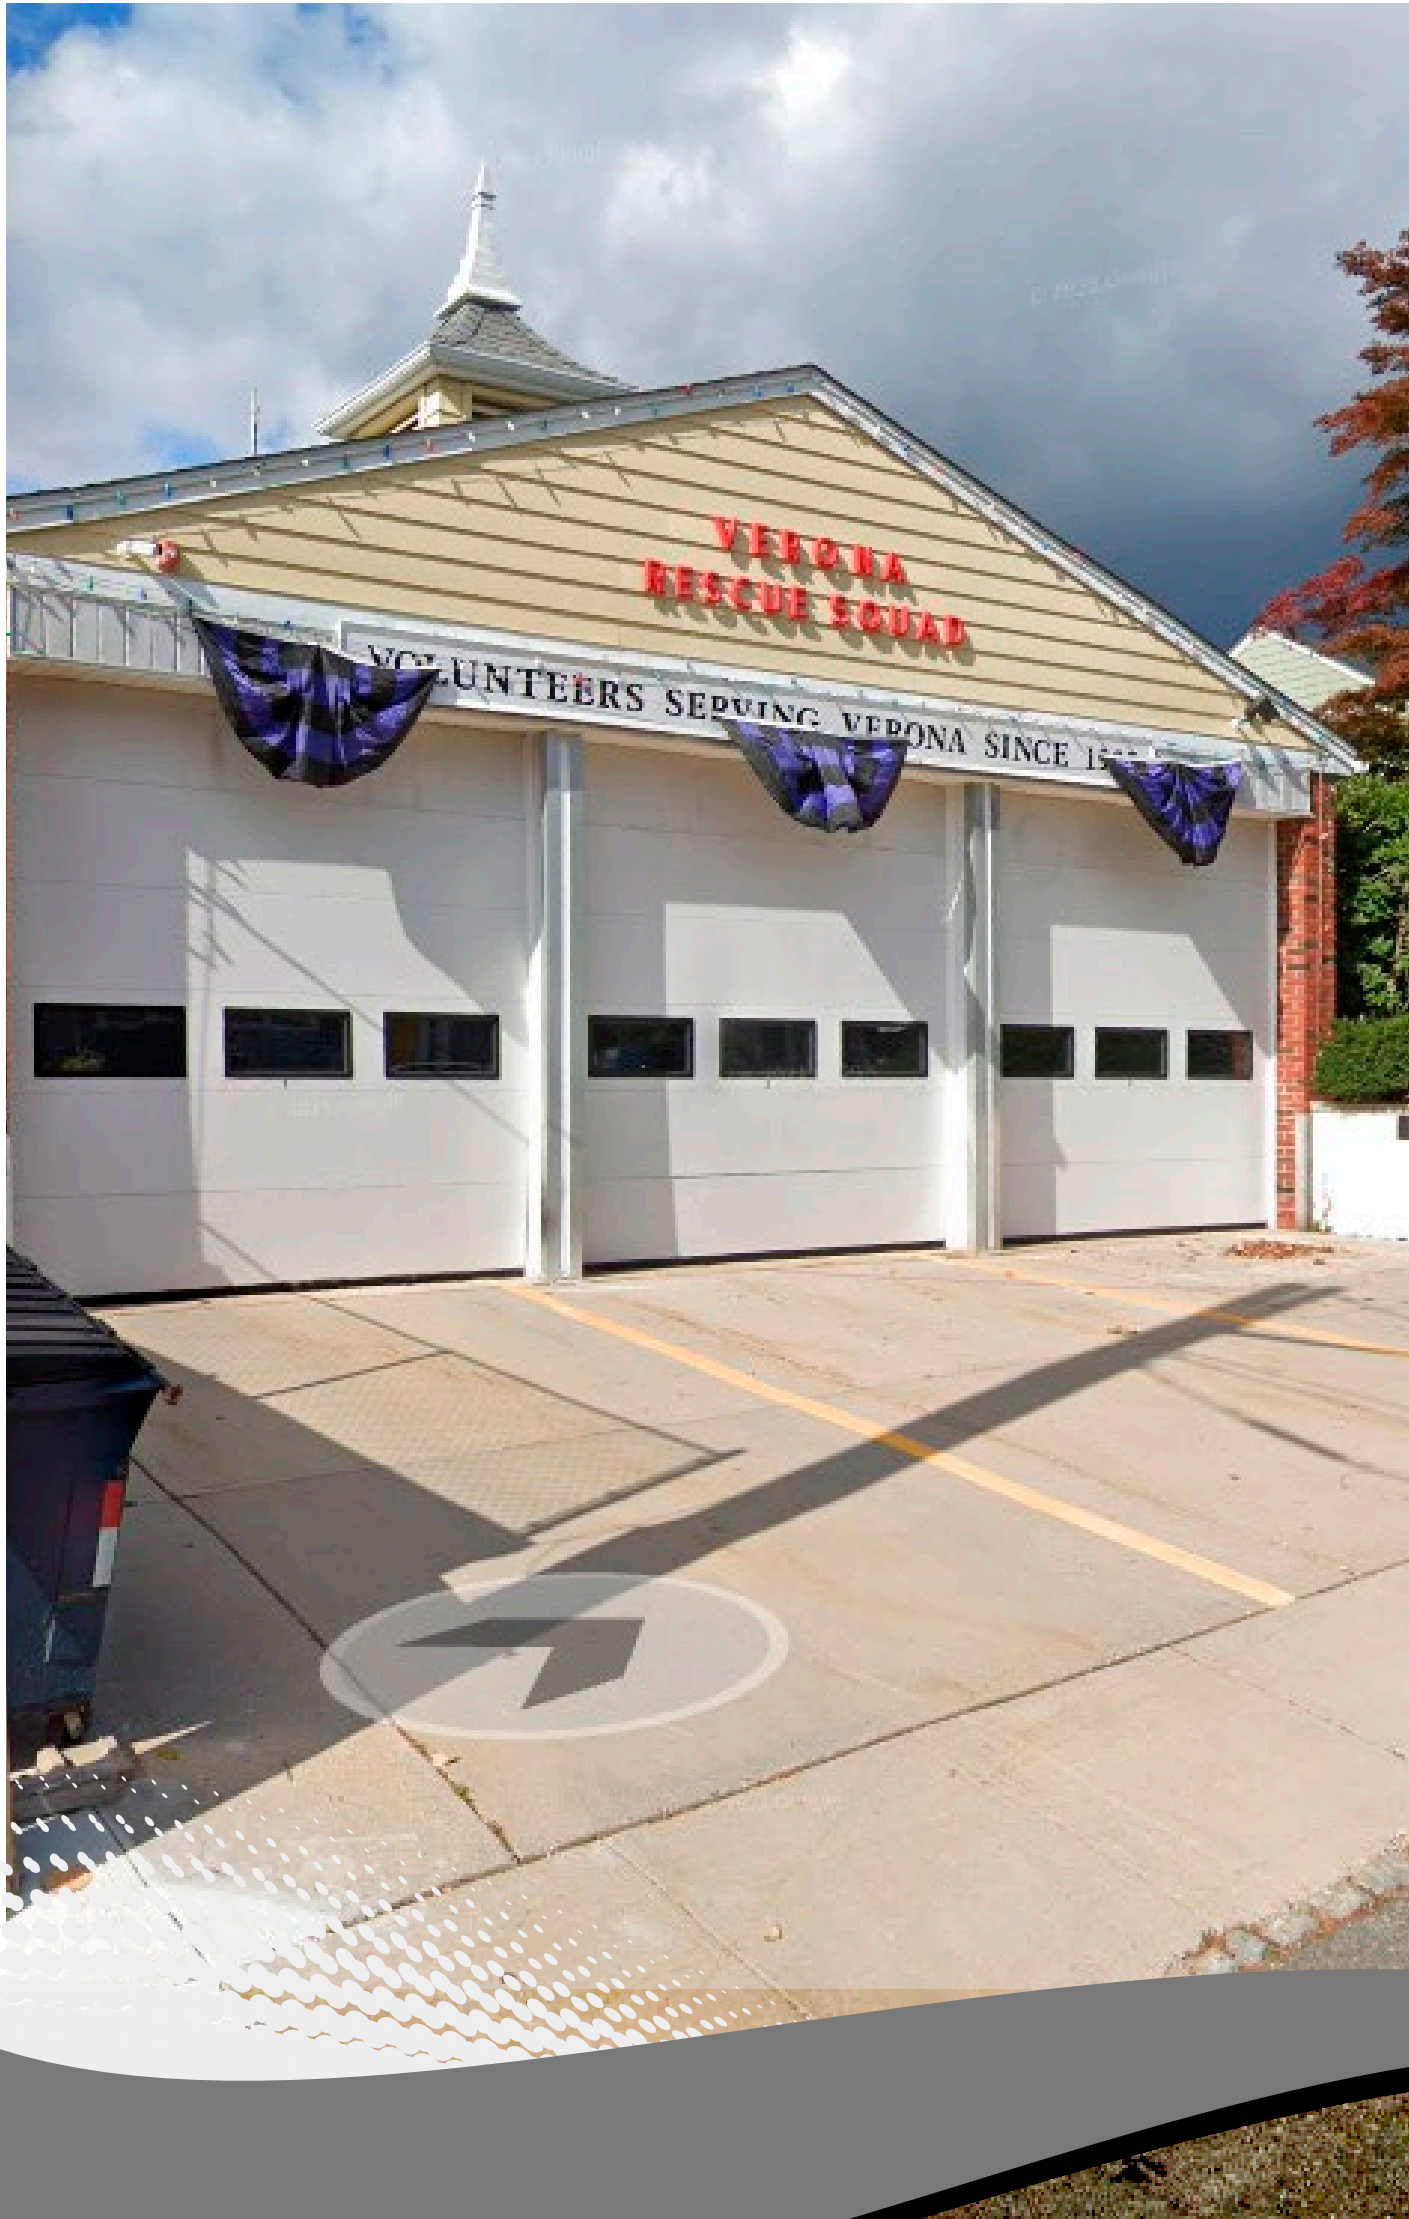
- » The report determined that the existing facility lacks some very essential building planning elements. And operationally is very inefficient.
- » The report suggested proper planning concepts that would result in a safer, more efficient facility capable of a faster turnout which is so critical for life saving operations.
- » The report highlighted that the existing facility, if renovated, would still lack necessary program elements or the ability to accommodate growth.

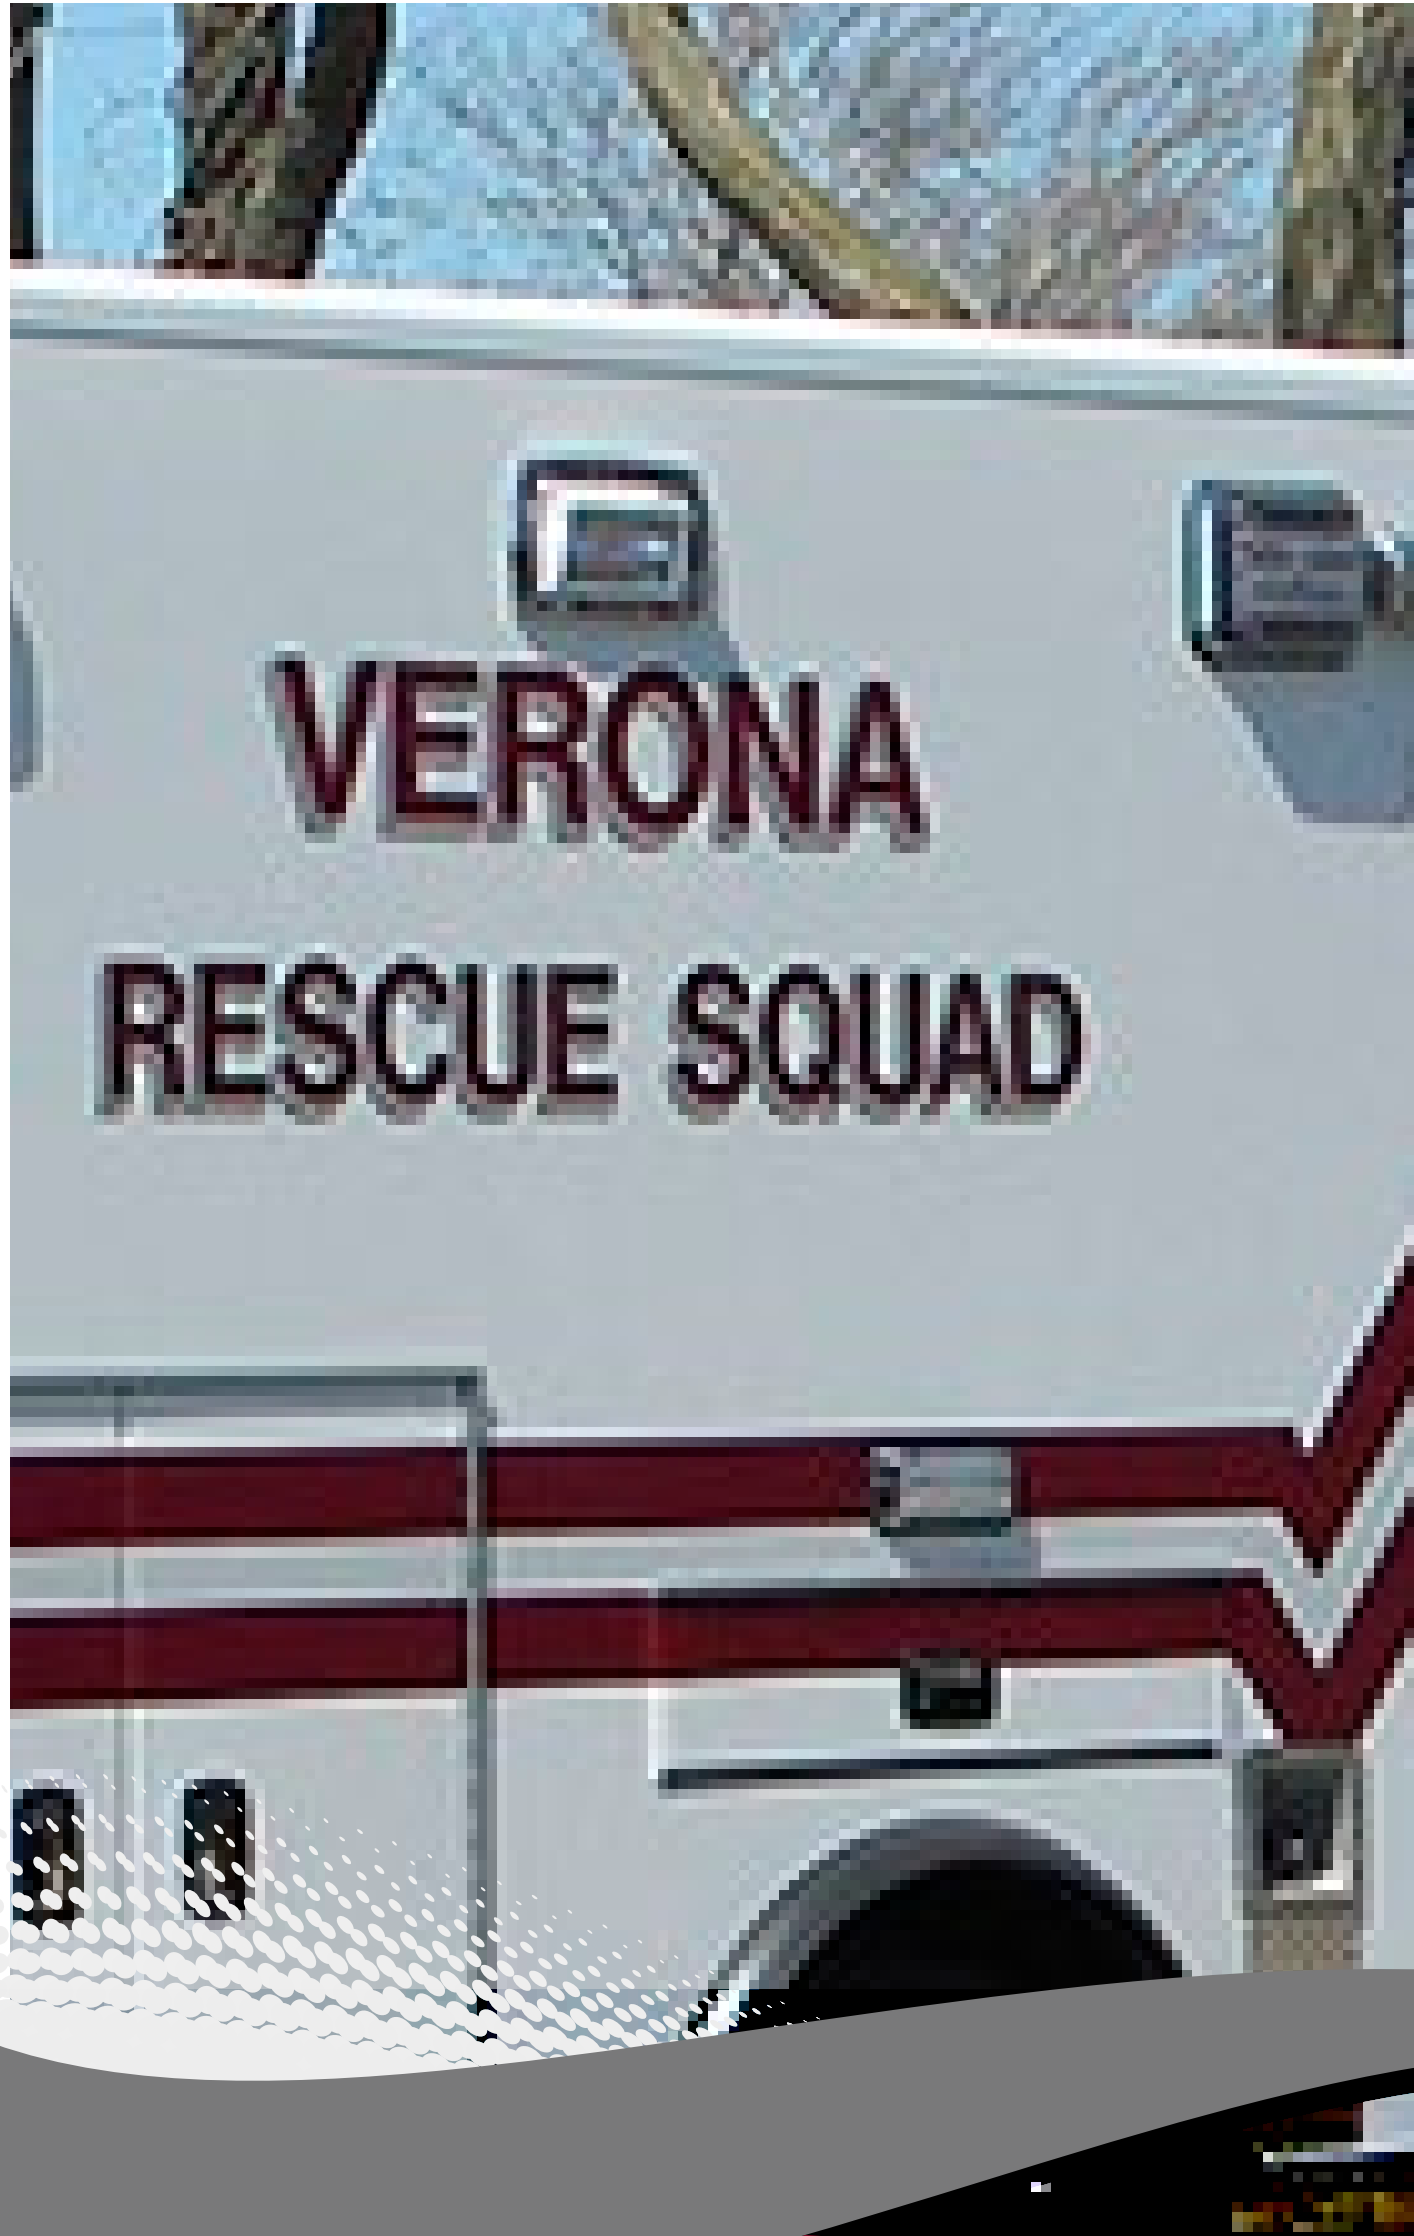
- » Commonly, existing facilities often fail on the criteria of adequate space.
 - » Main entrance public access / ADA compliance
 - » Additional, future apparatus bays; unsafe bay clearances
 - » Adequate space for a training room
 - » Adequate kitchen space
 - » Adequate office space / watch / report rooms
 - » No decontamination space / eye wash capabilities
 - » Adequate oxygen tank storage facilities
 - » No adequate toilet facilities or shower facilities
 - » No locker rooms, bunk rooms, or private space for calls that may regard sensitive HIPAA related subjects
 - » Maintenance / Work space
 - » Inadequate parking for members
 - » Deteriorated infrastructure, power, lighting, plumbing

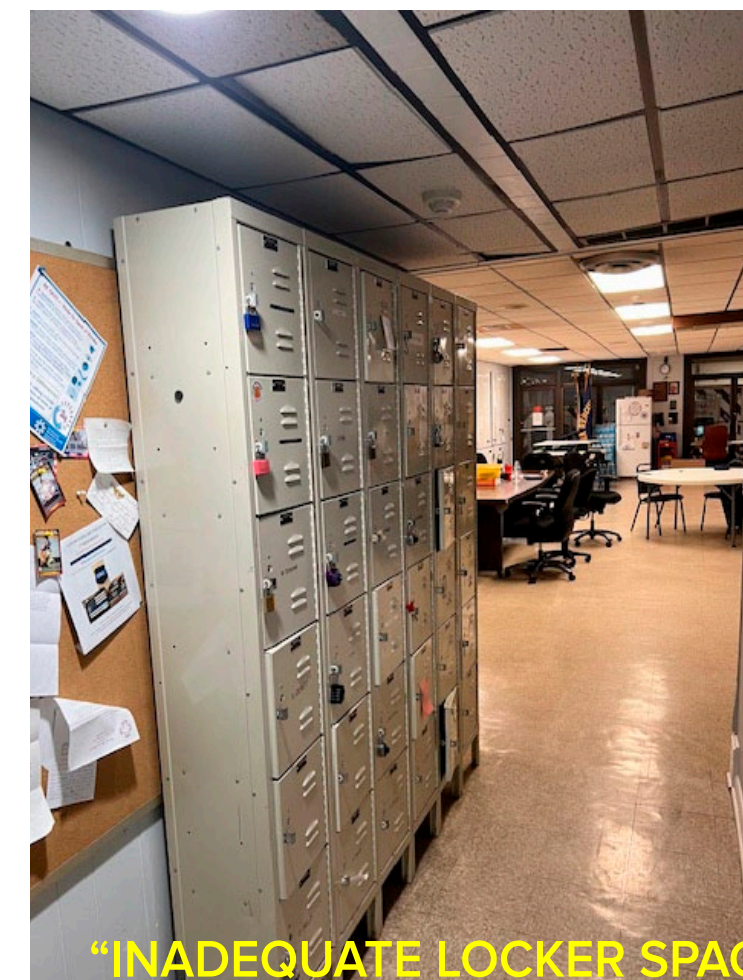
"INADEQUATE LOCKER SPACE"
