PUBLIC PRESENTATION

VERONA EMERGENCY SERVICES COMPLEX

POLICE DEPARTMENT, FIRE DEPARTMENT - CO. #2, RESCUE SQUAD

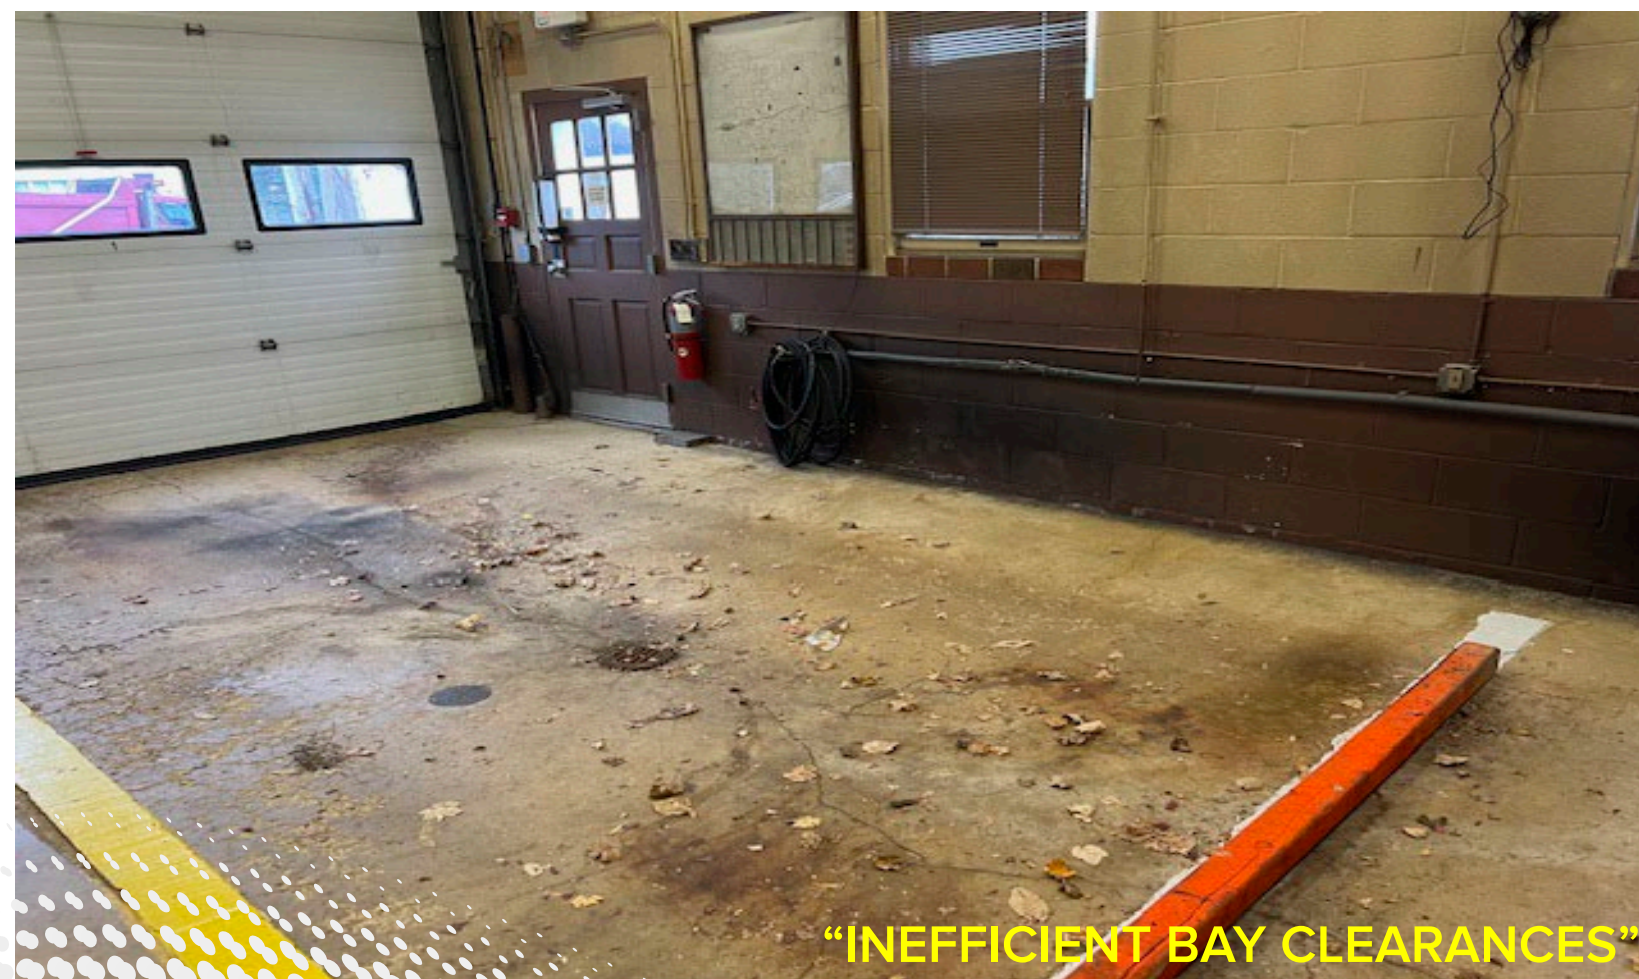
"INEFFICIENT BAY CLEARANCES"

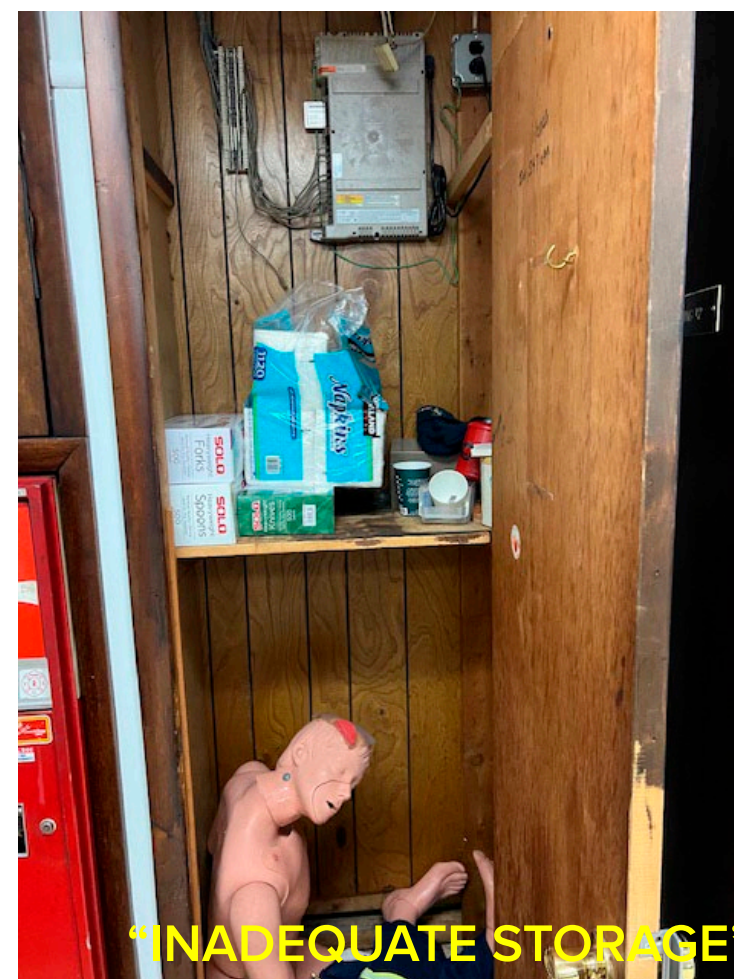
"INADEQUATE STORAGE"

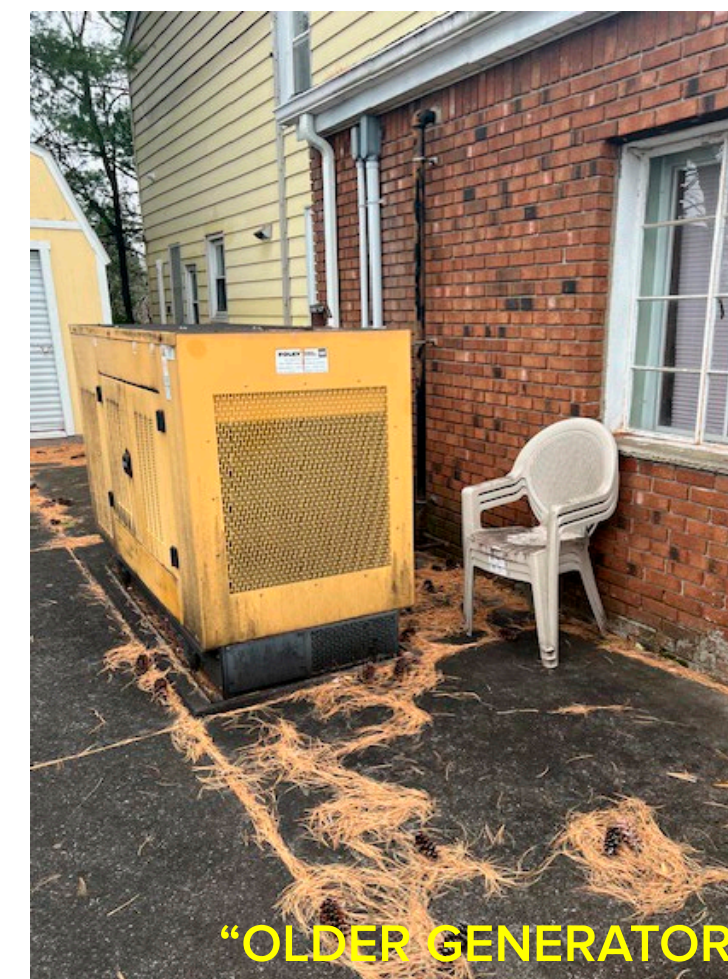
"OLDER GENERATOR"

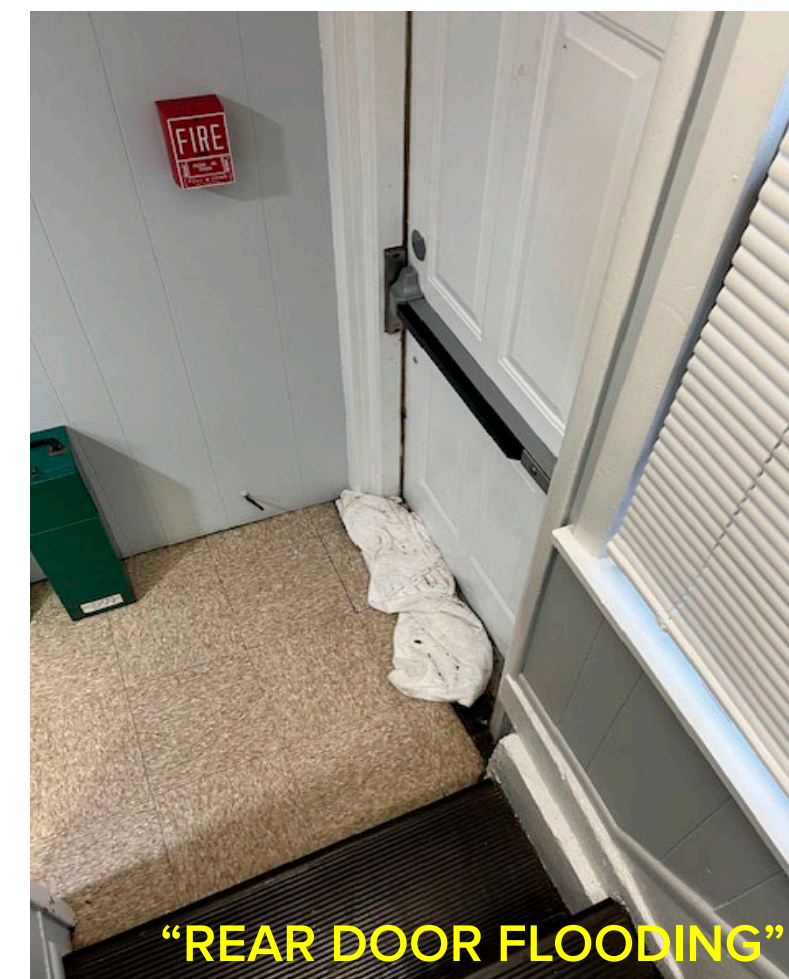
"REAR DOOR FLOODING"
