2021 - Potable Water System Asset Management Plan Report

June 6, 2022

Township of Verona
Water Supply Treatment and Distribution Department
Essex County, New Jersey

Project No. 21004548A

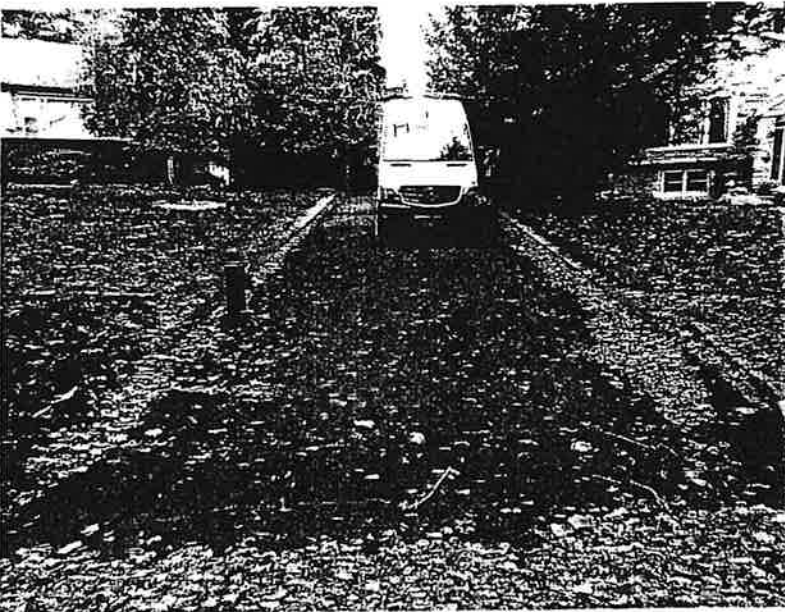
Photo # 2

Entrance to site.

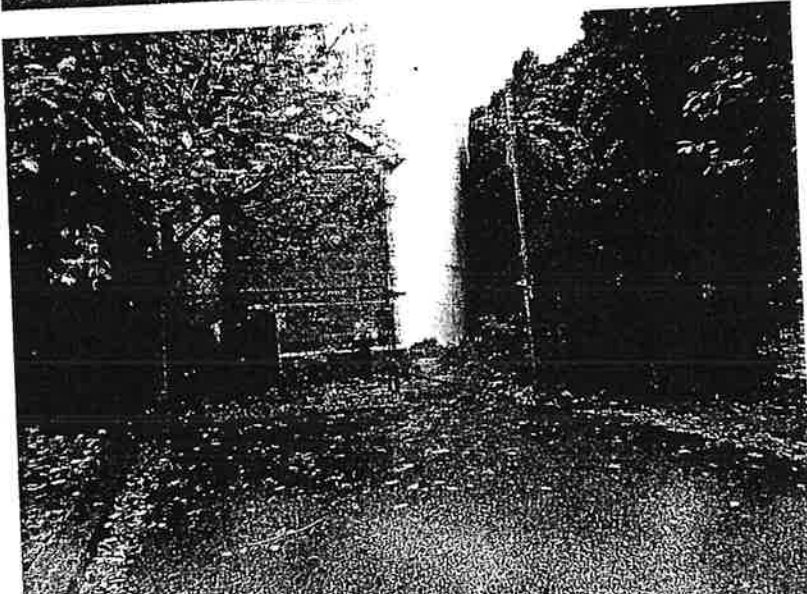
Photo #6

The tank is located in a residential area of Verona Township in Verona, NJ. The tank site is surrounded by a 8' high chainlink fence topped with barbed wire. The barbed wire is damaged or missing at the rear of the site. A lock is present on the fence gate and the valve vault door is locked. A locked ladder gate is present on the shell ladder and the roof manhole is locked. See photographs #6, #8, #12, #43, #46, #75, and #76.

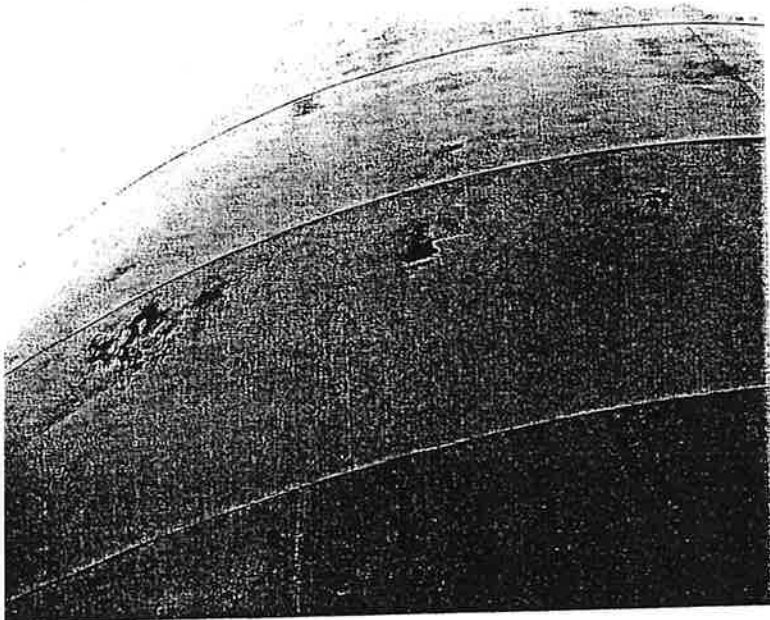
Photo # 20

Weathering with pinhole corrosion was present on the shell rings with sporadic coating breakdown down to prime coat occurring. Generalized mildew growth was present on throughout the bottom shell rings. Corrosion was affecting approximately 20% of the shell surfaces. Areas of checked coating were resulting in coating delamination down to prime coat. Corrosion was present on irregular surfaces such as the manhole lips, fasteners, overflow pipe, roof platform, ladder components, and base plate. Minor holidays were noted on the overflow pipe, ladder components, and rest platforms. See photographs #3-#5, #13-#42, and #44-#53.

Coating delamination on shell.

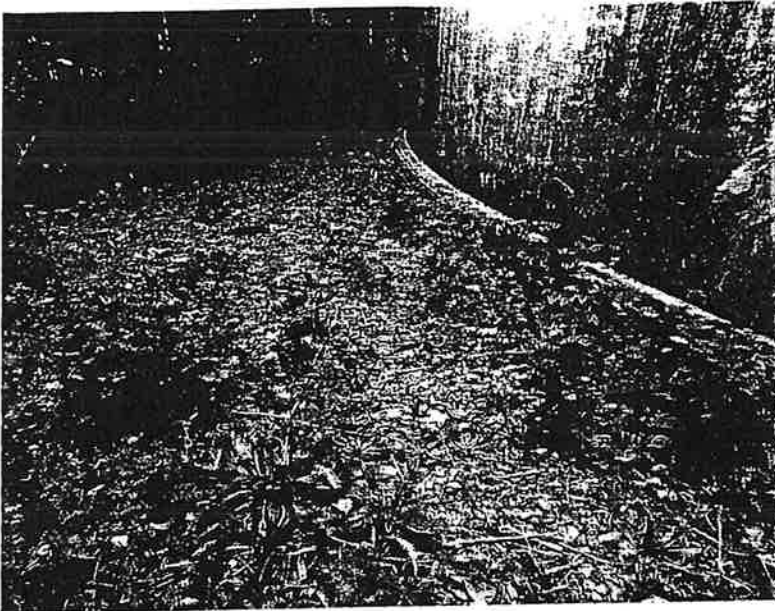
Photo #22

Corrosion on base plate, sealant breakdown, and foundation.

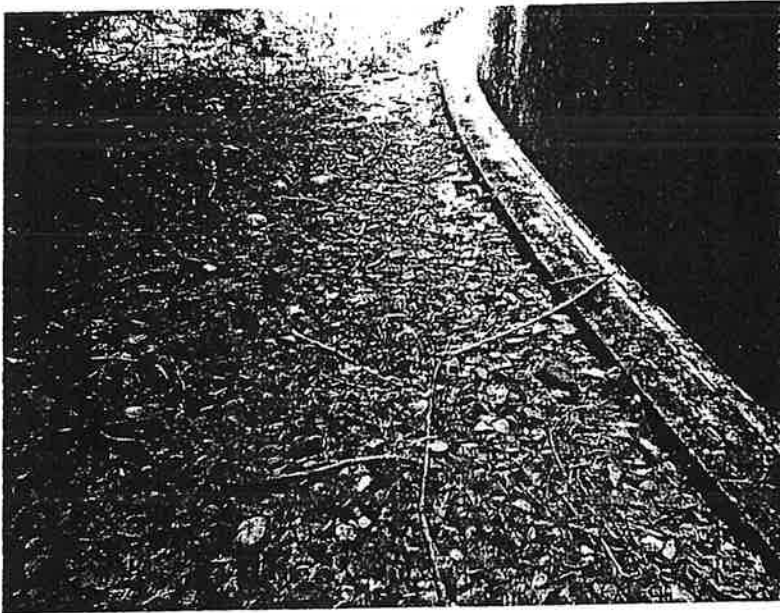
Photo #25

Overgrowth around tank foundation.
