PUBLIC PRESENTATION

VERONA EMERGENCY SERVICES COMPLEX

POLICE DEPARTMENT, FIRE DEPARTMENT - CO. #2, RESCUE SQUAD

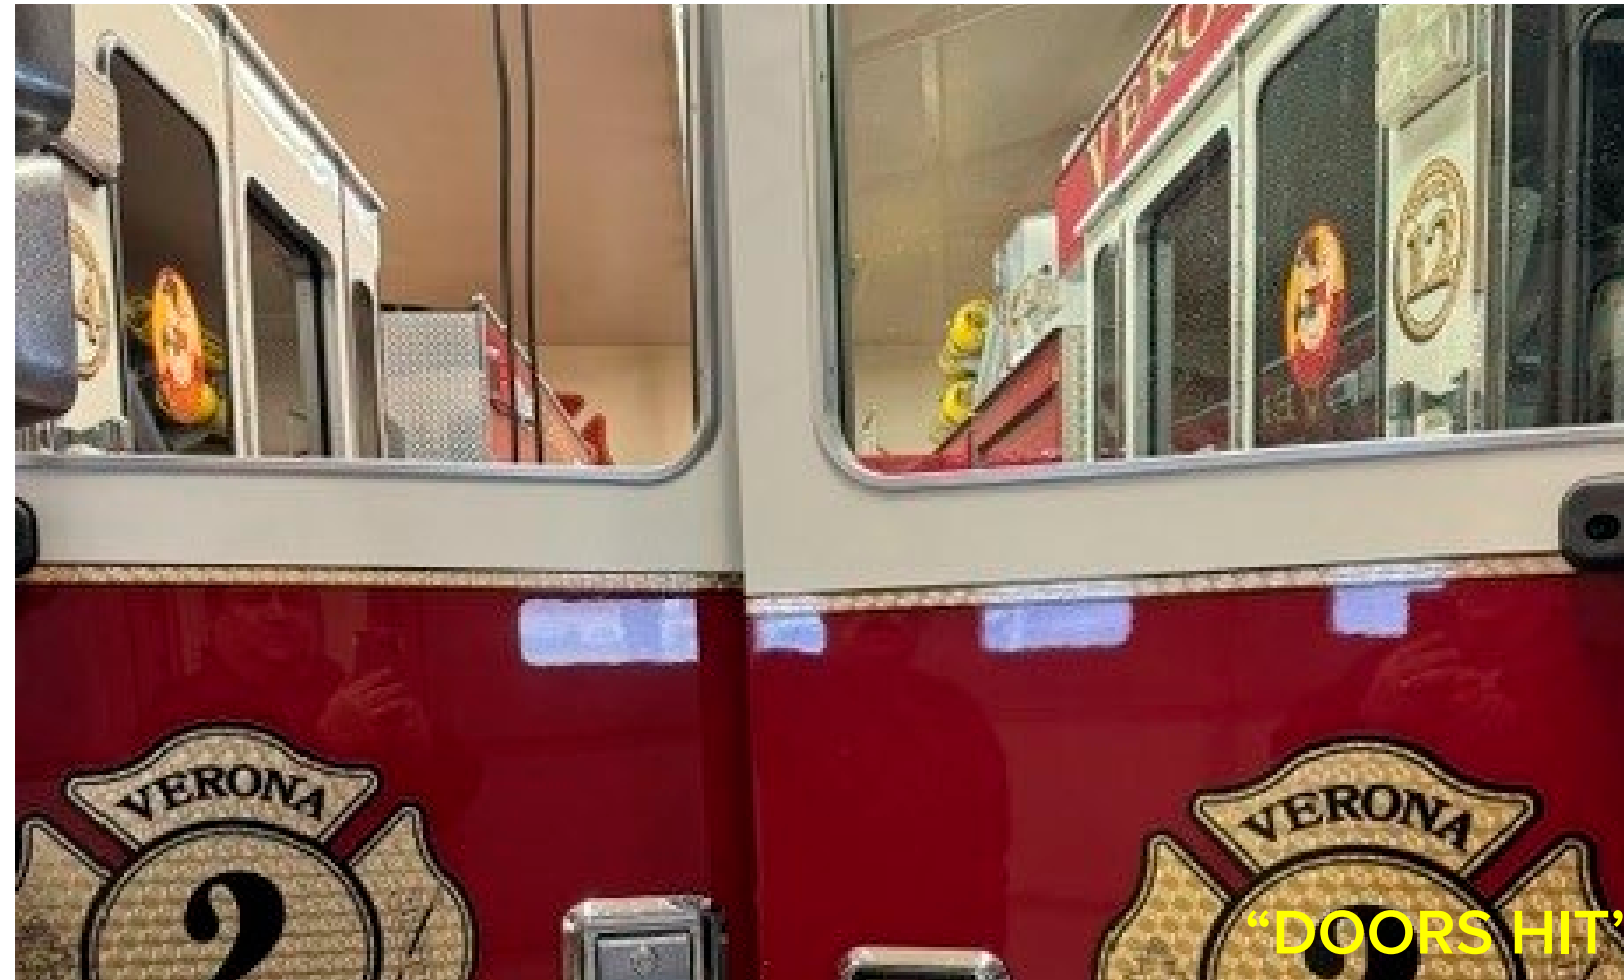
"DOORS HIT"

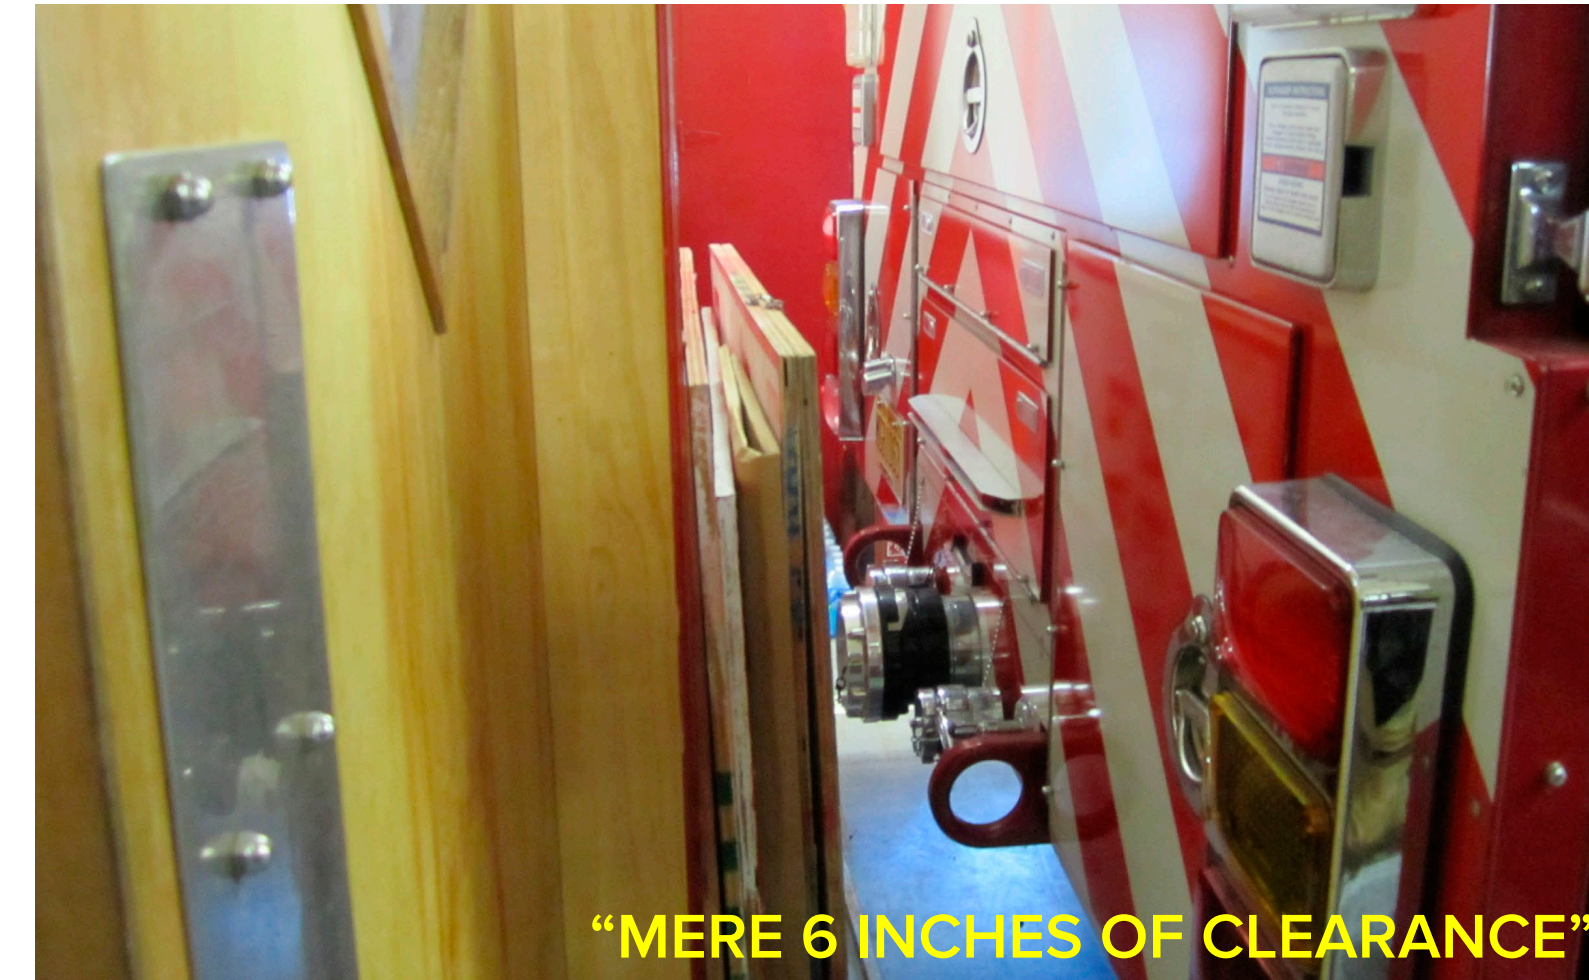
"MERE 6 INCHES OF CLEARANCE"

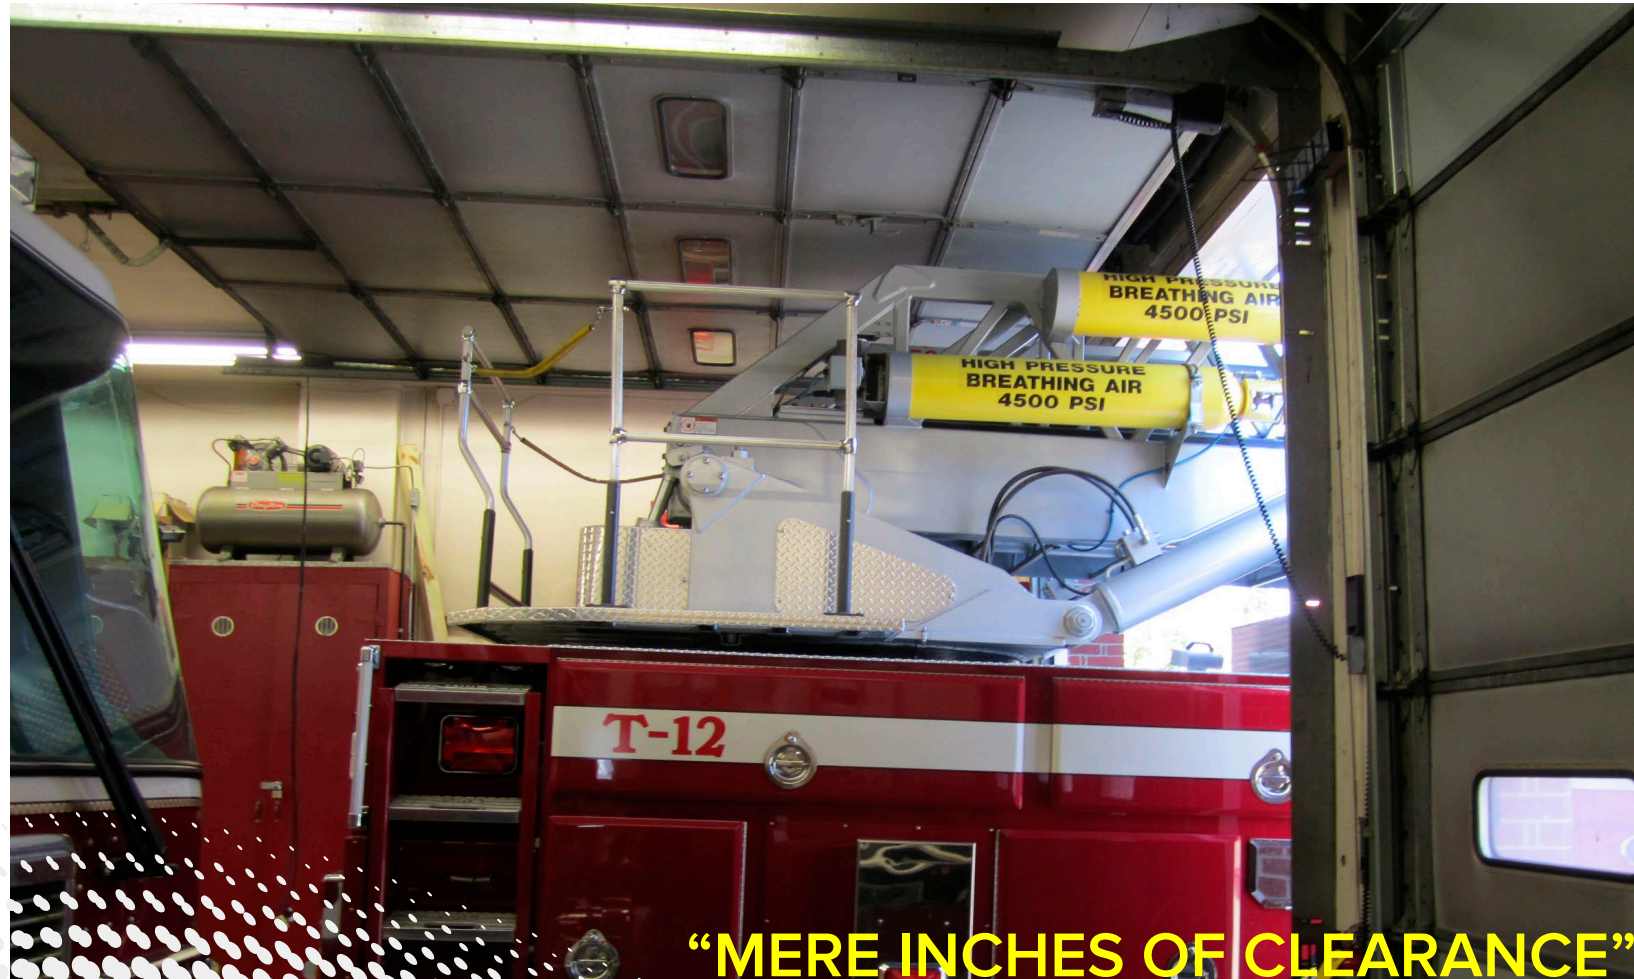
"MERE INCHES OF CLEARANCE"

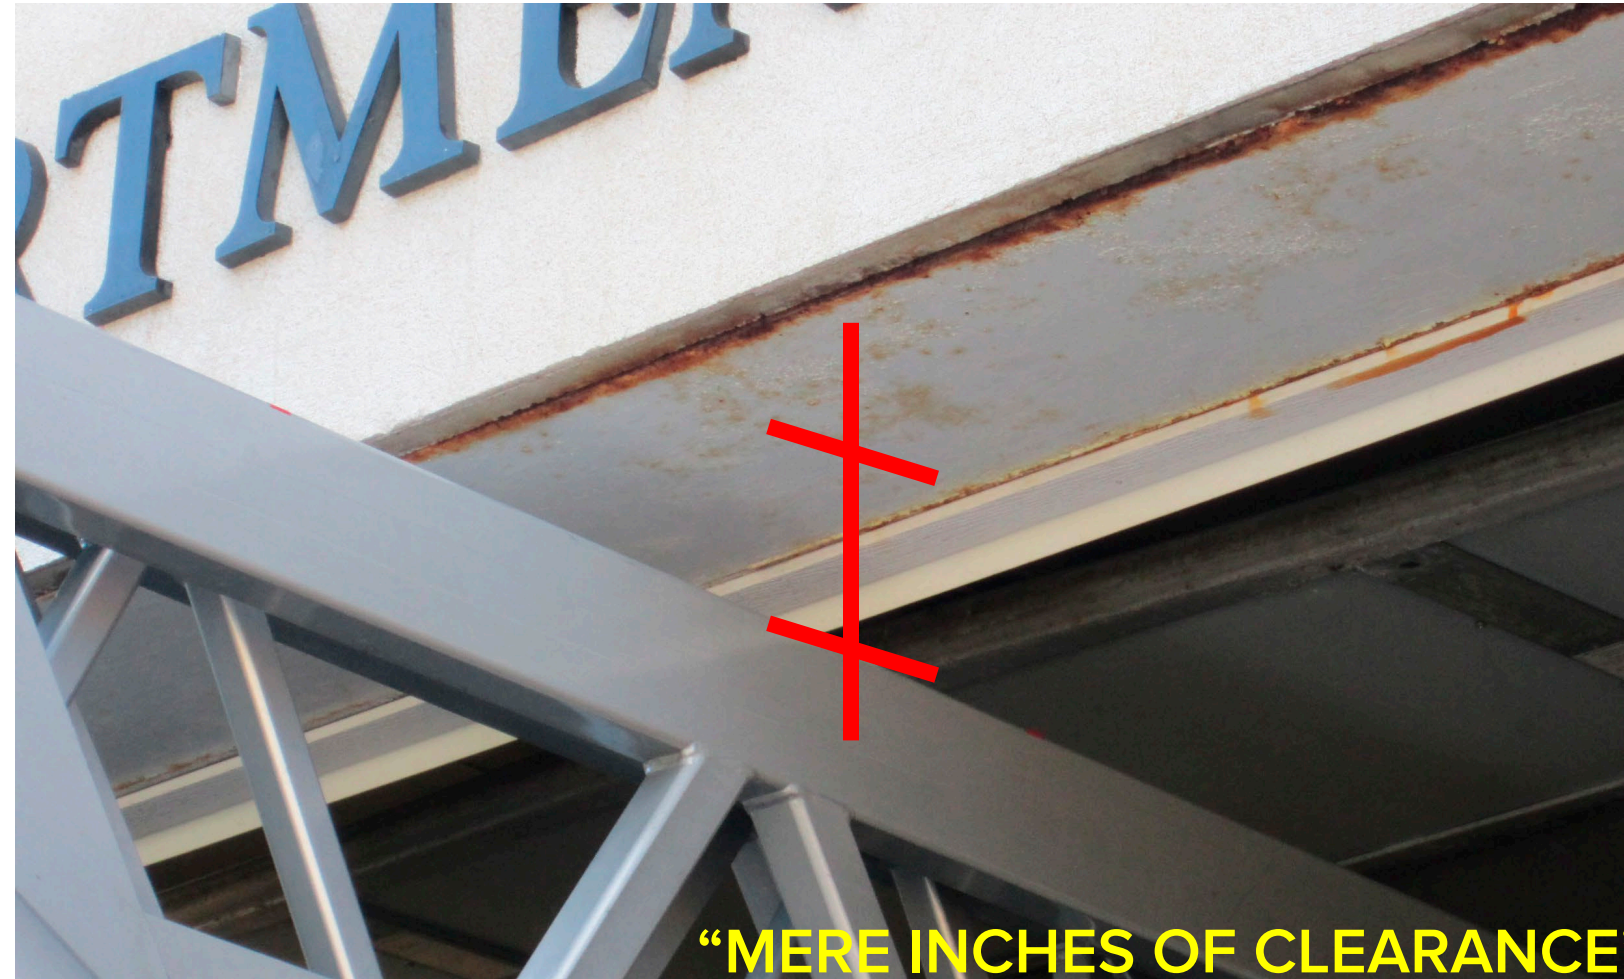
"MERE INCHES OF CLEARANCE"

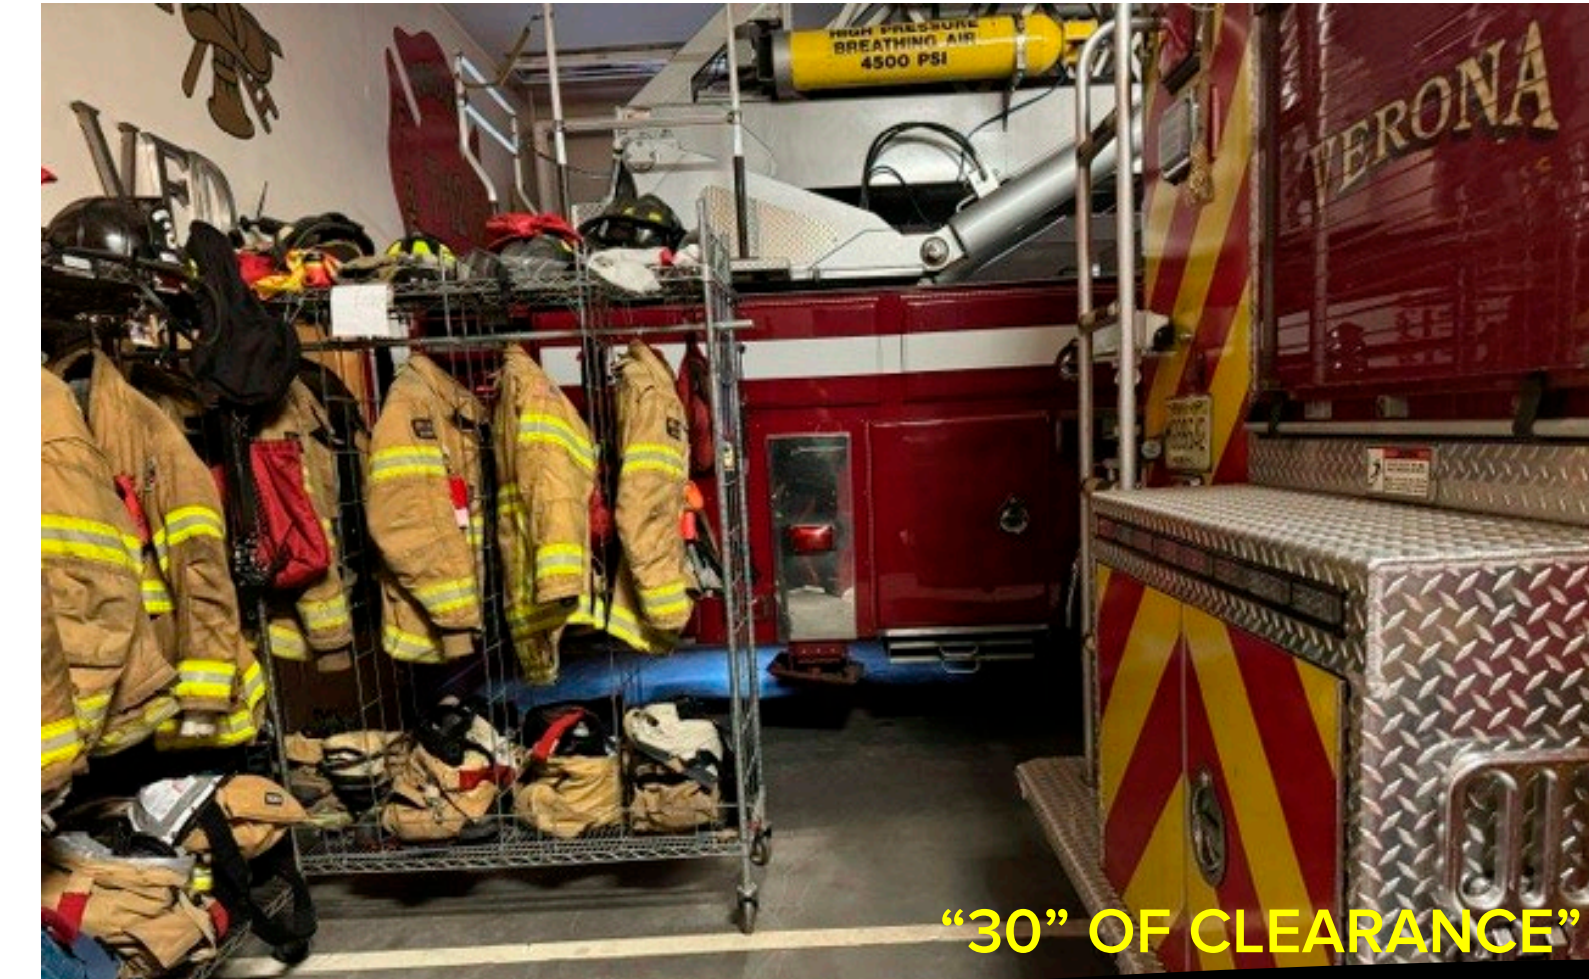
"30" OF CLEARANCE"
