THE NEED

VERONA EMERGENCY SERVICES COMPLEX

POLICE DEPARTMENT, FIRE DEPARTMENT - CO. #2, RESCUE SQUAD

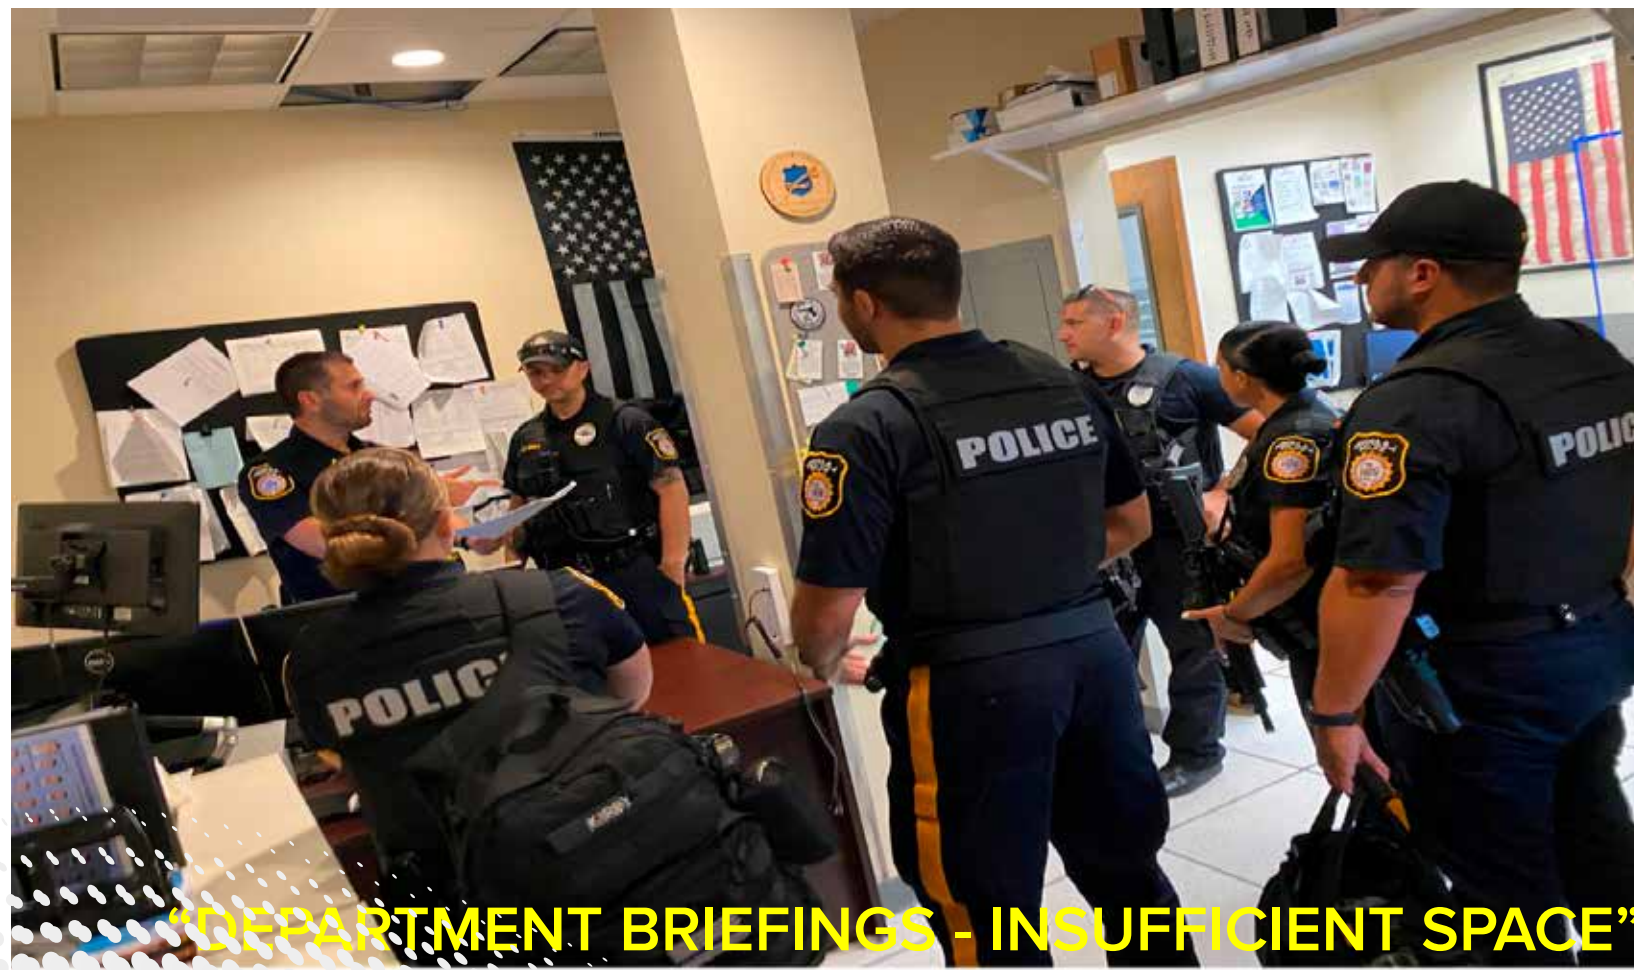
"DEPARTMENT BRIEFINGS - INSUFFICIENT SPACE"

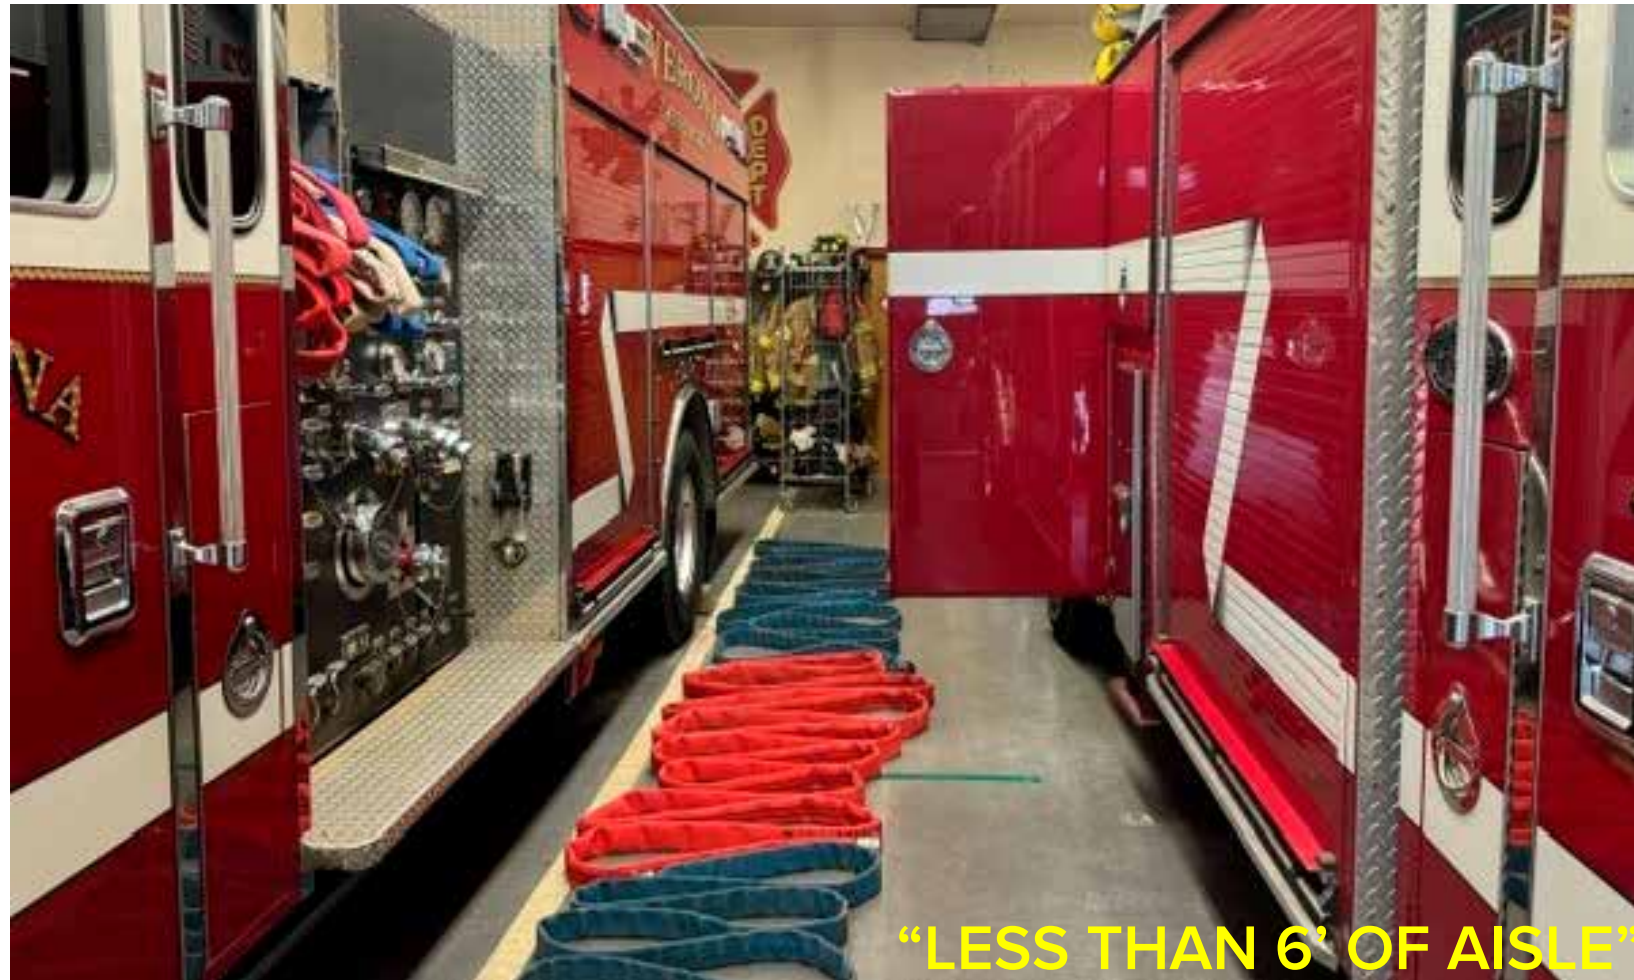
"LESS THAN 6' OF AISLE"

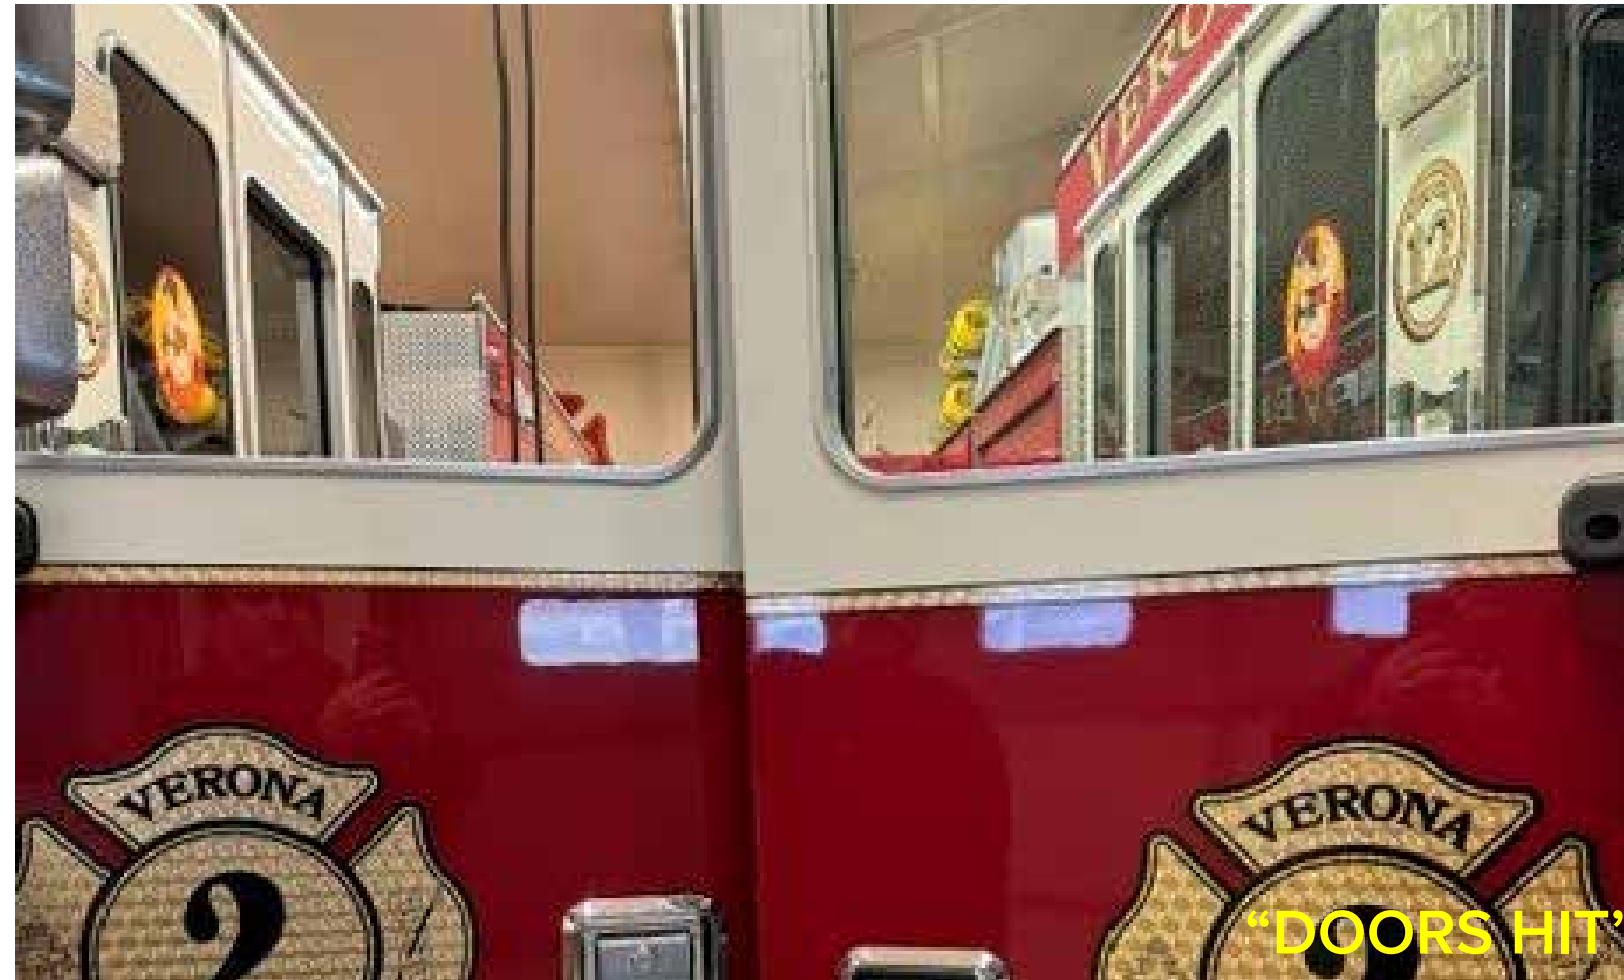
"DOORS HIT"

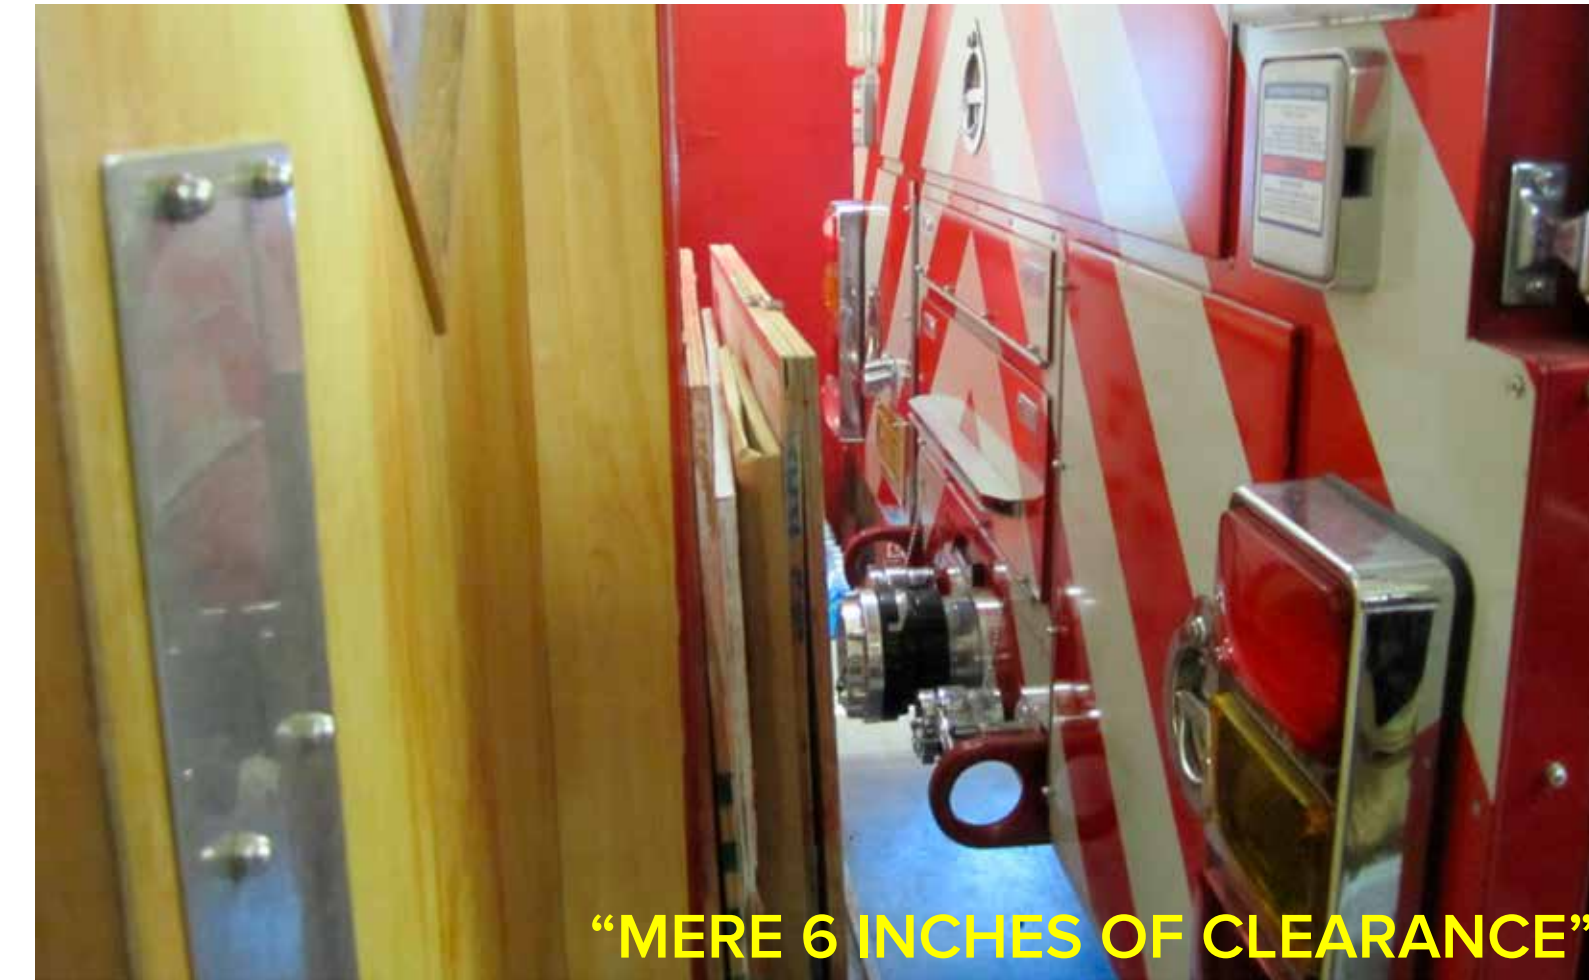
- » Building is 74 years old and is NOT OSHA compliant with present day standards:
 - » Apparatus bay is 50' - Ladder Truck is 48' and the platform on the ladder must have 1.5' clearance from the garage doors, leaving 6" from wall of the bay.
 - » There is no room for gear racks behind the ladder truck, all the gear racks are on the driver's side wall creating a safety issue when four or five members are donning the gear necessary to respond to a fire call.
 - » Overhead doors are only 12' high resulting in minimal clearance for certain apparatus.
 - » There are inadequate parking spaces. The company may have as many as 28 members and there are only 11 parking spaces.

"MERE 6 INCHES OF CLEARANCE"

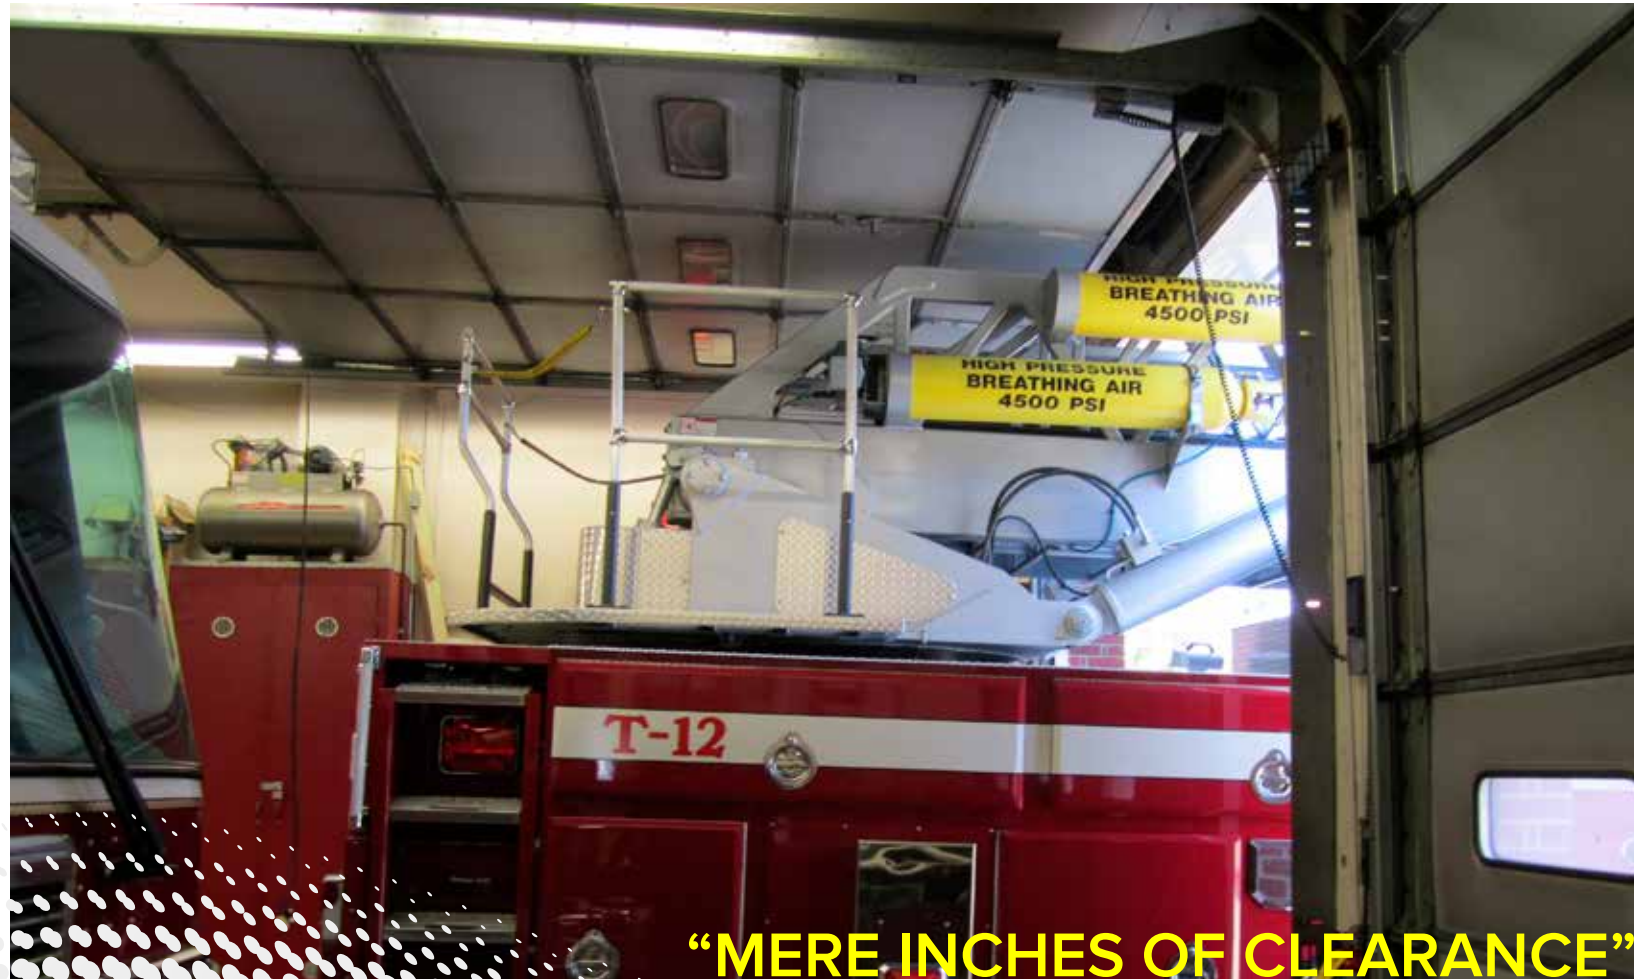
"MERE INCHES OF CLEARANCE"

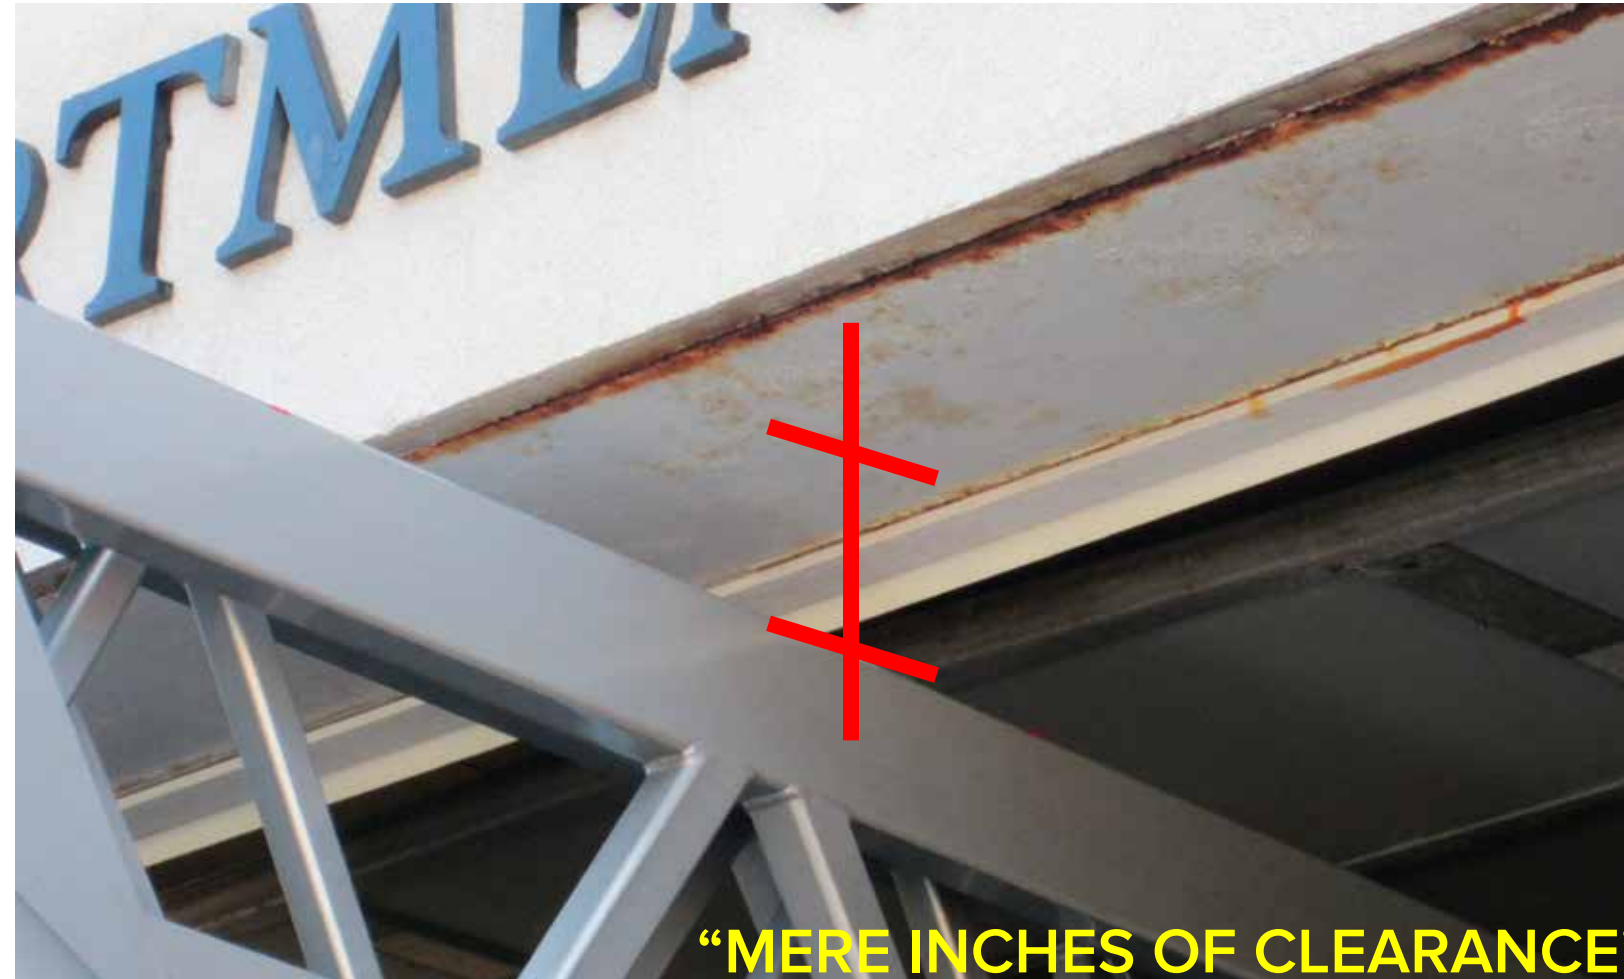
"MERE INCHES OF CLEARANCE"

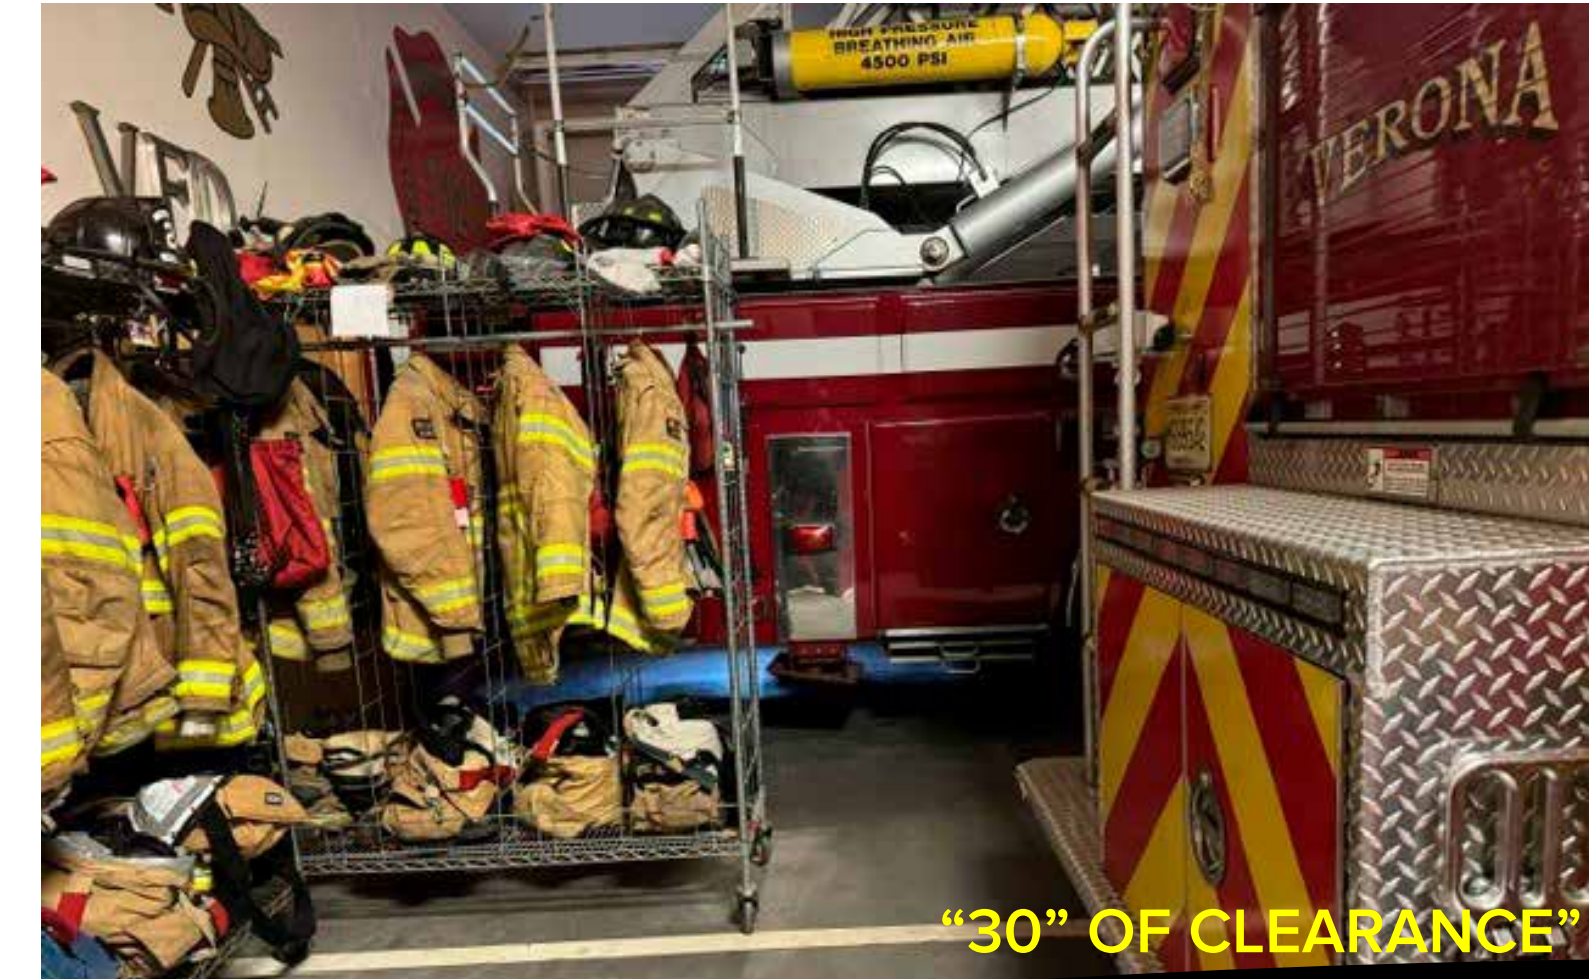
"30" OF CLEARANCE"
